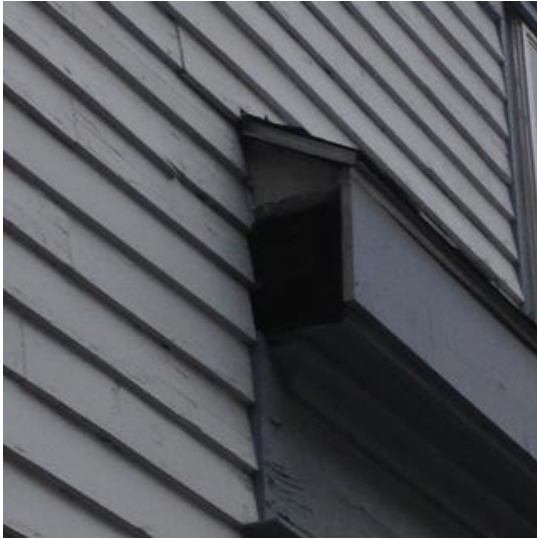
South Face of Residence
Closeup of Dormer Joint to be Repaired

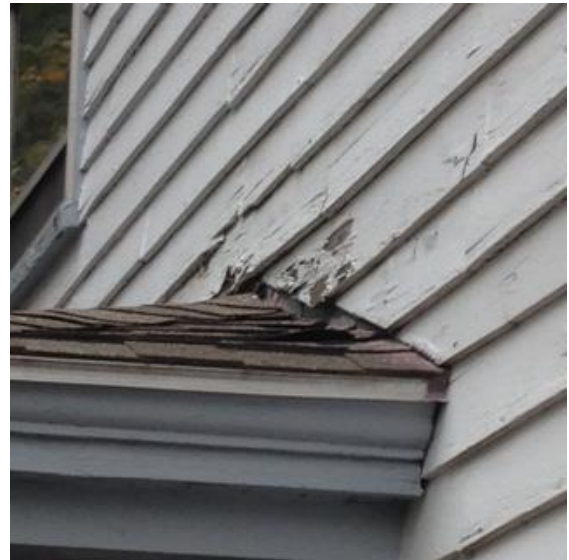
South Face of Residence
Closeup of Repairs and Flashing Work to be Done

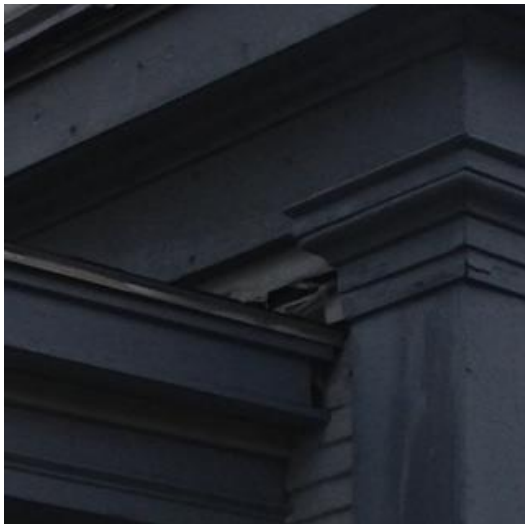
South Face of Residence
Closeup of Porch Roof Joint Area to be Repaired

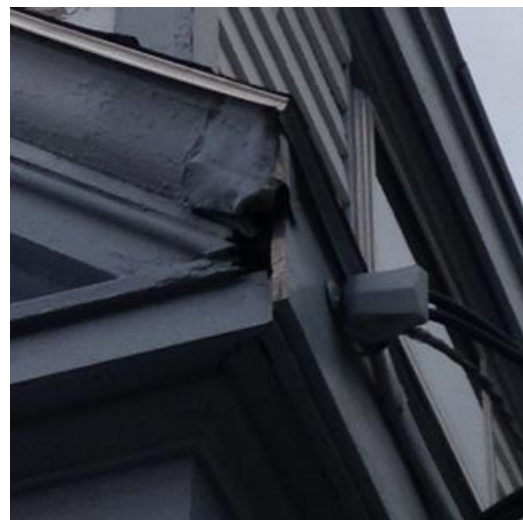
East Face (Front) of Residence
Closeup of Bay Window Trim to be Repaired
