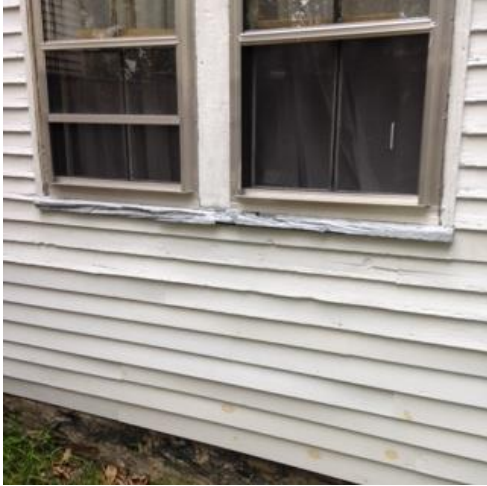
West (Rear) Face of Building
Window Sills to be Replaced

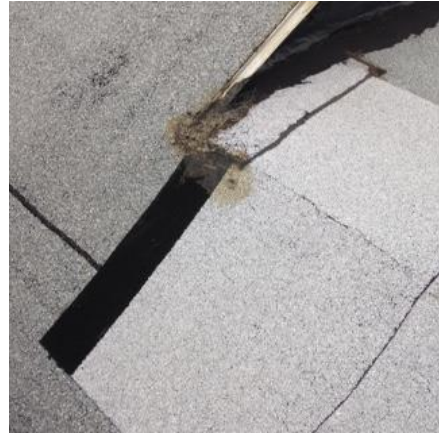
Roof
Transition Area to be Repaired
