Re: Review of structural impact from increasing wall openings

FLOOR PLAN UNIT SIX

180 HIGH STREET

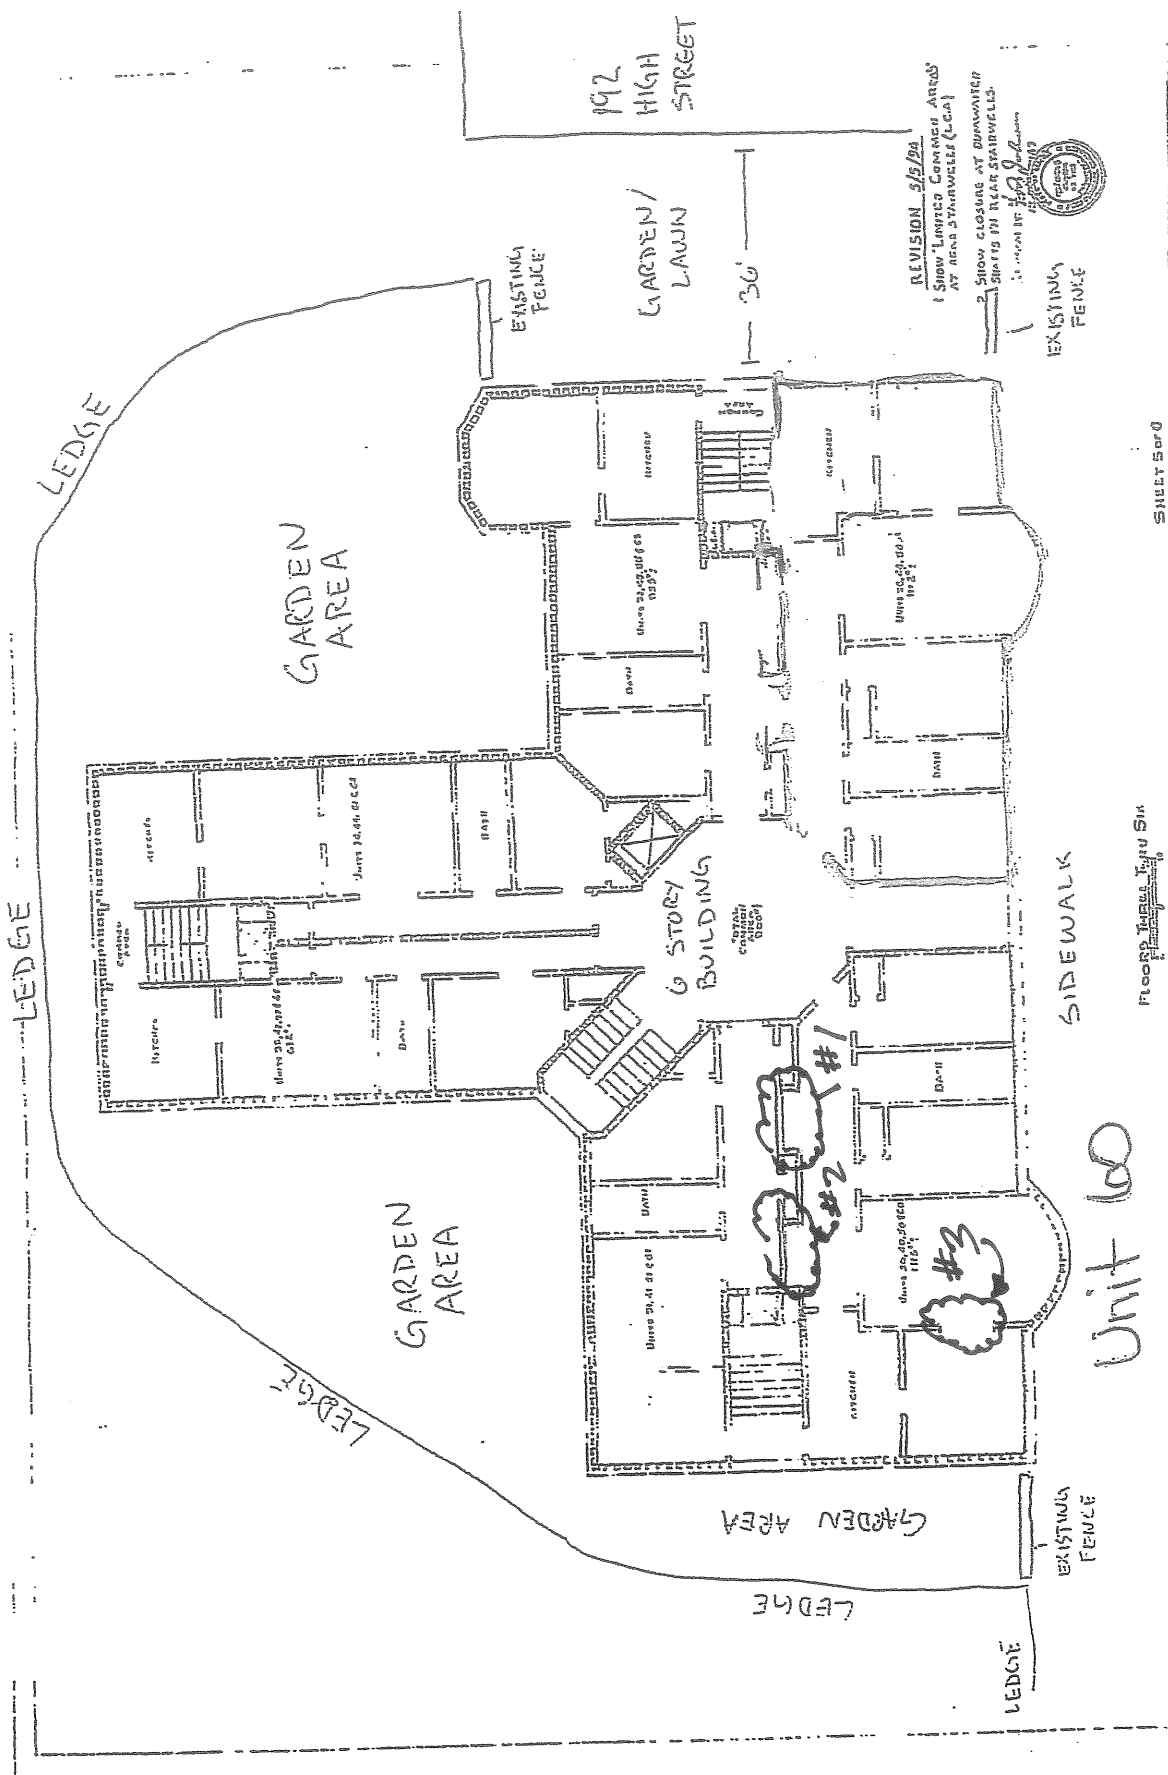
SHEET 500

Regarding the planned renovations, the load-bearing portion of the wall that contains openings #1 and #2 does not extend to opening #1. It does extend about 3' into the widened 6' opening #2. However, since the joists are continuous over the top of the wall without splices and the spans on either side of the wall are only 3'-6" and 5'-6", it is not necessary to provide temporary support for the roof construction during demolition. This assumes that the demolition and reconstruction can occur when there is not a significant snow load on the roof. I do recommend that the header utilized to span the new 6 foot opening consist of 2-2x8 members of #2 Spruce-Pine-Fir, or better. The wall that contains opening #3 is parallel with framing members and, therefore, is not load-bearing.

To summarize, I find that openings #1 and #3 do not occur in load-bearing walls. Standard details for framed openings in a non-bearing partition may be utilized. At opening #2, approximately 1/2 of the opening is within a load-bearing portion of the wall. But because the rafters above are continuous over the wall with short spans on both sides of the wall, shoring of the roof construction is not required during construction unless that construction is delayed to

coincide with a period of heavy snow accumulation. Over opening #2, a lintel should be used with a minimum size of 2-2x8 of lumber #2 grade and Spruce-Pine-Fir species graded under NLGA rules, or better.
