Re: Special Inspections Final Report
645 Congress St.
Portland, Maine

Final Report of Structural Special Inspections

Project: *Renovations to 645 Congress Street*
Location: *645 Congress Street; Portland Maine*
Owner: *Bayside Maine, LLC*

Structural Design Professional in
Responsible Charge: *David A. Price, PE / Price Structural Engineers, Inc.*

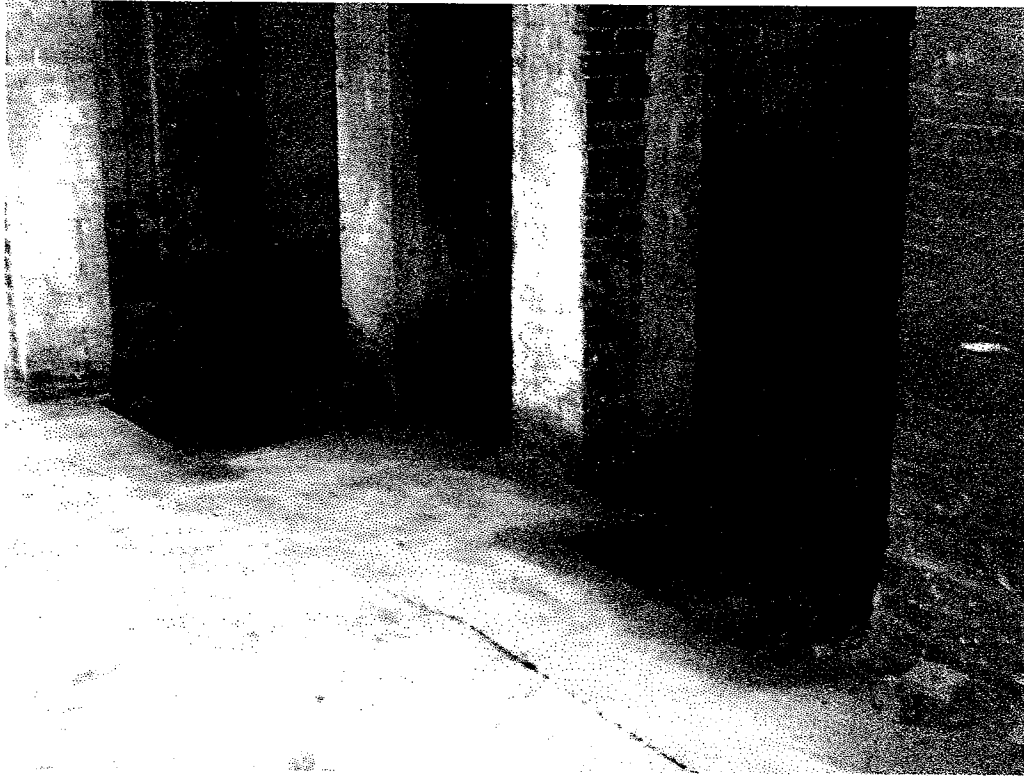
Photo # 1 – Sawcut slab at Basement (Grid A)

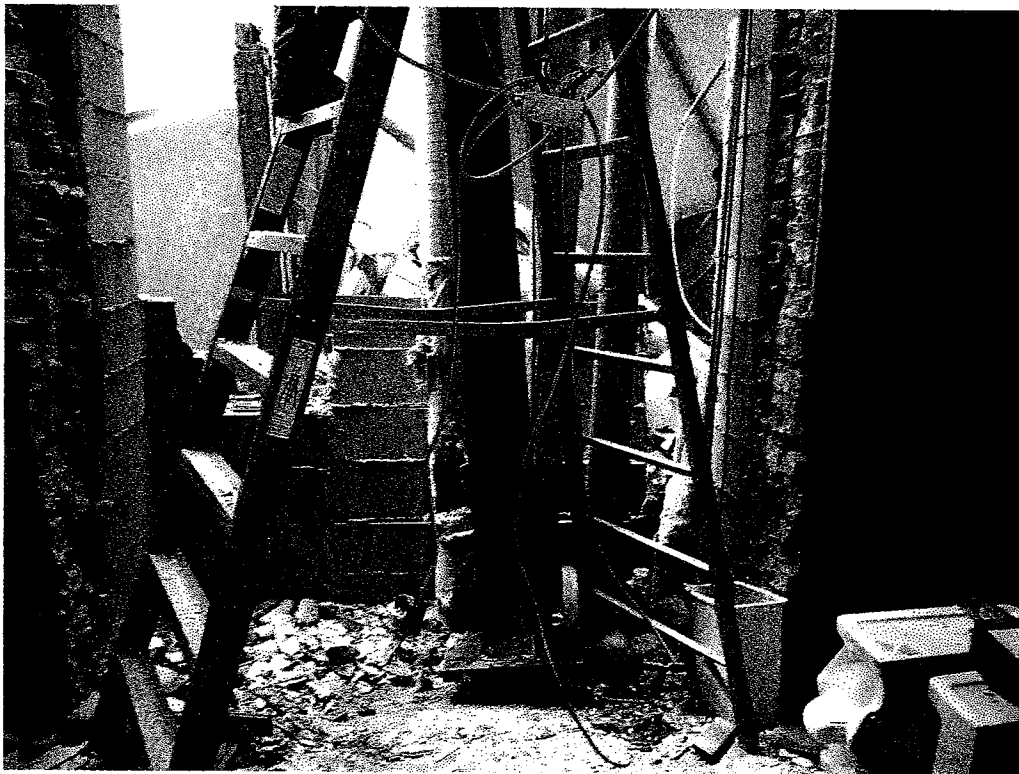
Photo # 2 - Installation of Column at Grid F/5.8 (1st Floor)

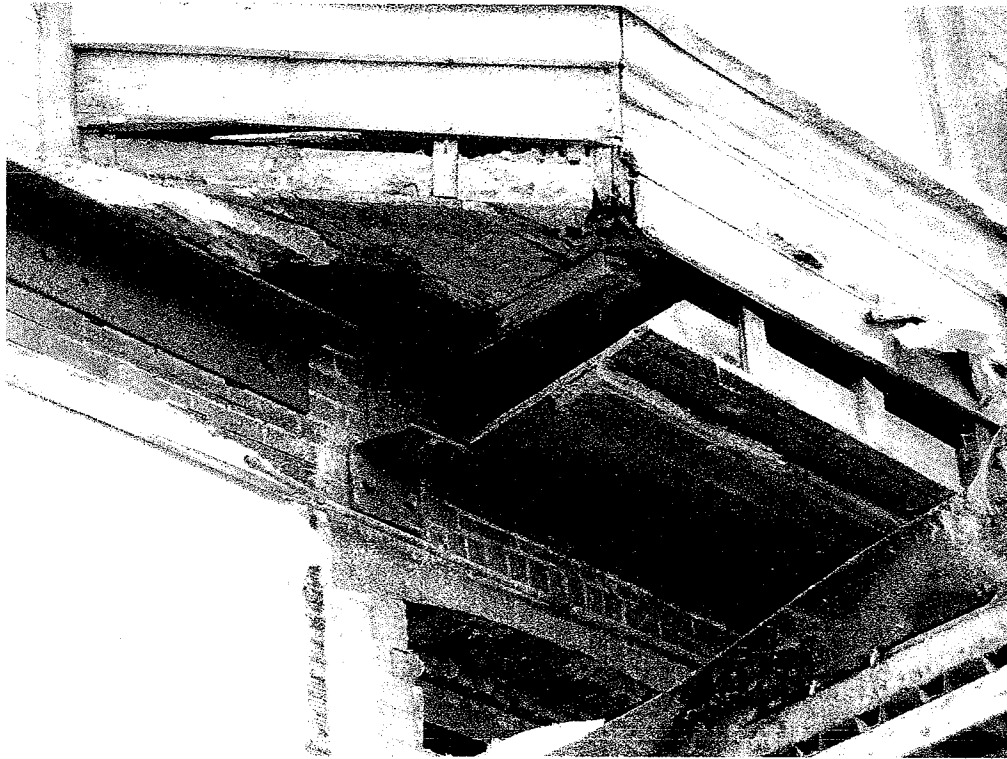
Photo # 1 – Damaged support of existing second-floor bay window at grid F/4.8

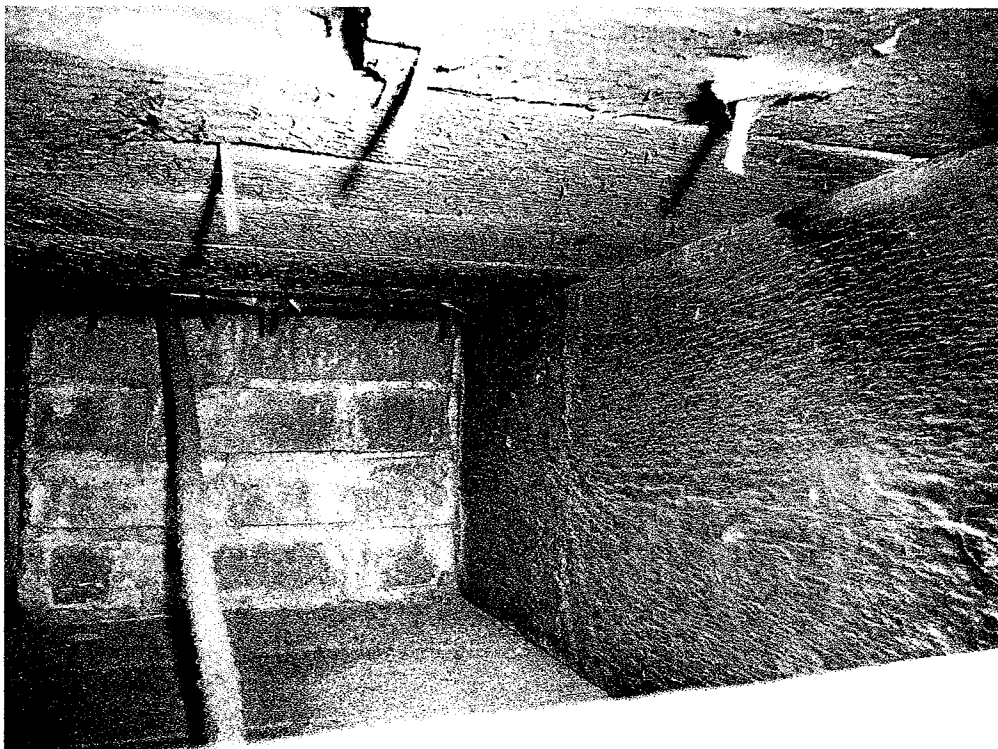
Photo # 2 – Wood framing below existing second-floor bay window at grid F/4.8 mortared into existing brick.

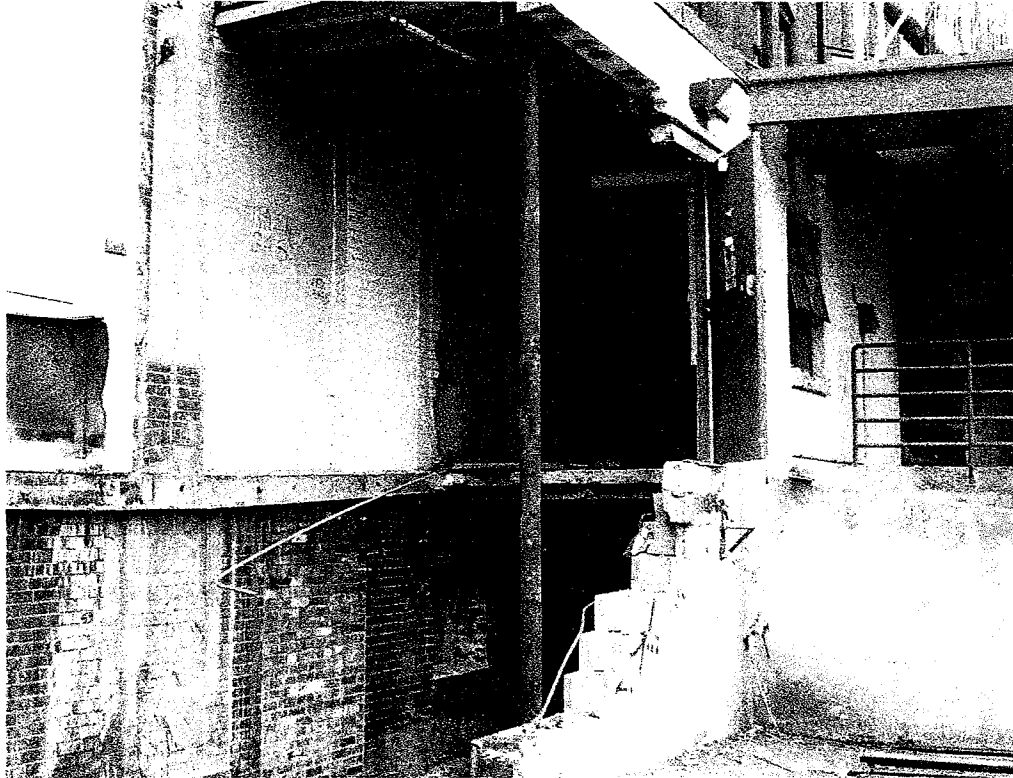
Photo # 3 - Collapsed CMU assembly at grid F.4 / 4.5

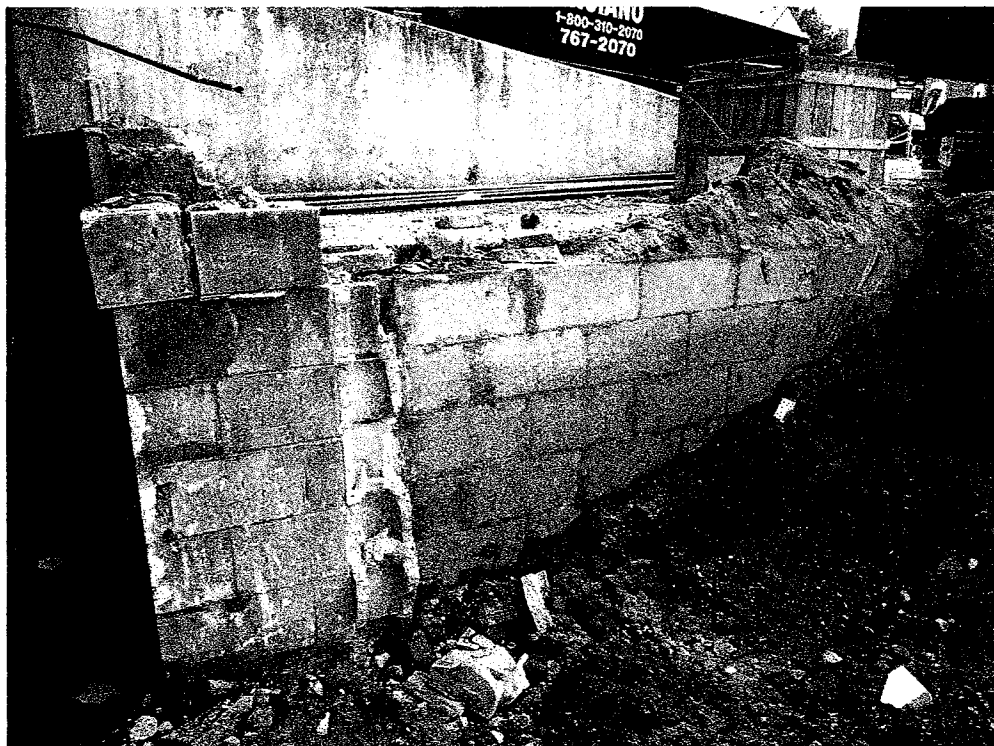
Photo # 4 - Existing ungrouted 8" CMU foundation at grid 4.8 (rear entry)

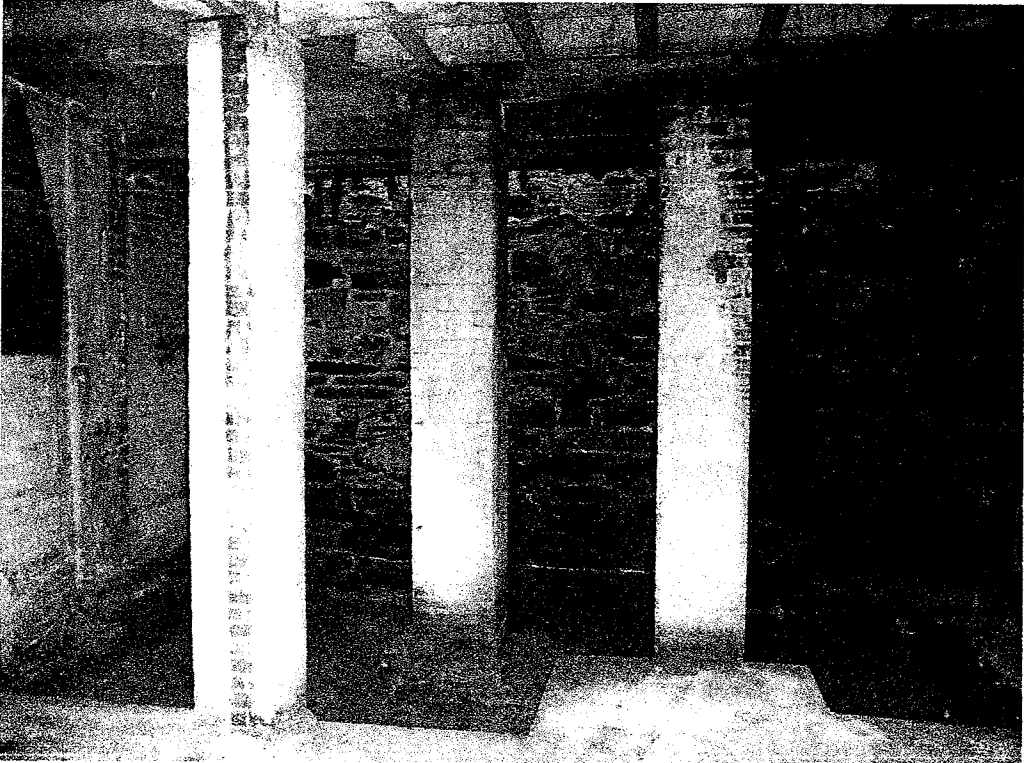
Photo # 5 – Existing brick column and footing in basement at grid A./8 (shown at center).

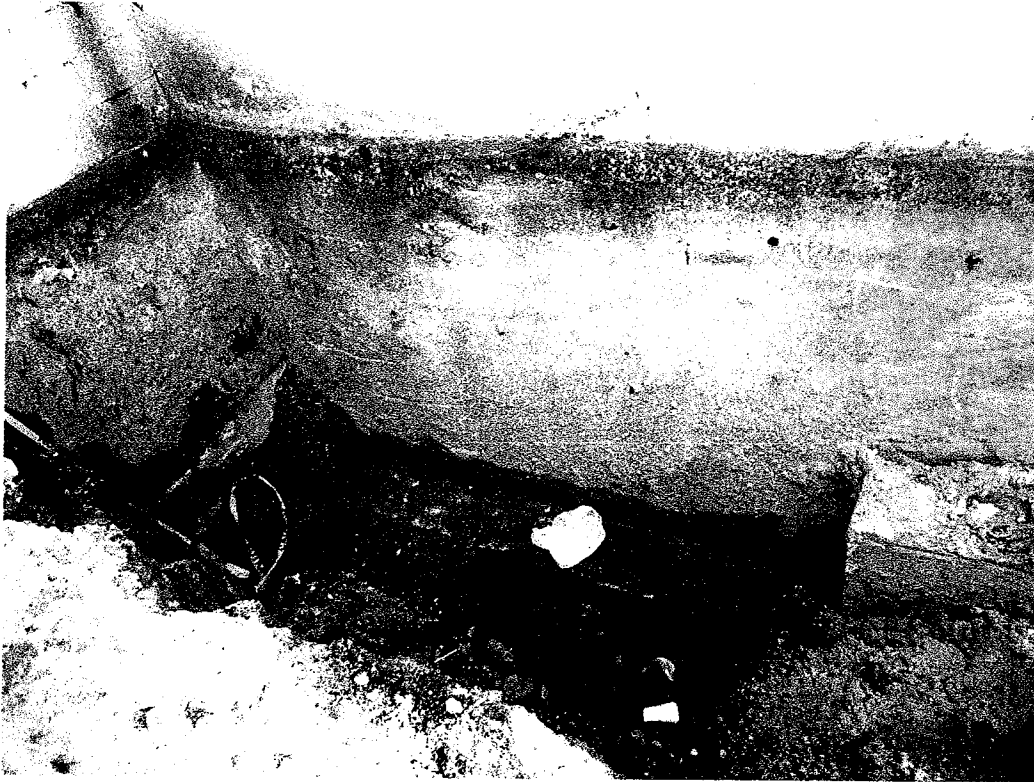
Photo # 1 – View looking southwest at existing wall footing adjacent to dumpster concrete wall (approximate grid location G.1/4.2) – note interfering footing at right side.

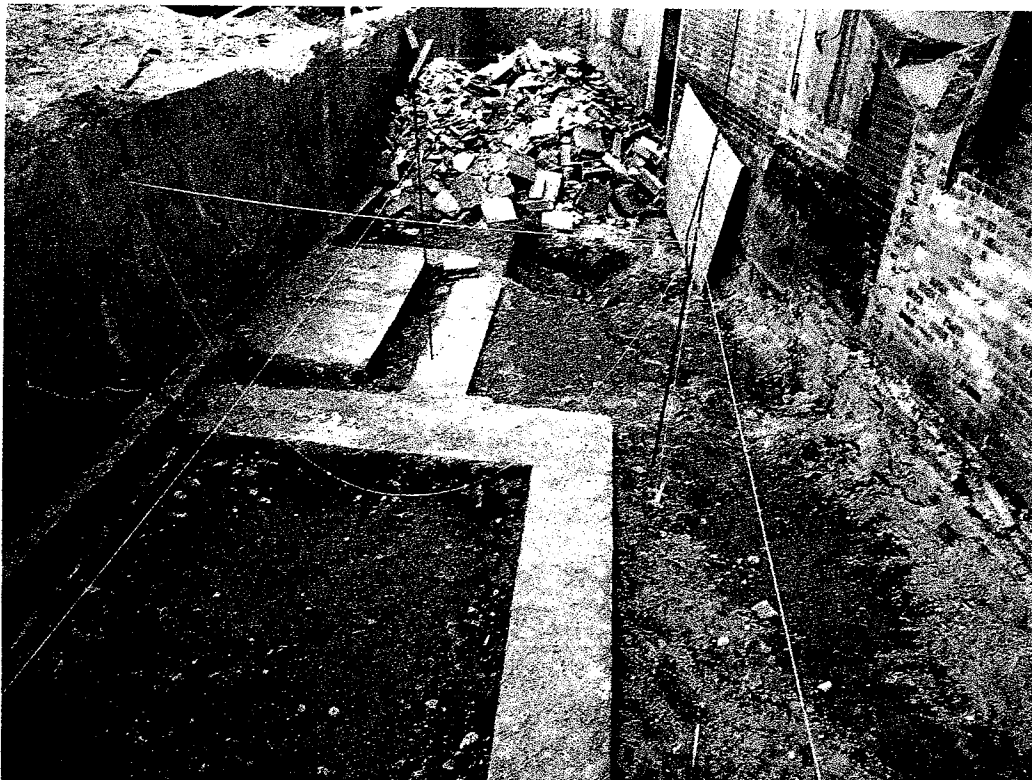
Photo # 2 – Existing first entry foundations and footings (view looking east)

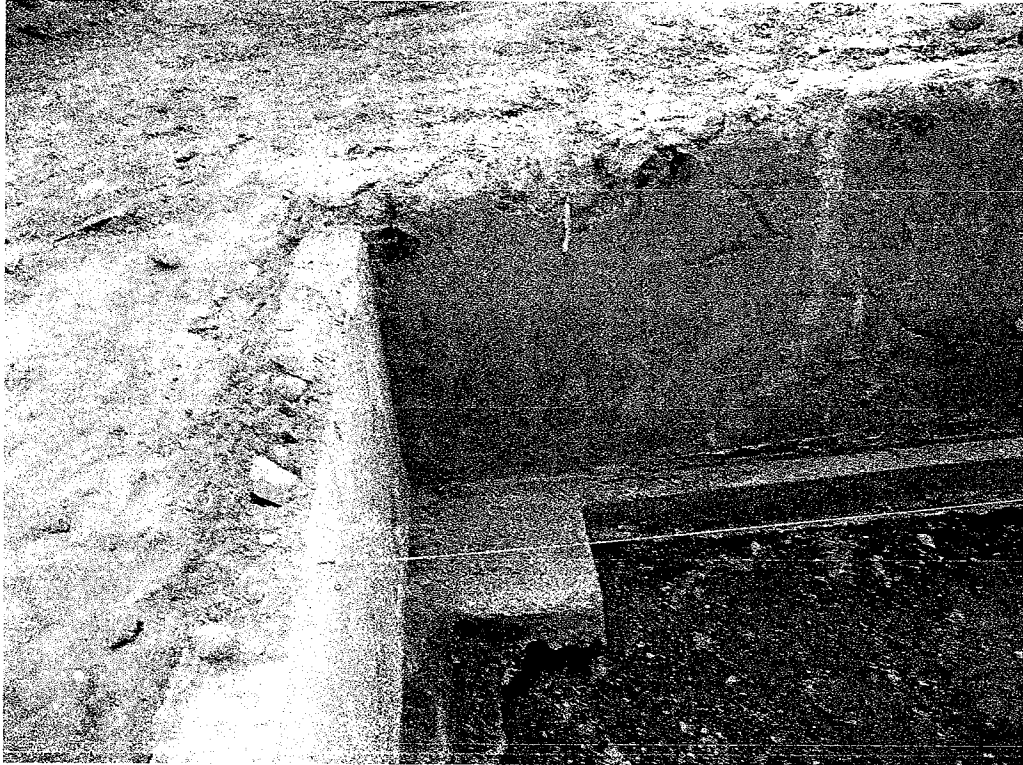
Photo # 3 – View looking north at grade 4.8 - note significant damage to top of existing concrete wall located at grade G.1/4.8 (occurred during demolition).

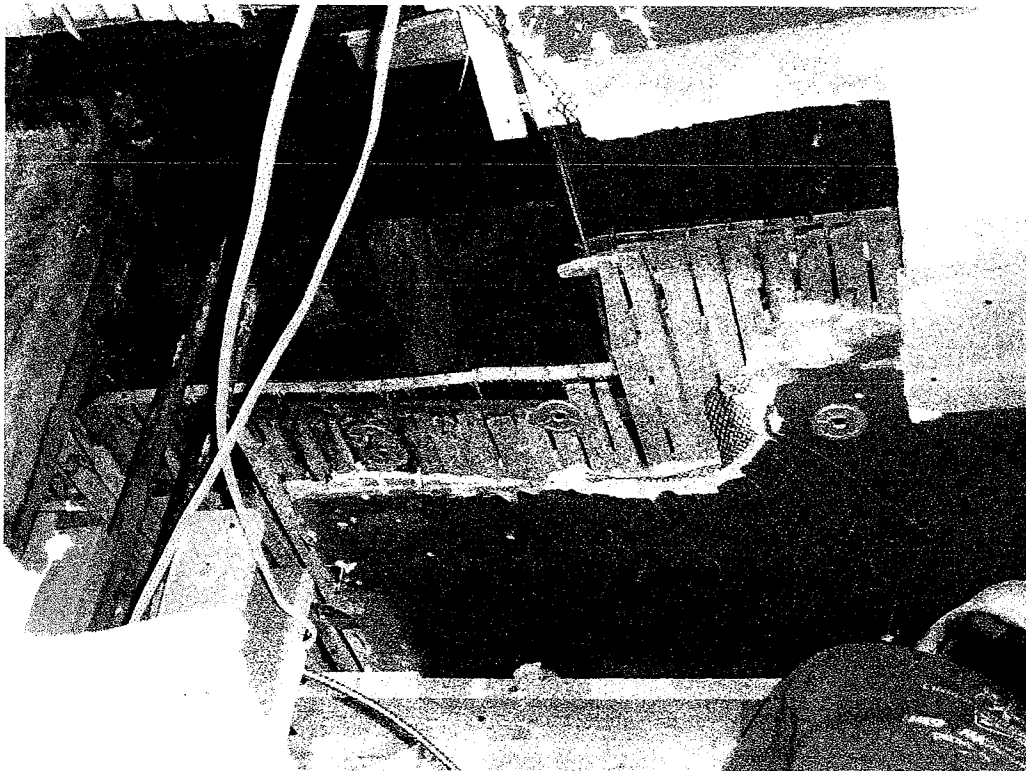
Photo # 4 – Existing ceiling above ground floor, located near grid D/8. anchors being added to reconnect wood ceiling to joists above

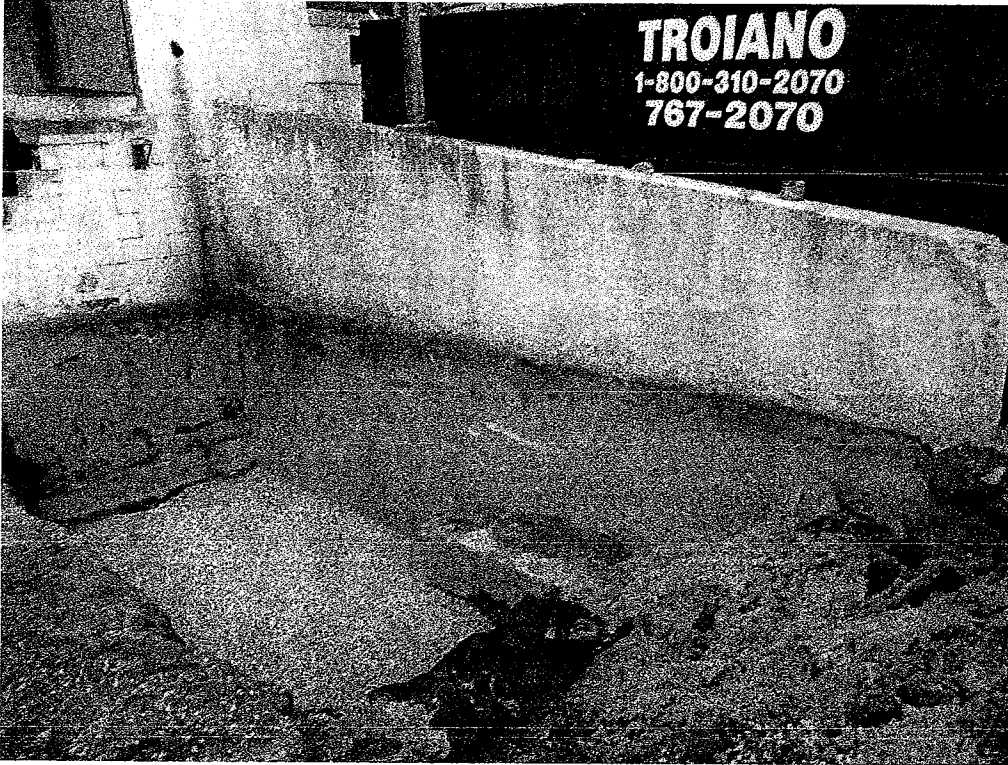
Photo # 1 – Compacted stone at grid G.1/4.2 as recommended by S. W. Cole engineers

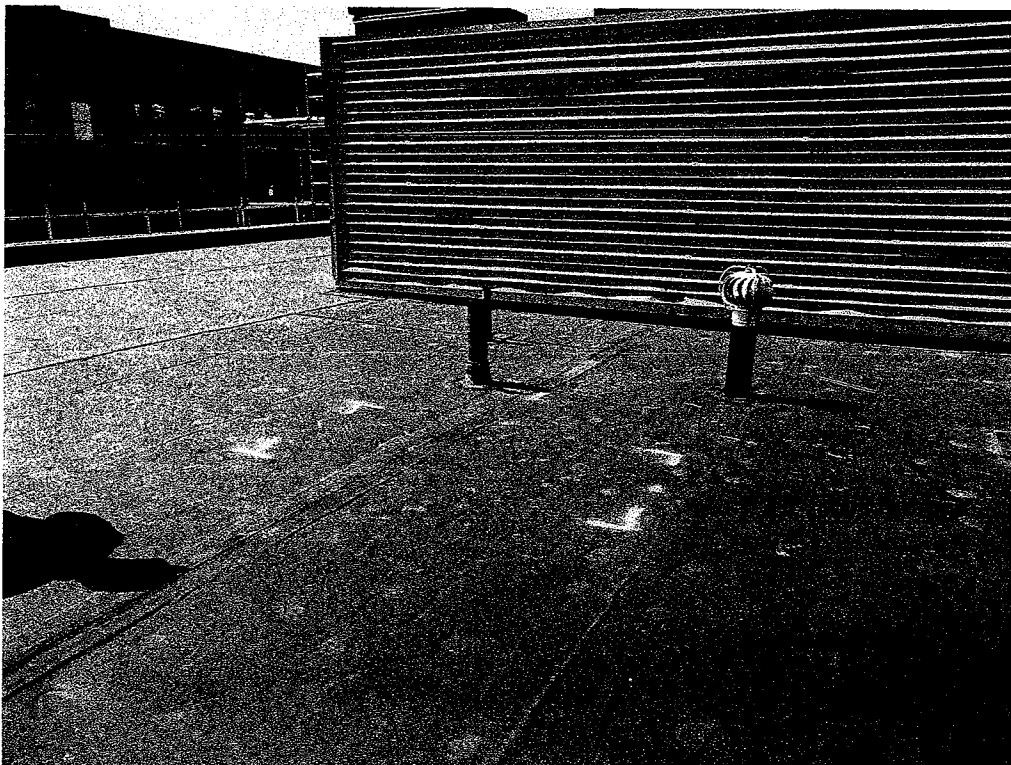
Photo # 2 – Revised relocation of rooftop HVAC (shown by yellow marking on roof) located over column

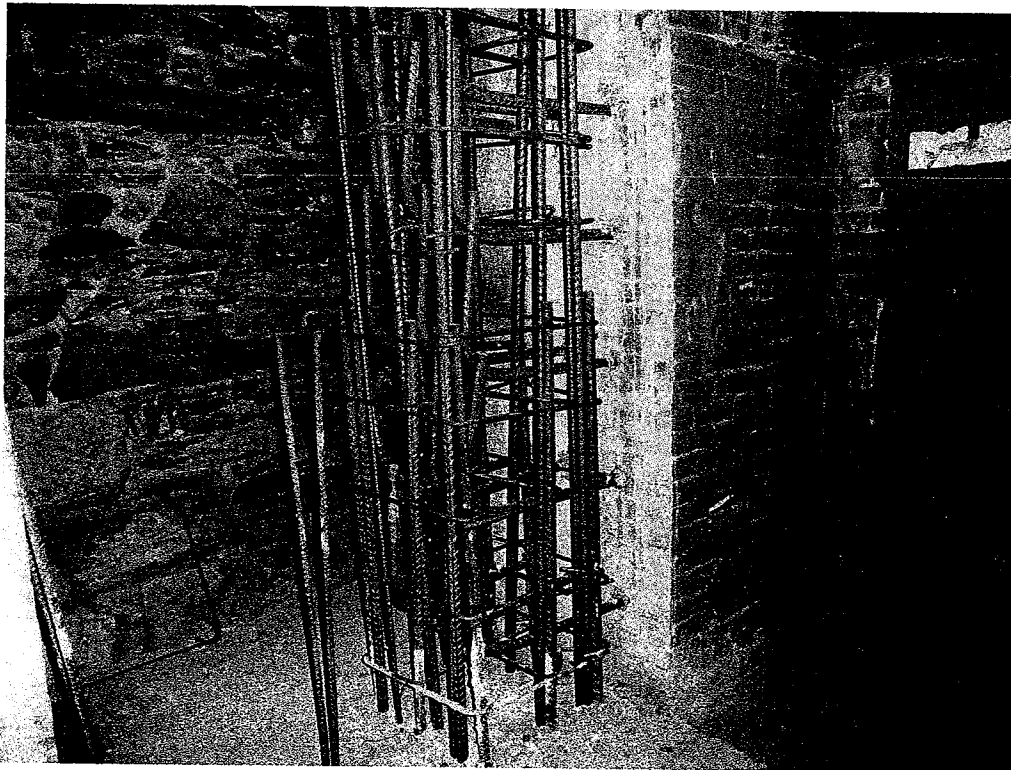
Photo # 4 – Reinforcement for new concrete piers in basement at Grid A (note dowels into the existing brick)

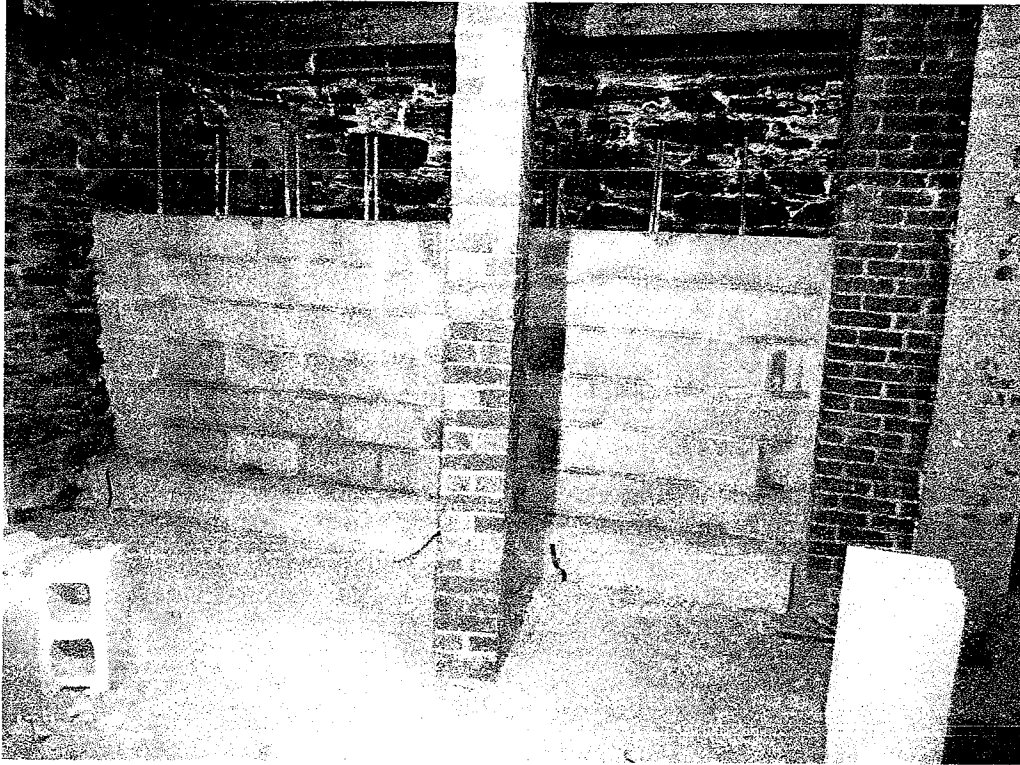
Photo # 1 – Four foot tall 8” CMU at basement grid A/8 to A/10

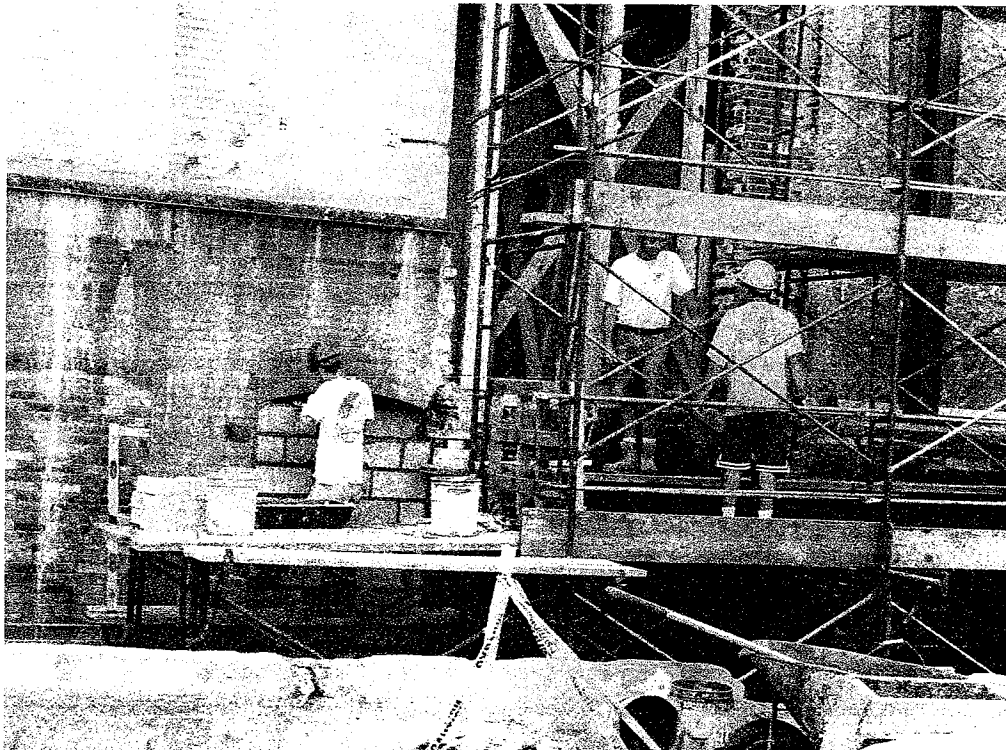
Photo # 2 – Infill of existing hole in basement brick foundation wall at grid F/7

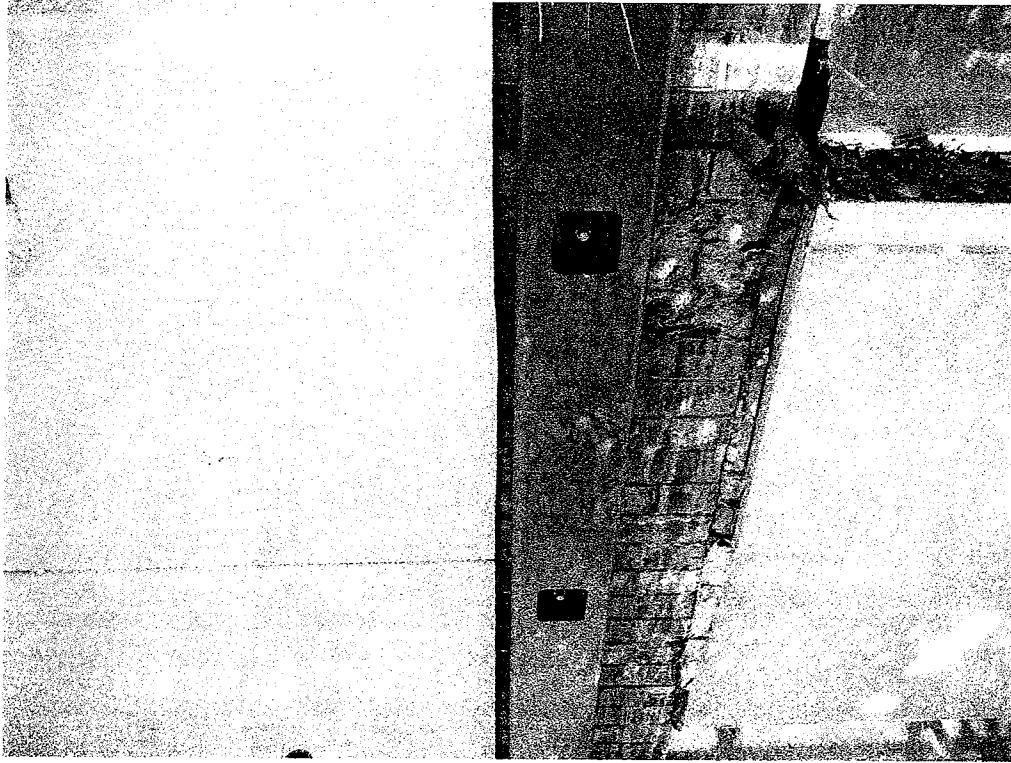
Photo # 3 – Steel tubes HSS 6"x2" bolted to front of building for new bay windows on Congress Street.

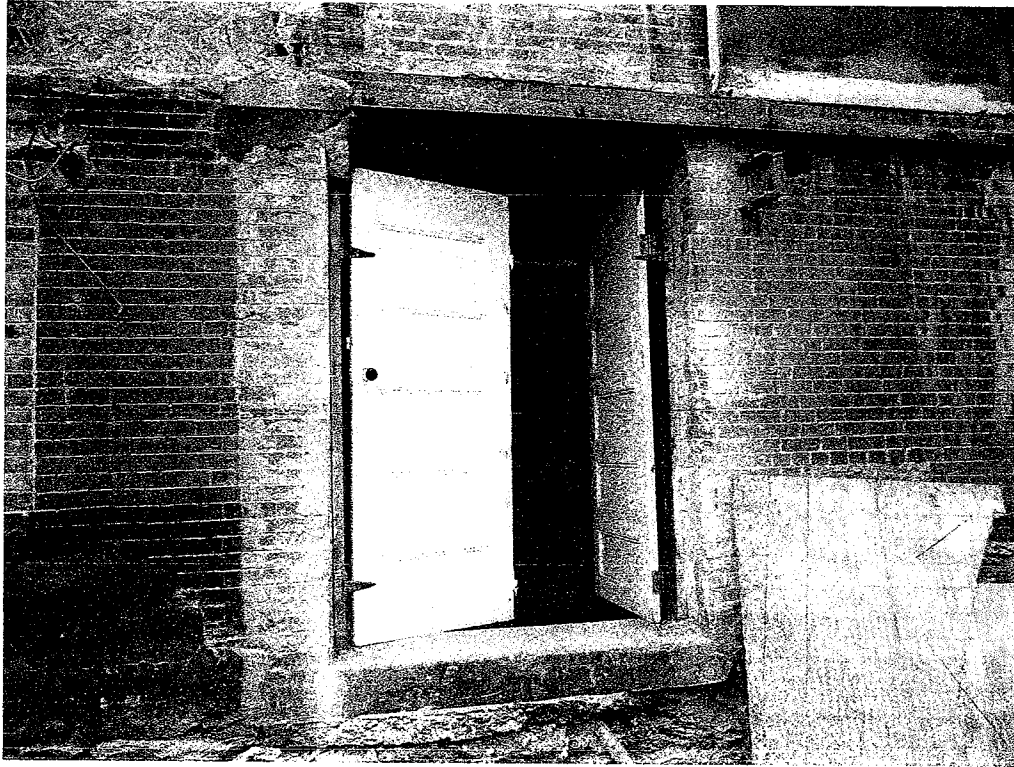
Photo # 3 – Existing lintel above basement door at grid F/5.2

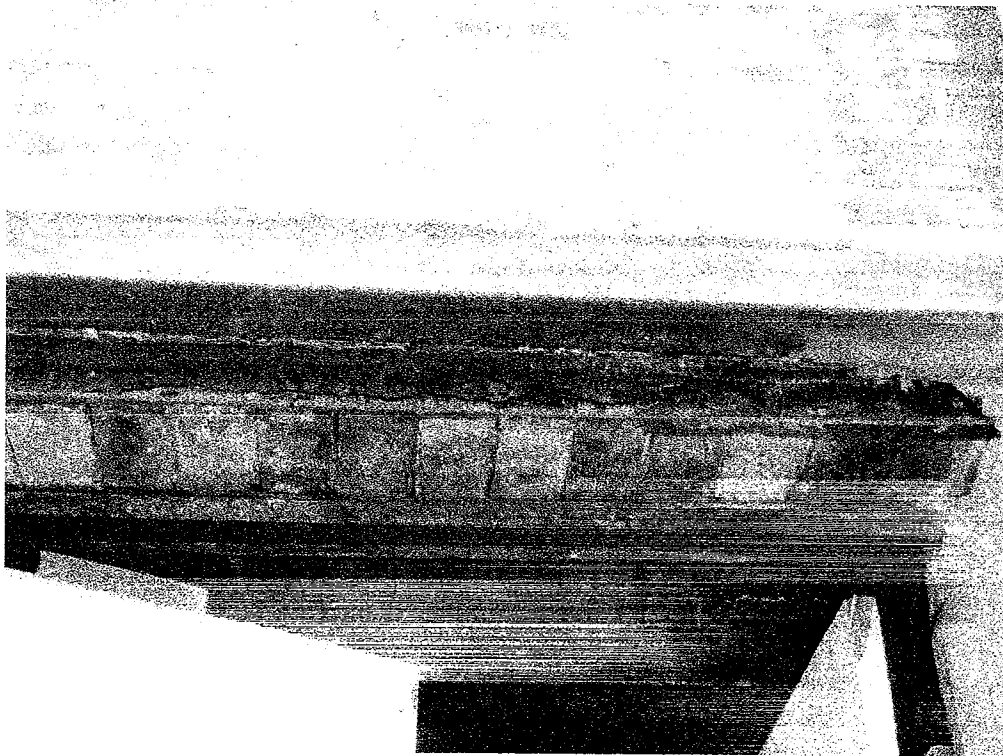
Photo # 4 - Note severe corrosion at existing lintel above basement door at grid F/5.2

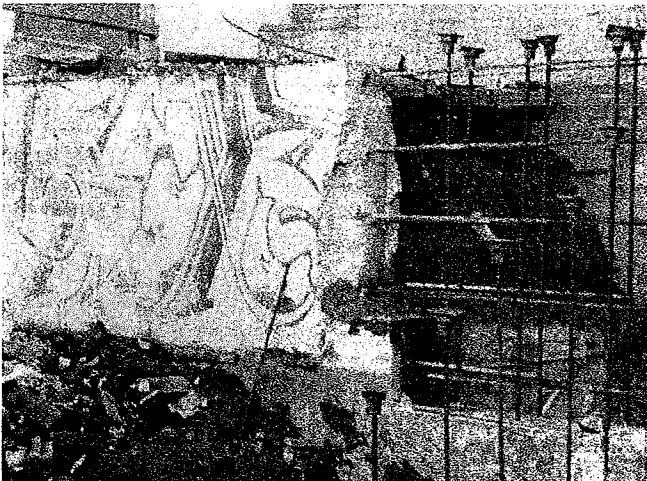
Photo # 5 Spalled Exist. wall @ Rear Sidewalk

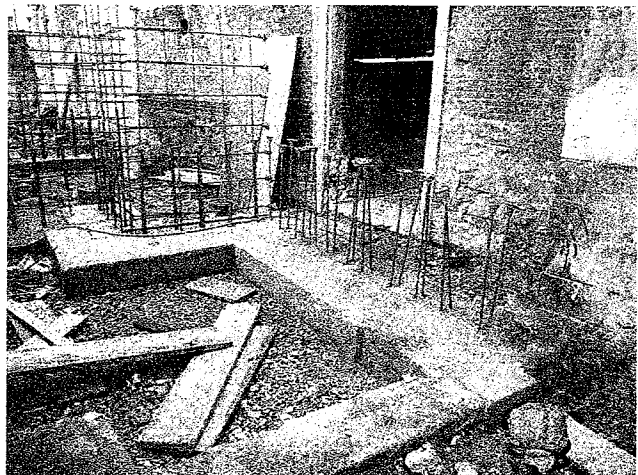
Photo # 6 – Reinf. @ rear retaining wall fig. (Grid F.4/5.2)

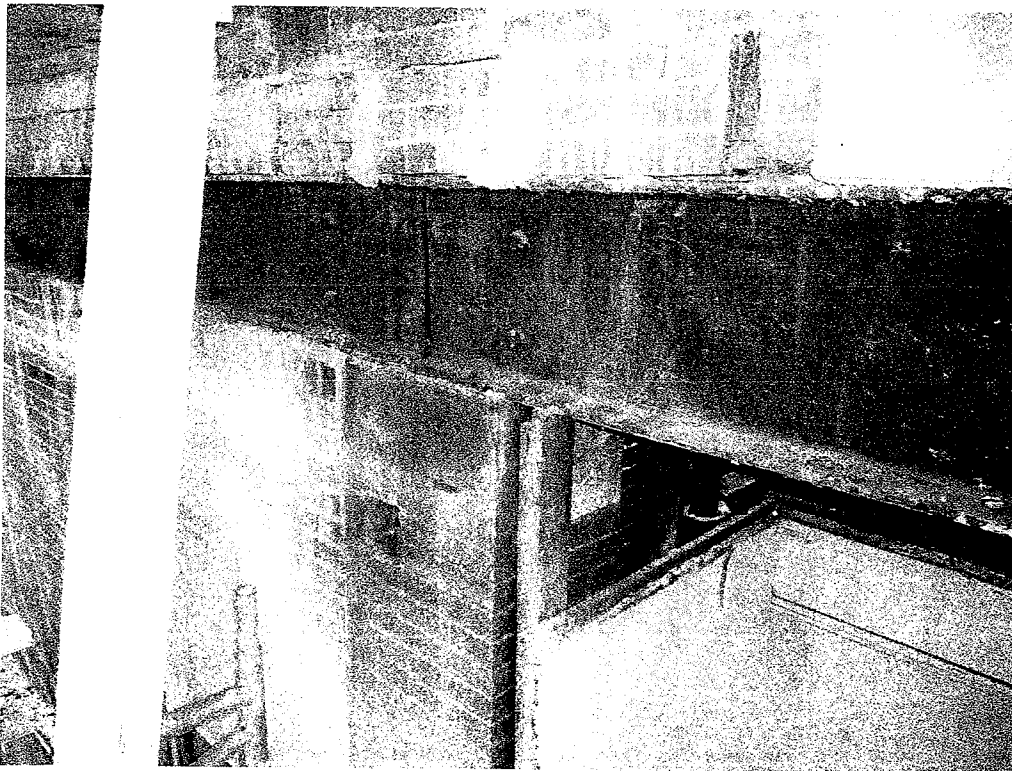
Photo # 2 – View looking north at existing steel beams located at grid A/5.

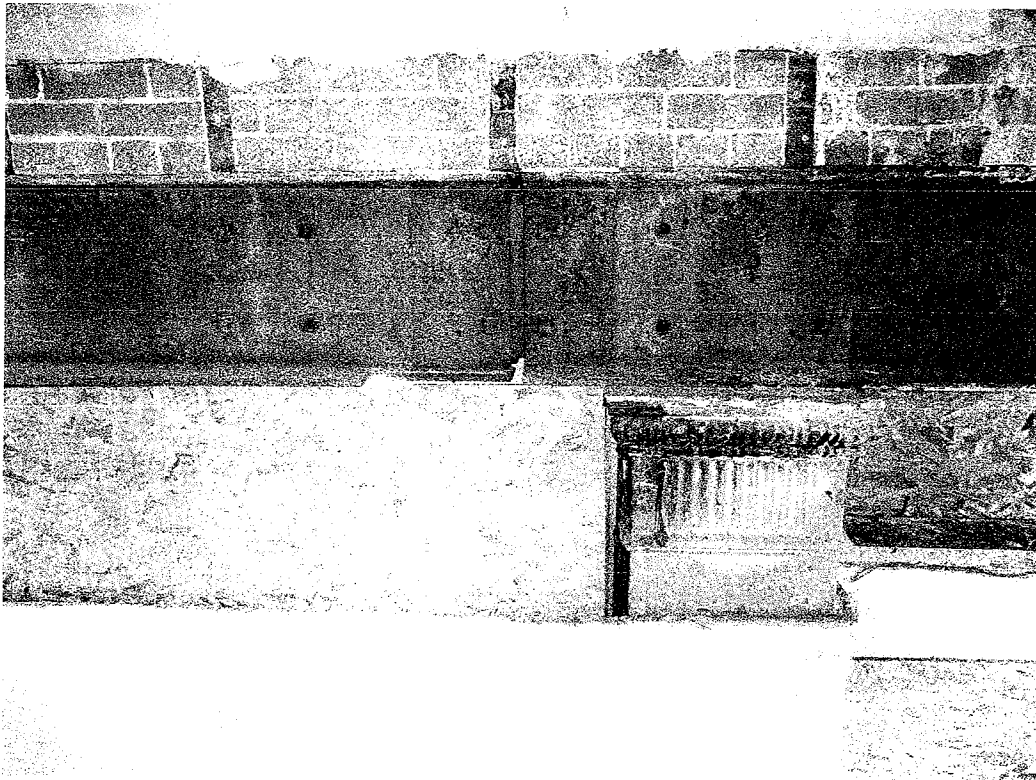
Photo # 4 - View looking north at existing steel beams located at grid A/7. Note that splice is located 15.5" west of column centerline and that splice plate is on the inside face of the beam.

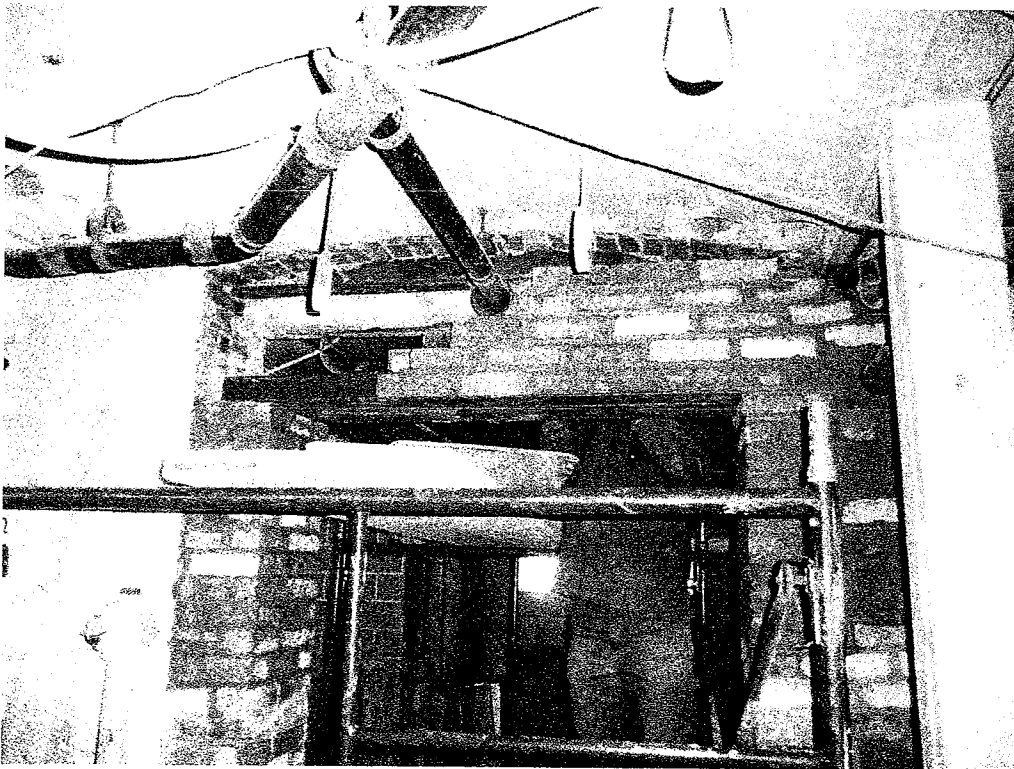
Photo # 2 – New lintel at grid 2.3/G.7 in basement.

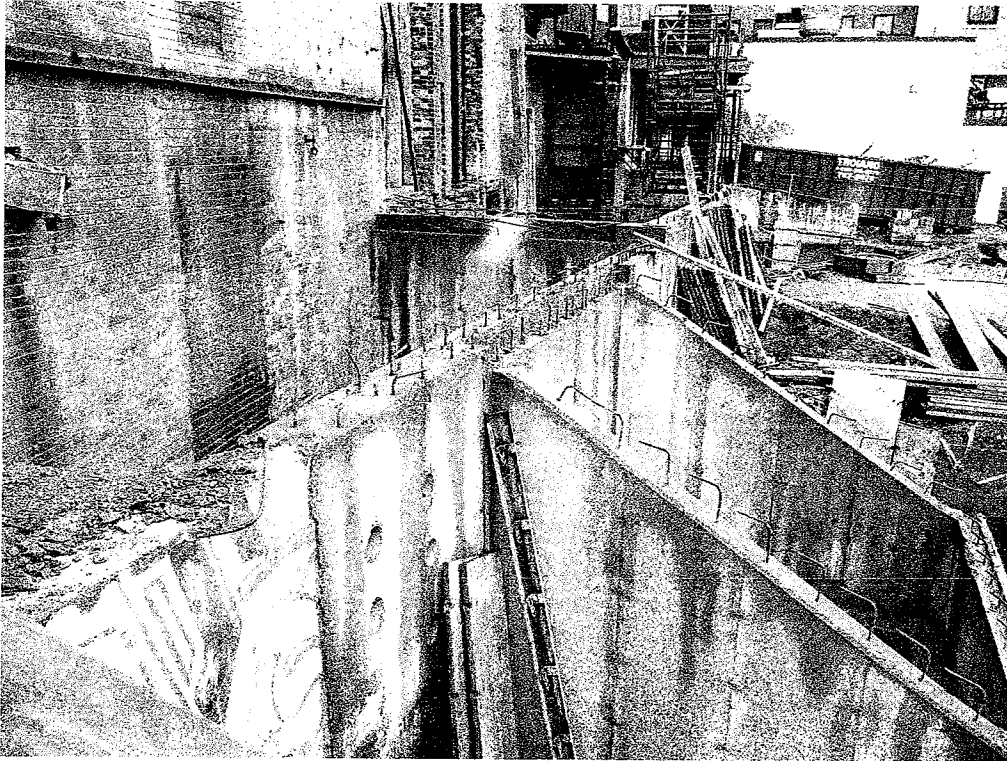
Photo # 3 – Back entrance foundation wall. Note sleeves in wall adjacent to stairs.

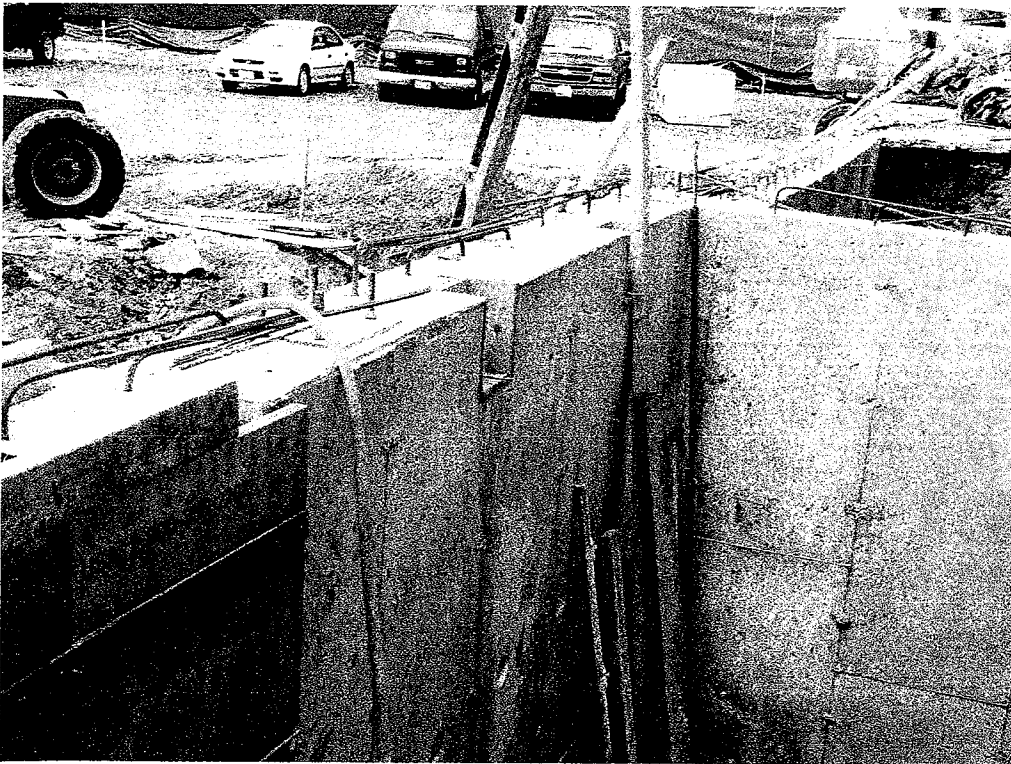
Photo # 4 - Back entrance foundation wall. Note beam pocket and dowels at top of foundation wall.

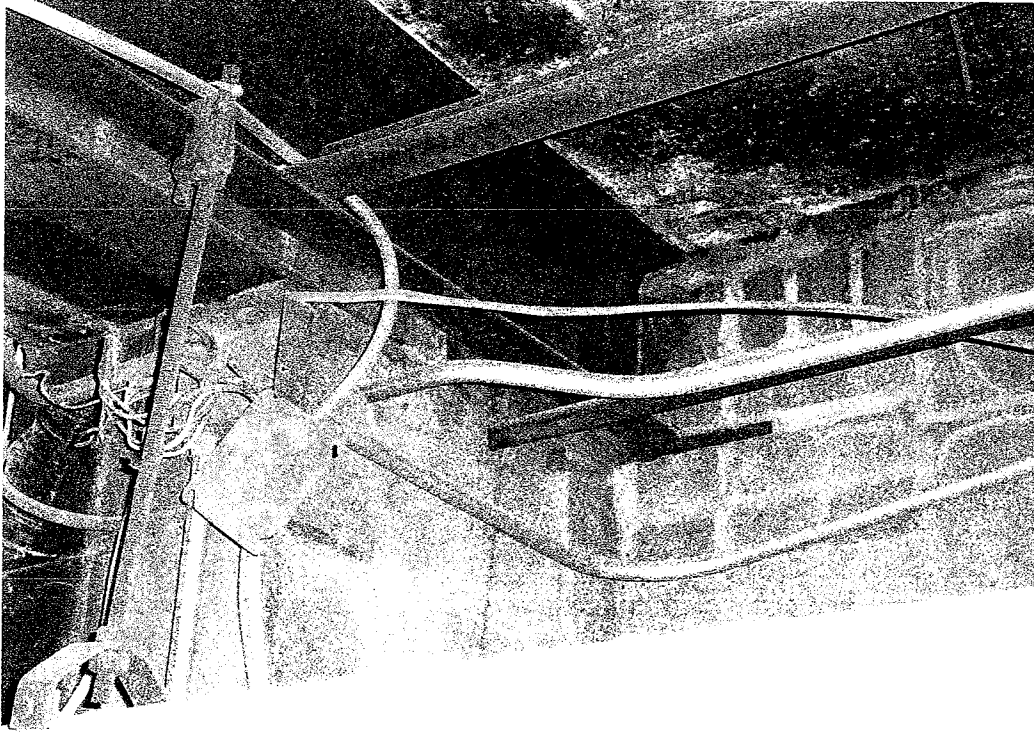
Photo # 5 Existing CMU wall at end of lintel previously considered for core drilling.

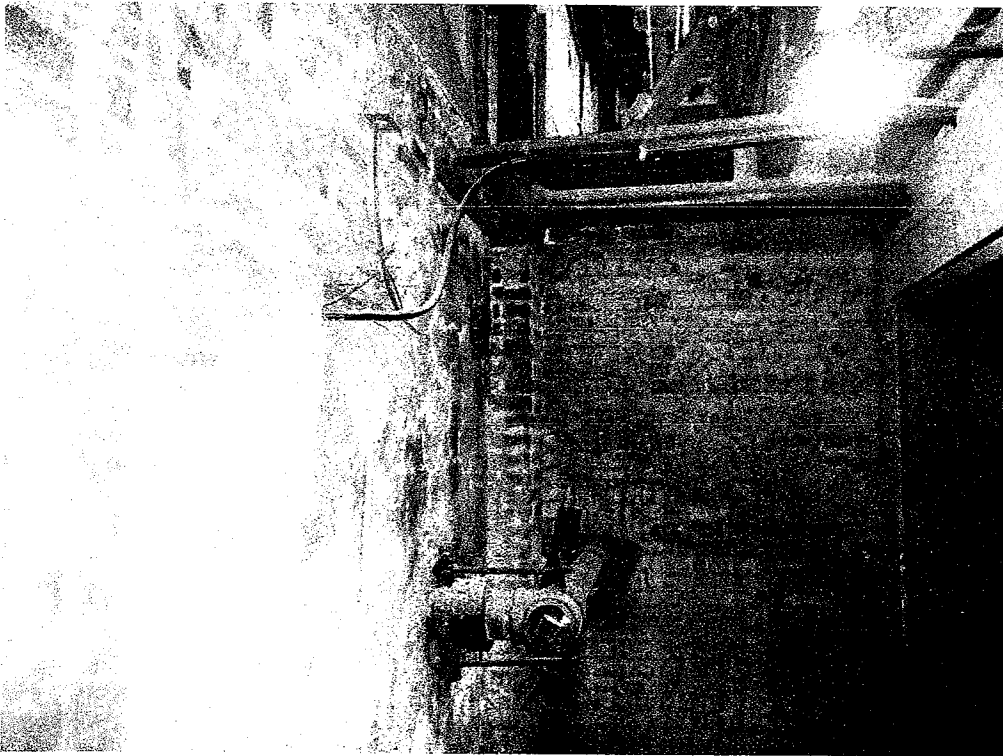
Photo # 6 Existing foundation wall at grid A/4.1.

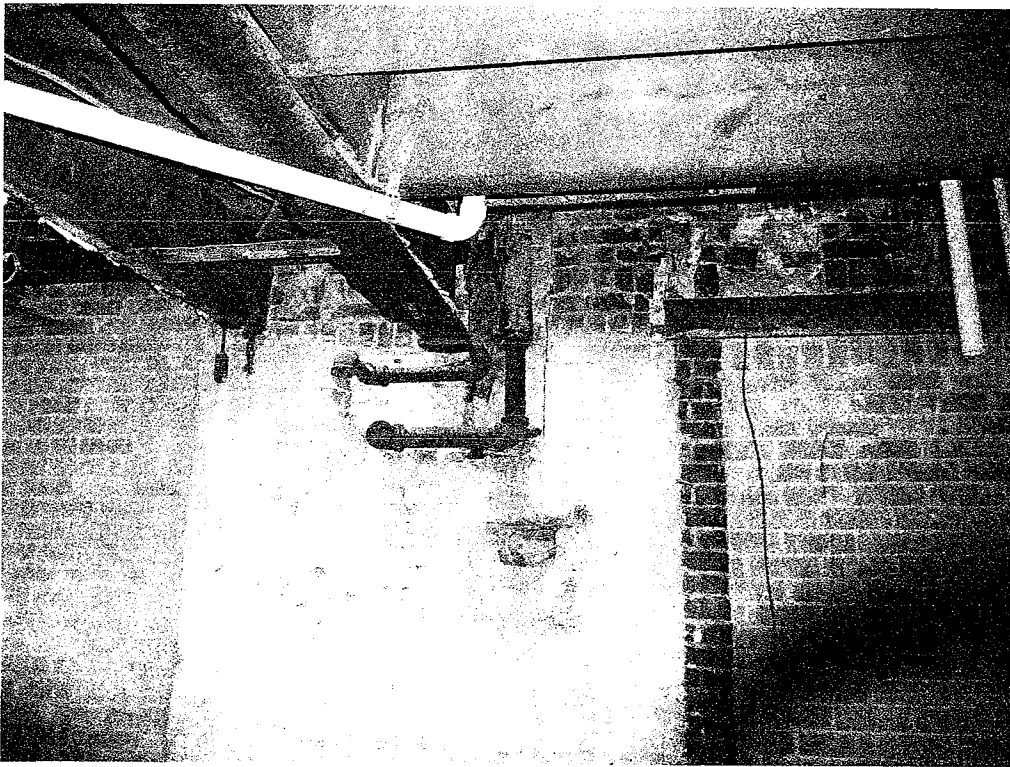
Photo # 4 Existing pipes to be removed prior to restoring bearing below beam.

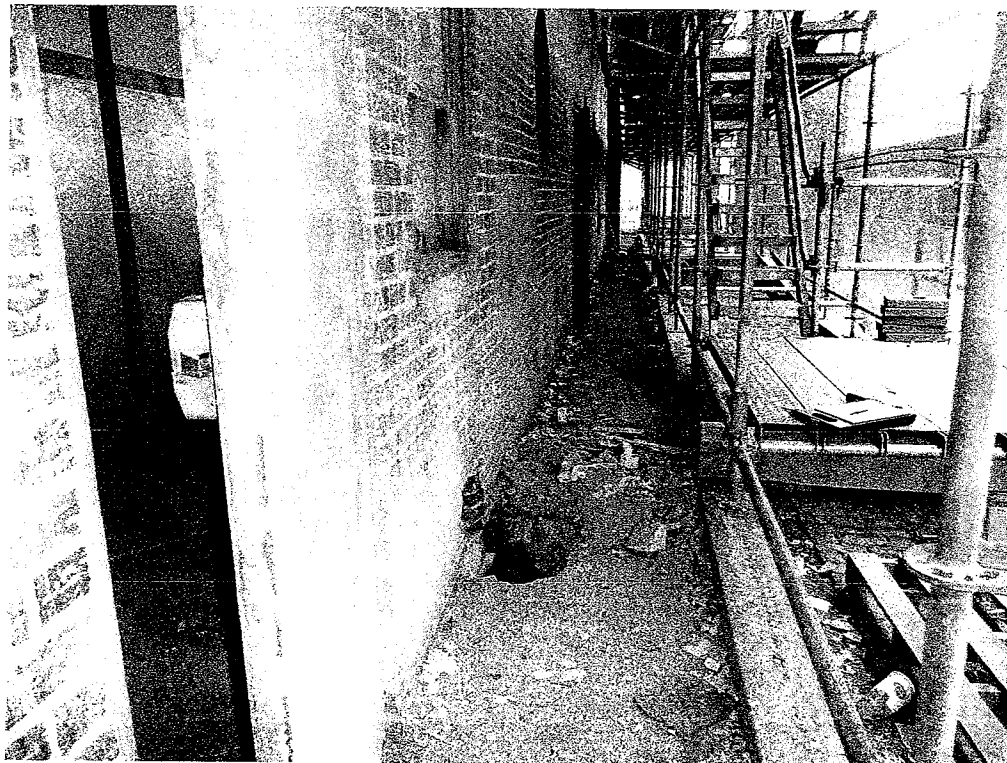
Photo # 1 – Opening at bottom of brick wall permitted access to measure existing foundation profile.
