Re: Special Inspections Final Report
645 Congress St.
Portland, Maine

Final Report of Structural Special Inspections

Project: *Renovations to 645 Congress Street*
Location: *645 Congress Street; Portland Maine*
Owner: *Bayside Maine, LLC*

Structural Design Professional in
Responsible Charge: *David A. Price, PE / Price Structural Engineers, Inc.*

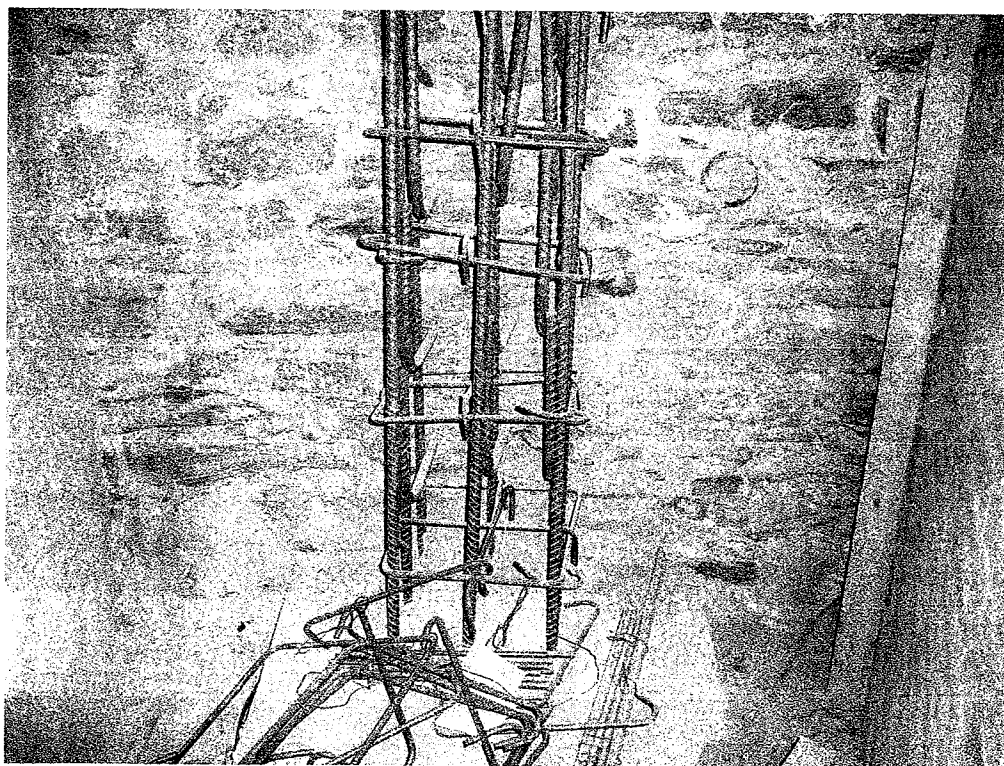
Photo # 2 – Steel reinforcement already in place for concrete pier at grid A/2.5

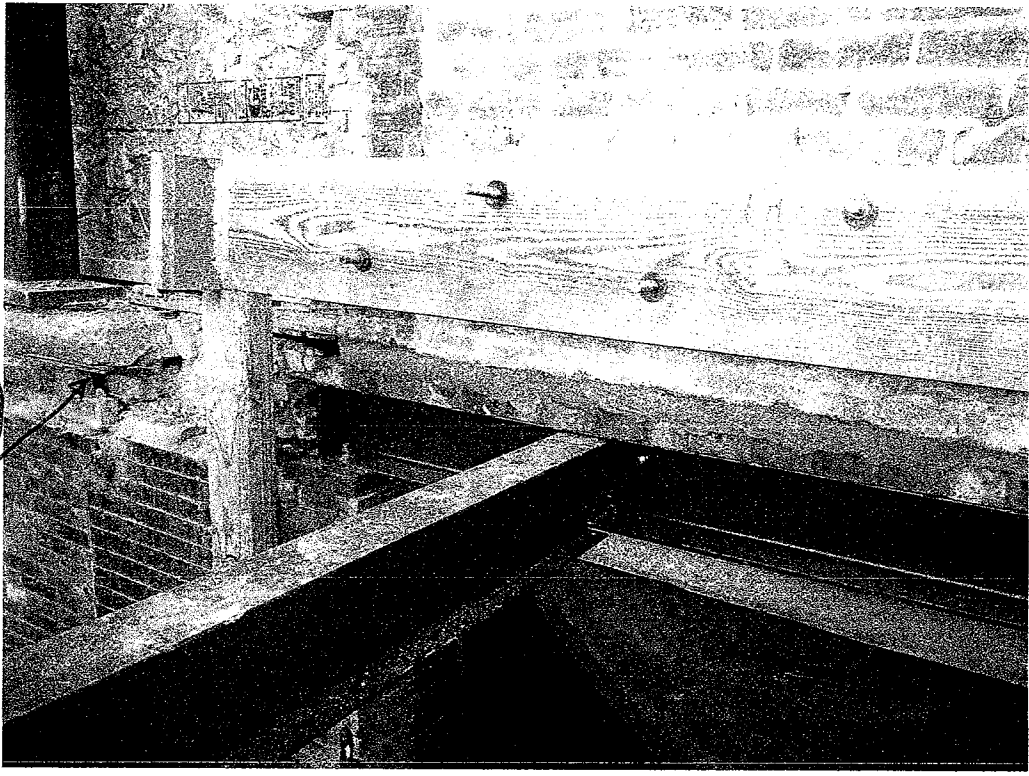
Photo # 3 – Structural steel lintel above door at basement grid F/5.4. Note plywood below existing F/5.8 column at upper left corner of photo.

Exist
plywood
remove!

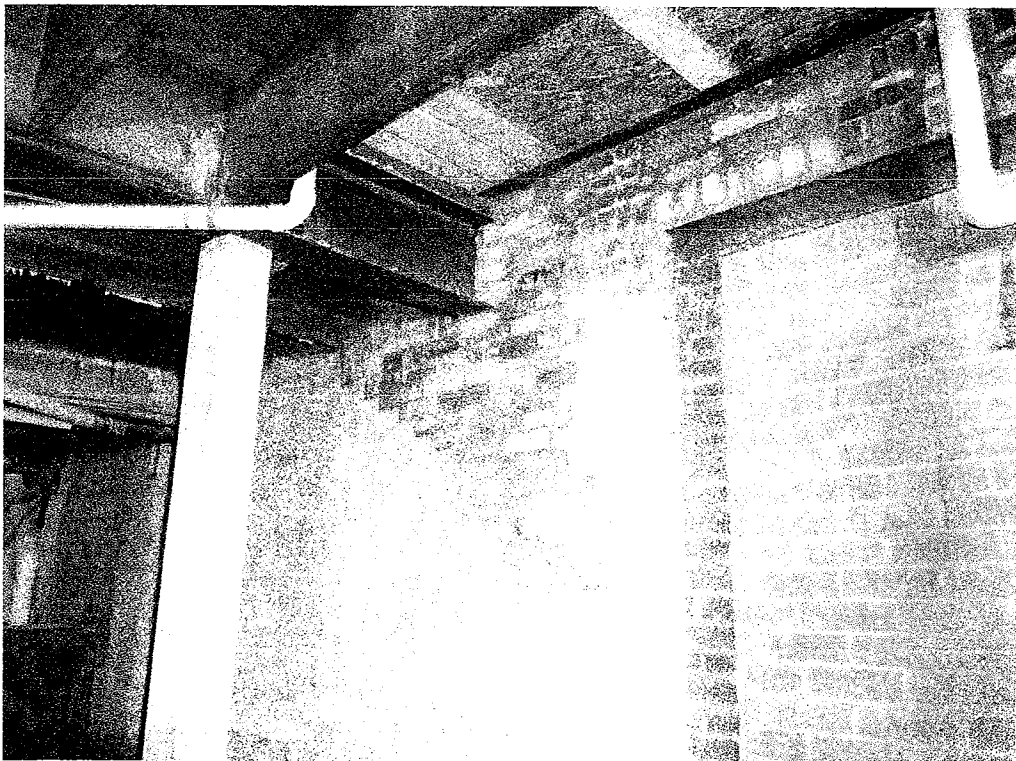
Photo # 4 – Bearing below existing steel basement beam at grid F/2.5 has been repaired.

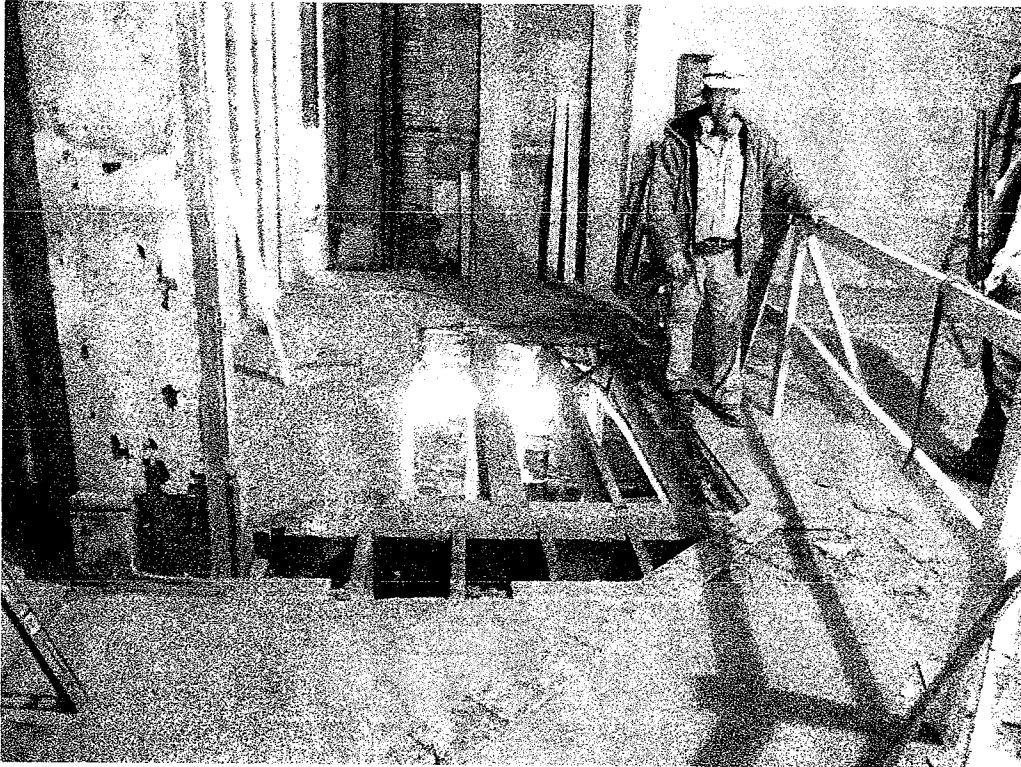
Photo # 5 – Work progressing for construction of main entrance at grid A/5.5.

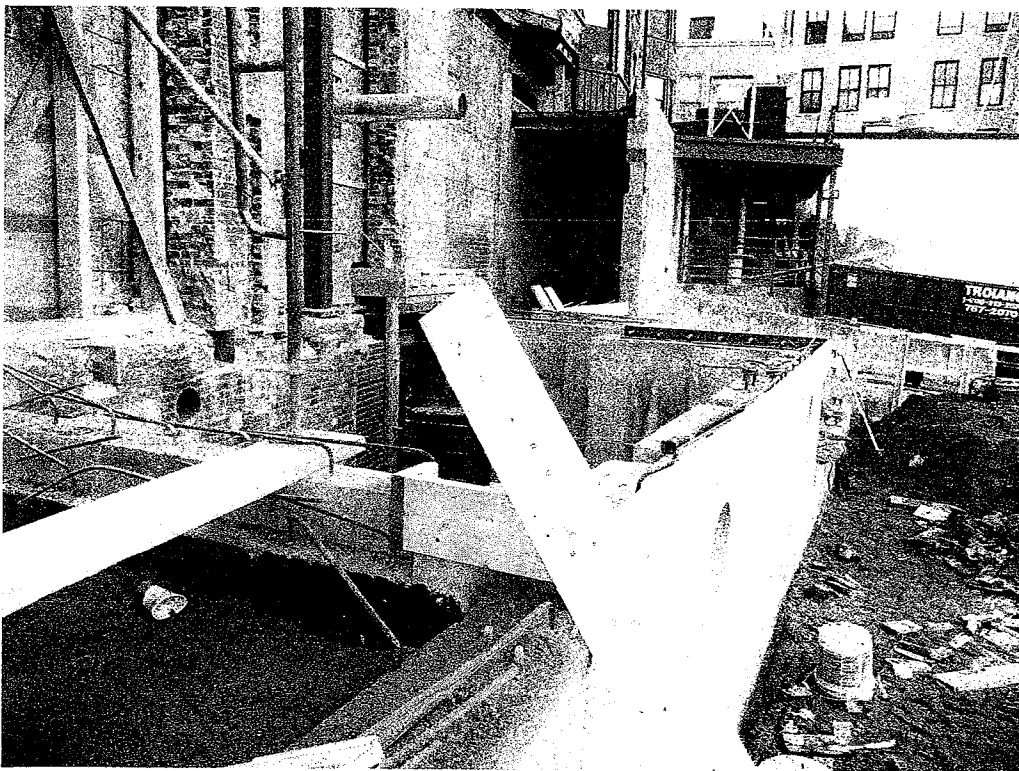
Photo # 6 – Preparations being made for installation of structural steel floor framing and elevated slab.

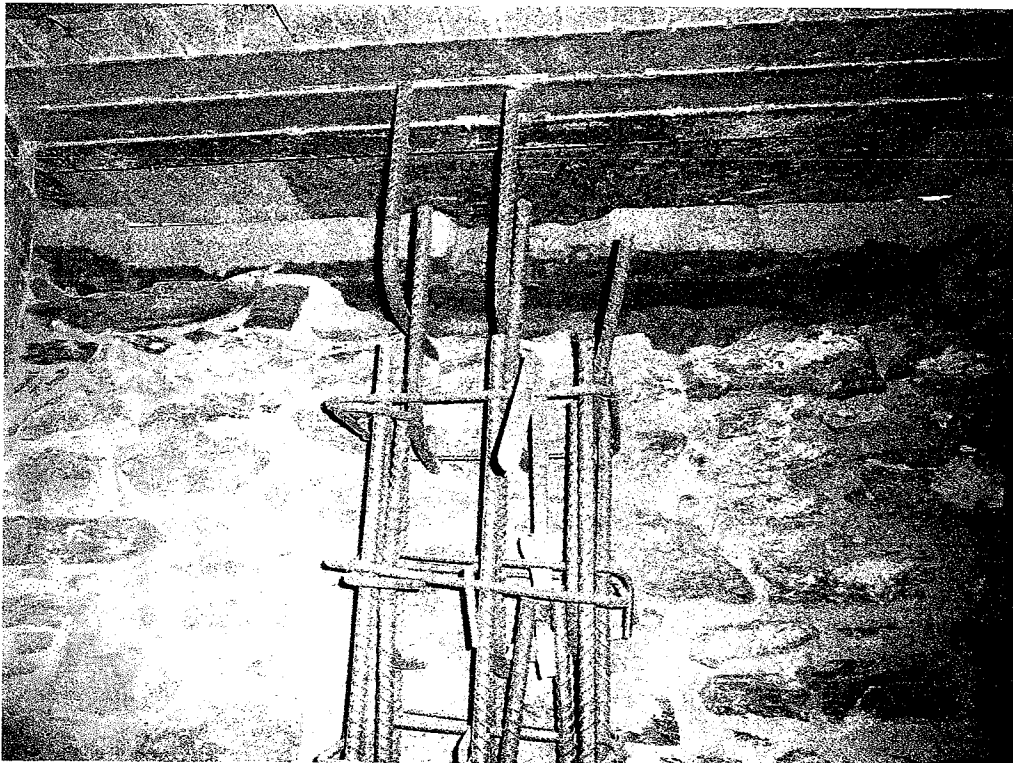
Photo # 2 – Demolition of top of existing stone foundation at Grid A/2.5, Note existing column A/2.6 removed.

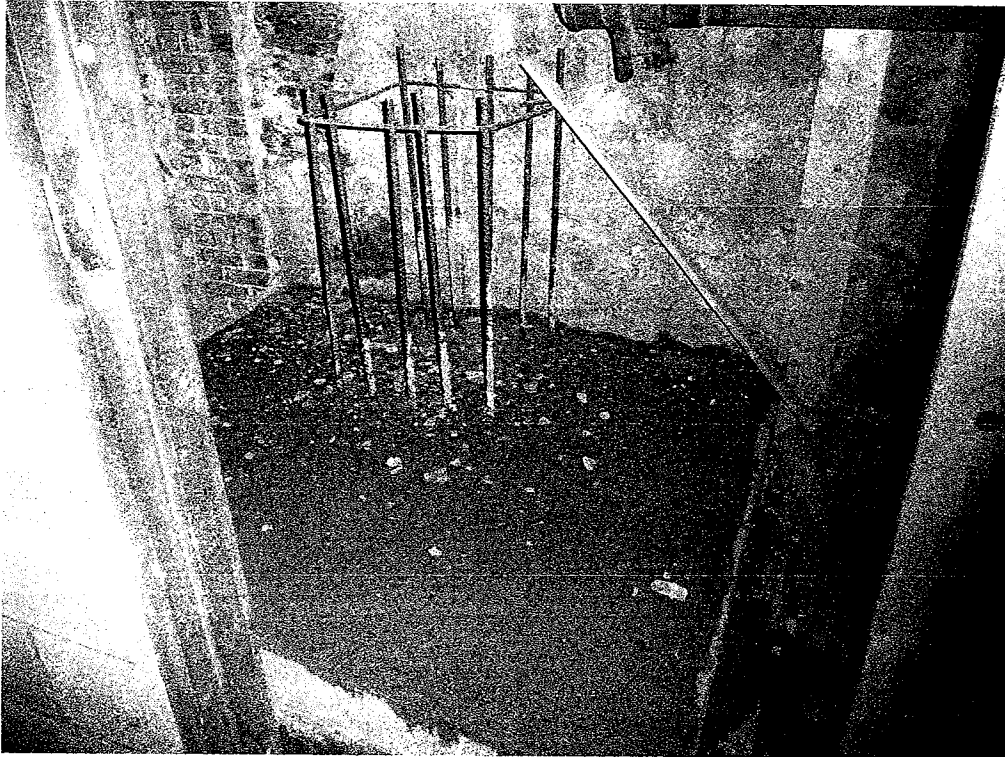
Photo # 3 – New Concrete footing adjacent to A/4.2 foundation

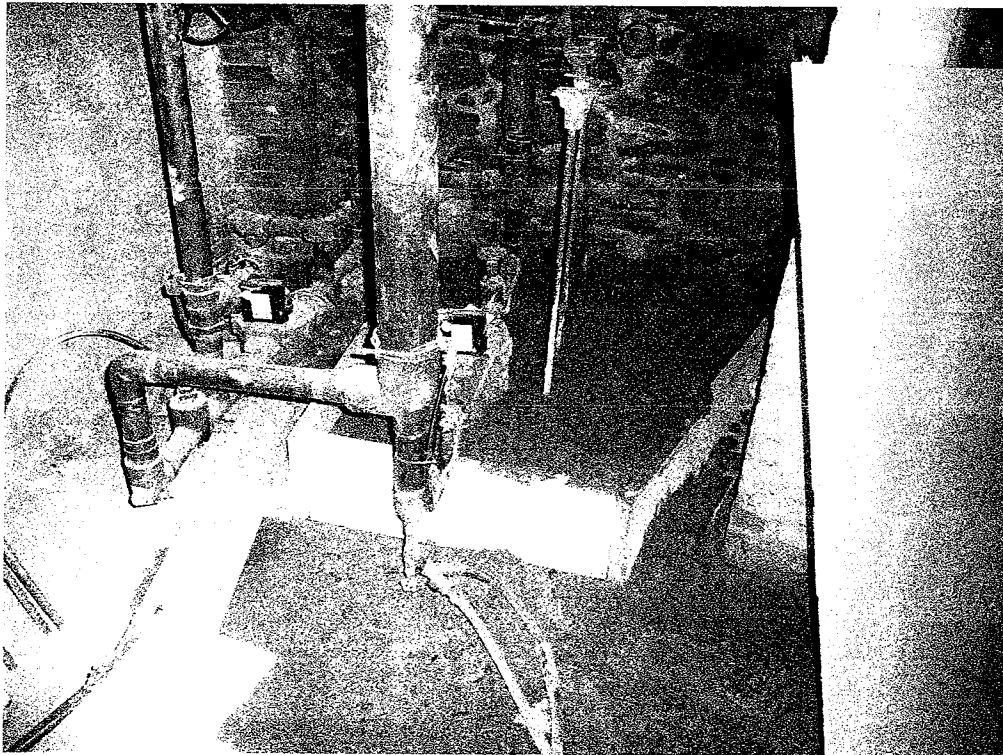
Photo # 4 – New concrete footing for short CMU wall adjacent to Grid A/3.7

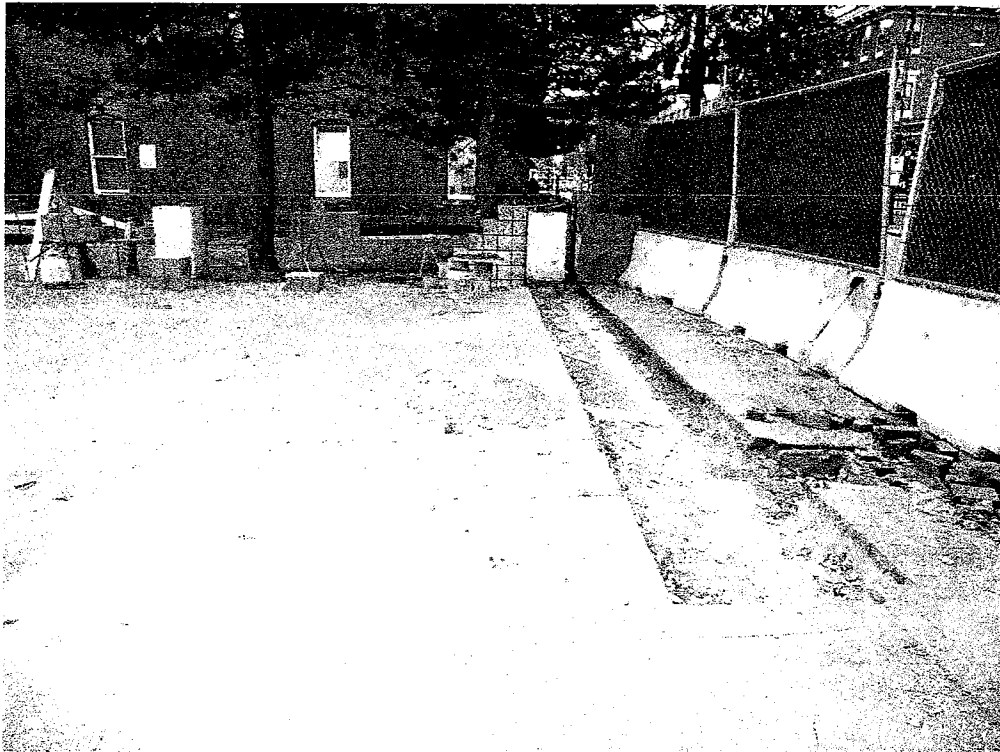
Photo # 8 – Exterior site landscape wall to be supported on existing building foundation

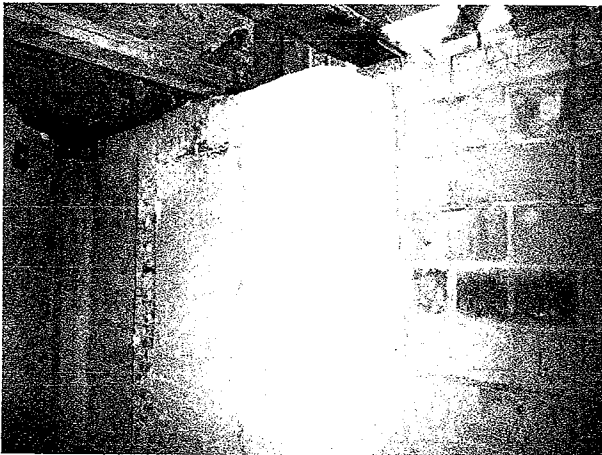
Photo # 9 – Concrete pier at grid A/5.9 with 9" thick cap.

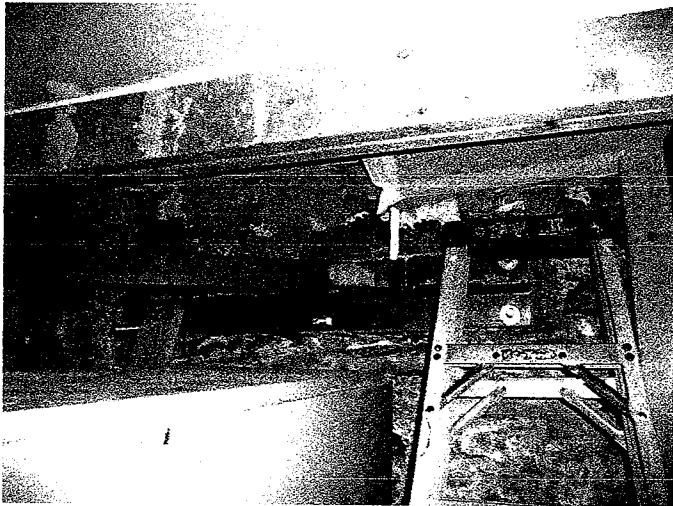
Photo # 8 – Steel brace at Grid A/2.9 foundation wall has been installed (reference SK-S69).

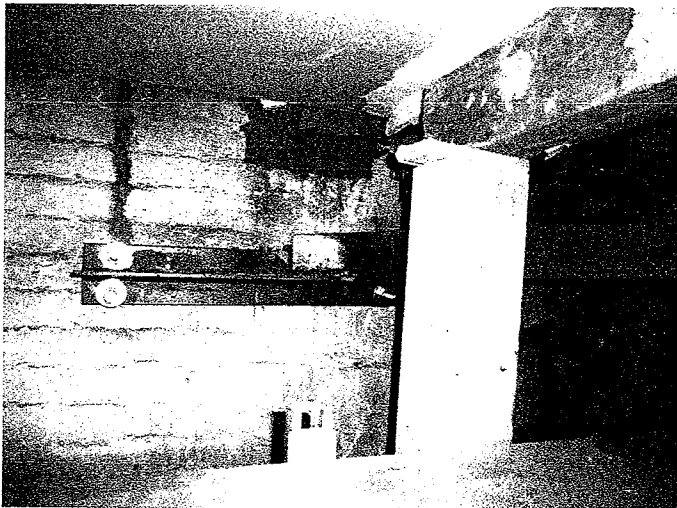
Photo # 9 - Steel brace at Grid A/2.9 foundation wall has been installed.
