3RD FLOOR REPLACEMENT WINDOW

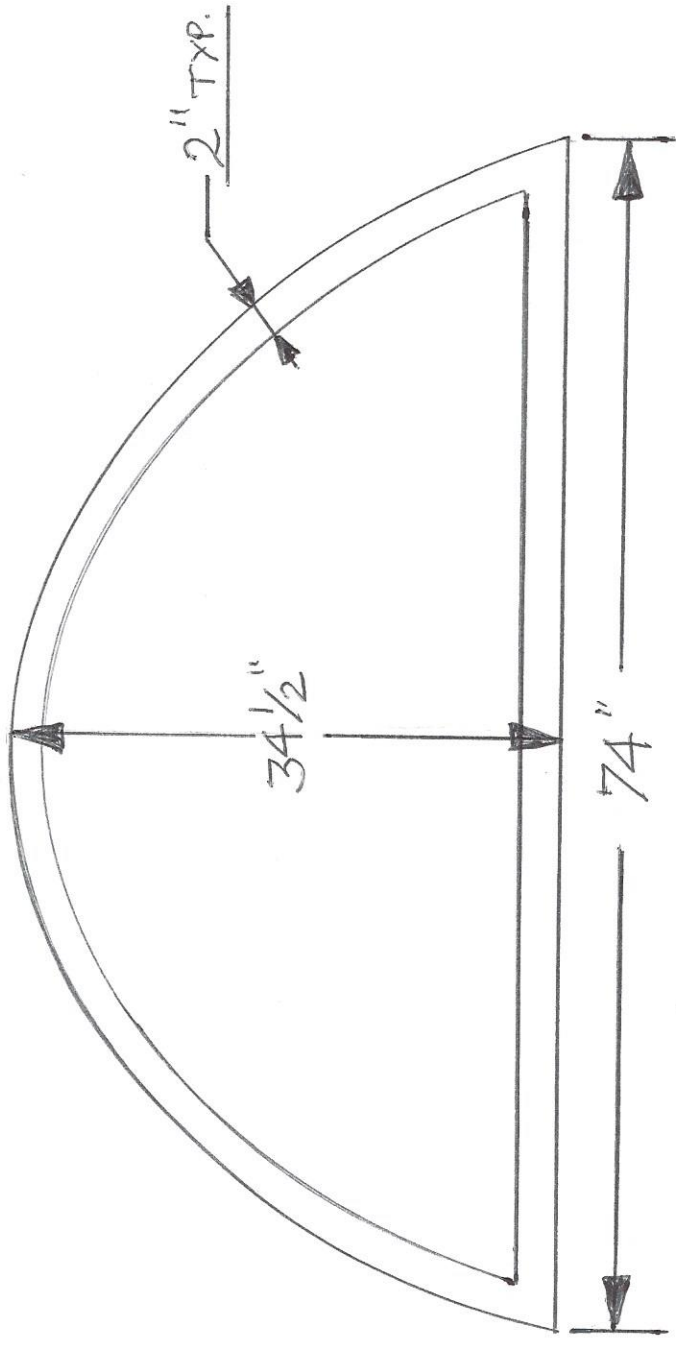
1. THE EXISTING WINDOW FRAME WAS SALVAGED + REPLICATED EXACTLY.
2. THE EXISTING GLASS WAS SINGLE PANE, THIS GLASS IS DOUBLE PANE.
3. THE WINDOW FRAME IS MADE OF SOLID MAHOGANY, AS PER ORIGINAL.
4. THE SIZE OF THIS REPLACEMENT IS SAME AS ORIGINAL, NO REFRAMING AT ALL.
5. THIS WINDOW MATCHES THE 1924 TAX PHOTO OF THE PROPERTY.
6. THIS WINDOW OPENING HAS BEEN COVERED WITH PLYWOOD FOR THE LAST EIGHT YEARS.
