MEMORANDUM

TO: Al Green, MMC
FROM: David Senus, PE and Craig Sweet, PE
DATE: August 17, 2018
RE: MMC Staff Parking Garage | Valley Street Trail Condition Assessment

The purpose of this memorandum is to summarize Woodard & Curran's assessment of the existing conditions on and around the Valley Street Trail, identified within Maine Medical Center's (MMC) Institutional Development Plan (IDP) as a potential walking route for staff between the future Staff Parking Garage at 222 St. John Street and the MMC Bramhall entrance atop the Western Promenade.

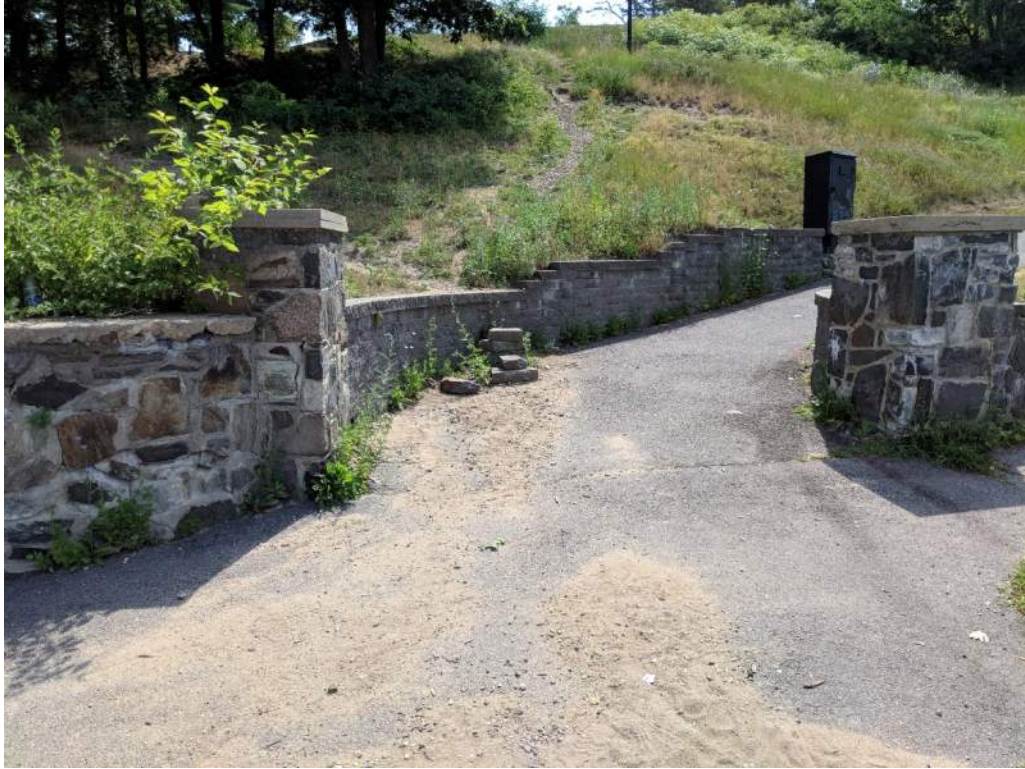
As stated above, the foot path connections show signs of erosion. This is due to the concentration of stormwater runoff funneled down these connector trails with no vegetation to control the rate of stormwater flow. Continued foot traffic compacts the surface further reducing its ability to grow vegetation and slow stormwater velocities. As stormwater flows down grade it begins to channelize within the foot path connectors, causing increased erosion. As the foot path connectors begin to erode the condition is exacerbated as the foot path deepens, further collecting and conveying fast flowing stormwater runoff. The combination of channelized stormwater runoff and the lack of ground cover results in noticeable, moderate erosion and sediment runoff conditions in several areas. The notable area of concern is the foot path connector located to the east of the Valley Street entrance, continuing along the norther edge of the trail towards Gilman Street. Large amounts of trail erosion was observed at the entrance of the Valley Street Trail as shown in Photographs 1 & 2.

Photo 1: Erosion from retaining wall

To address the drainage concerns at these foot paths we recommend that the foot path connectors be restored to their original intended conditions (field grass or planted trees/undergrowth). Additionally, a

series of stone berm check dams should be installed along the current foot path location to divert and/or slow stormwater flows and prevent further erosion. Please refer to the attached Valley Street Trail Possible Improvements Sketch for further detail.

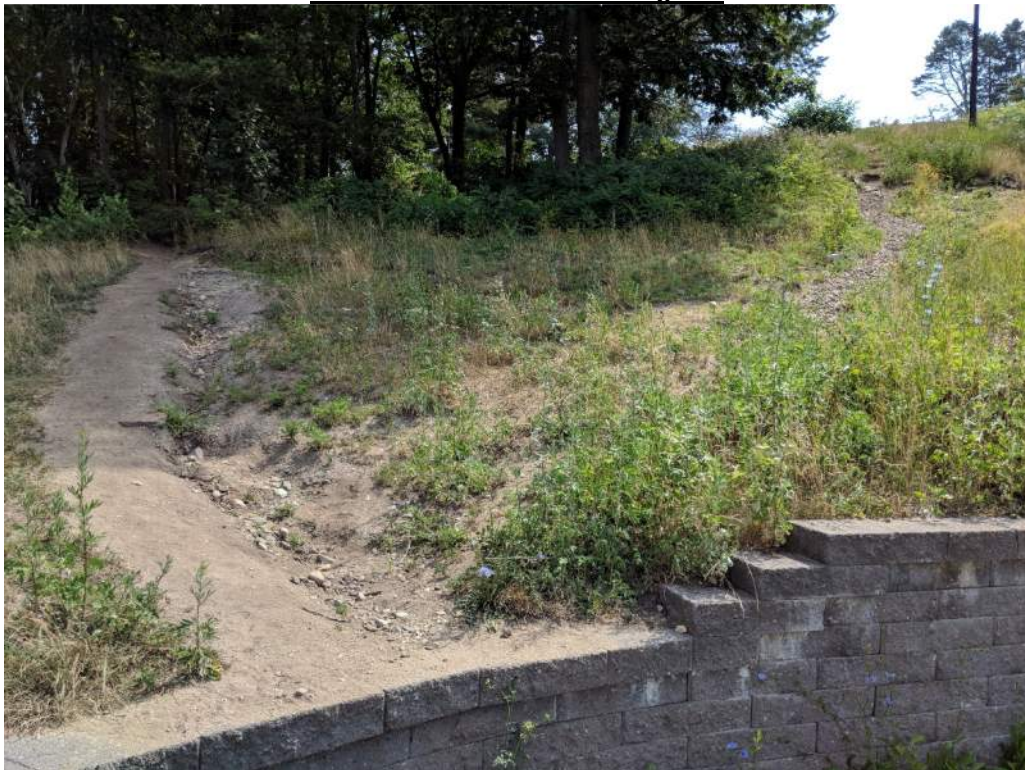
Photo 2: Foot path connection at top of retaining wall

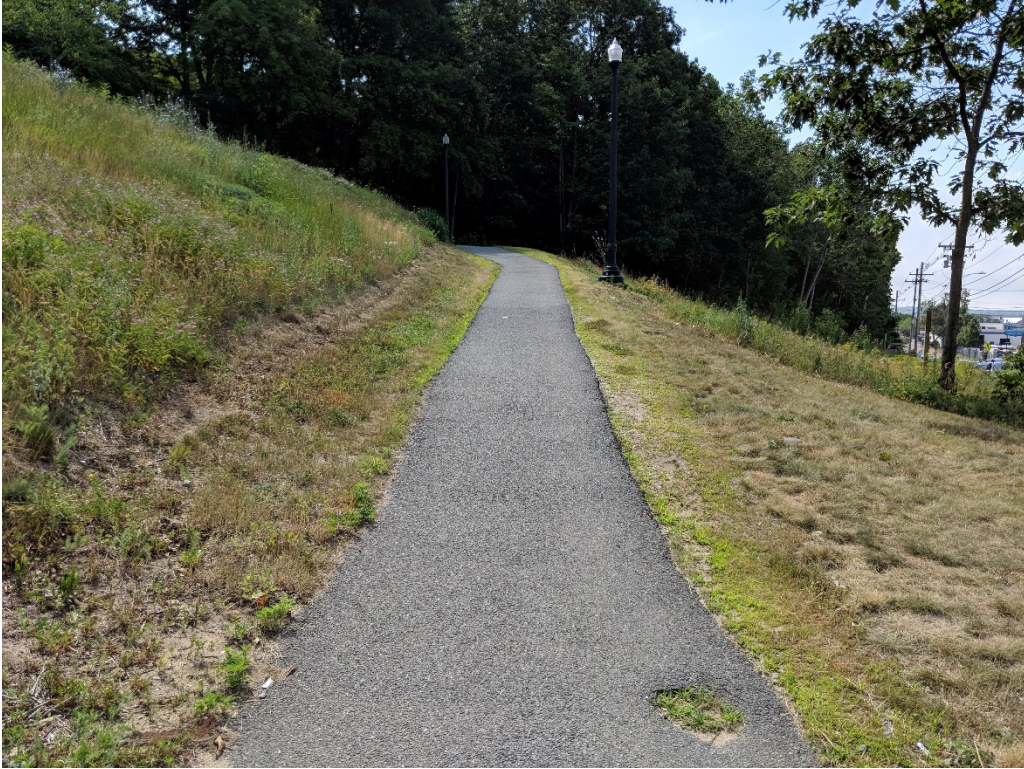
Photo 3: Trail section in good condition

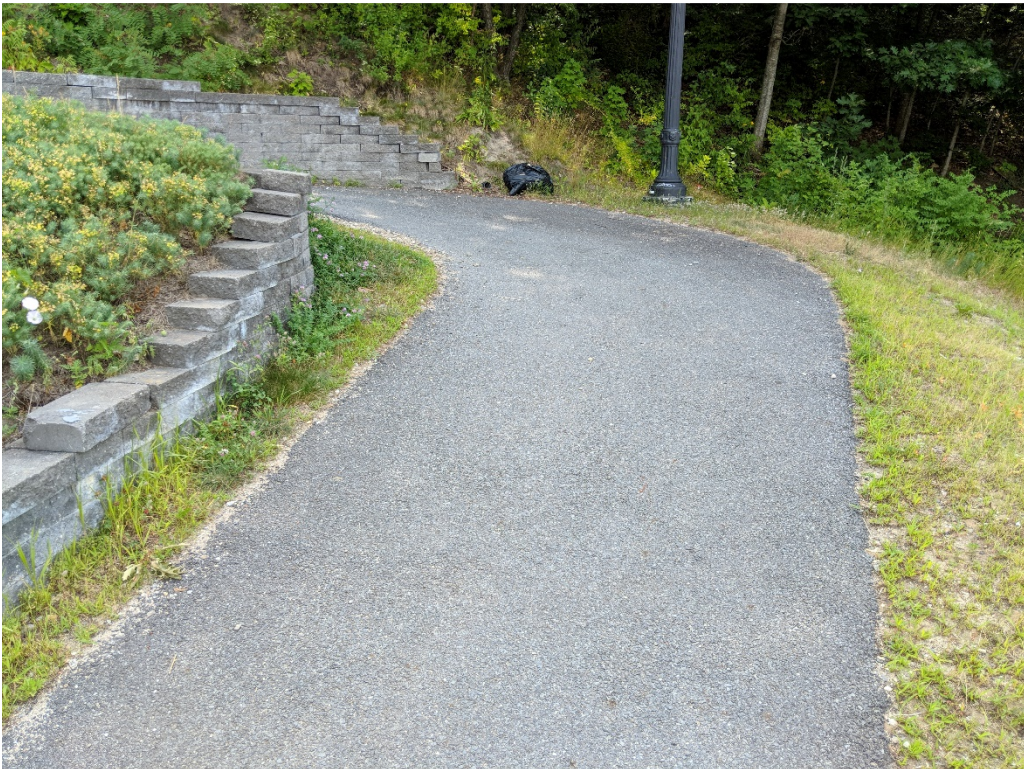
Photo 4: Trail section in good condition

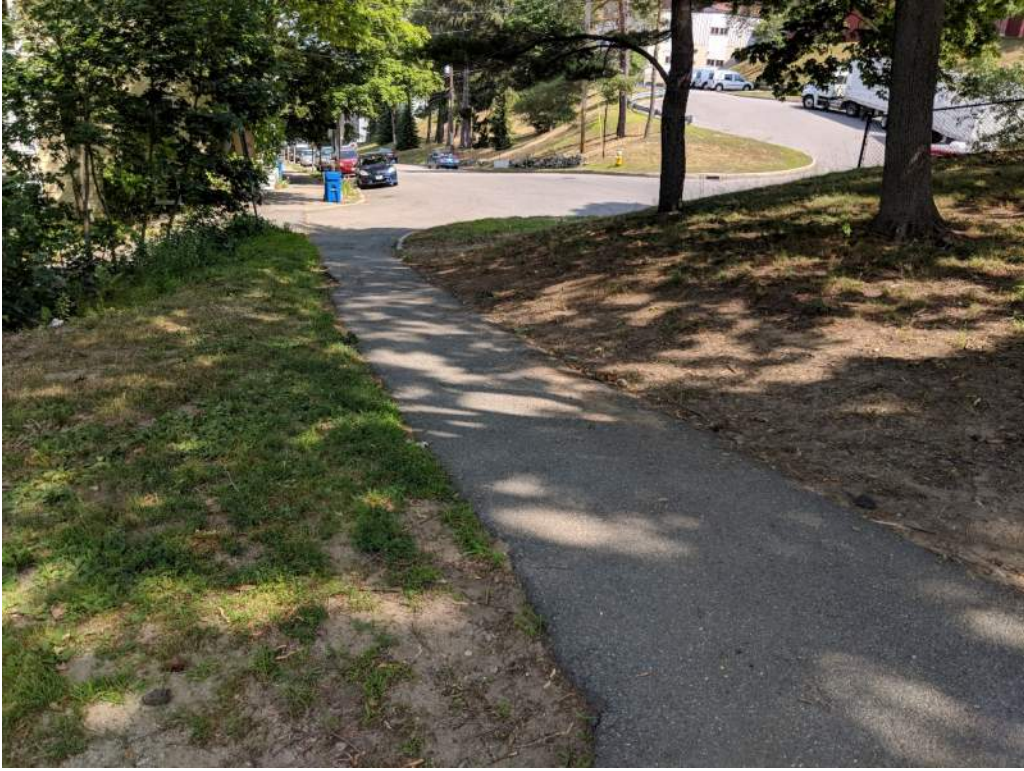
Photo 11: Trail section in good condition

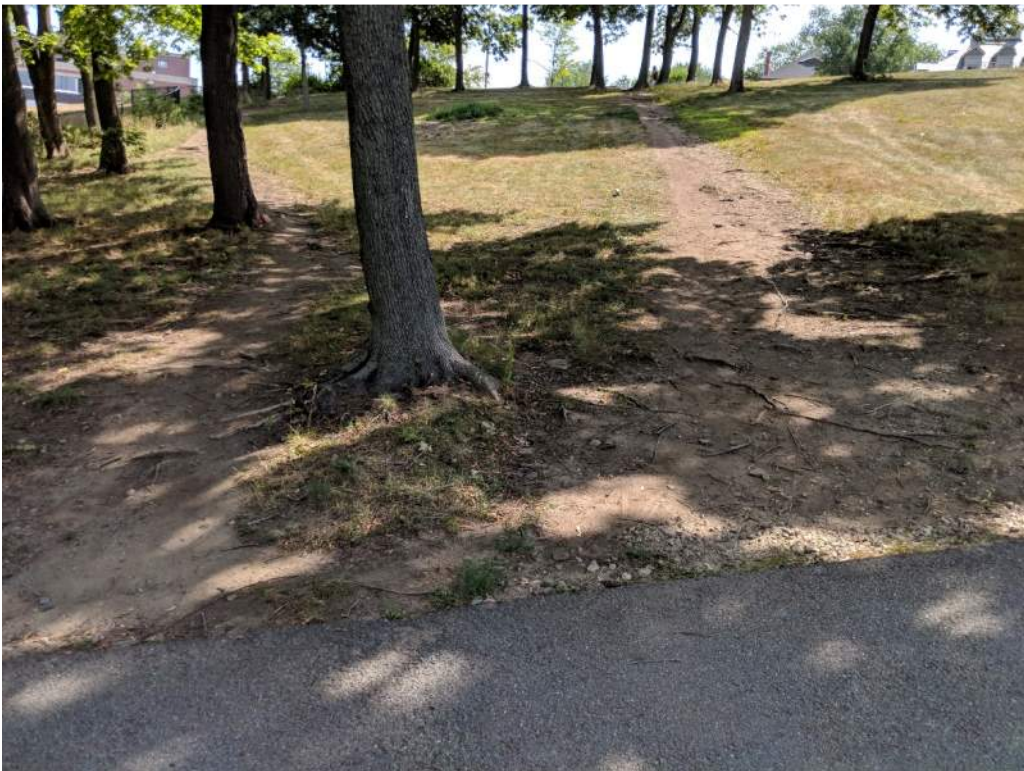
Photo 12: Foot path connections at trail tee intersection

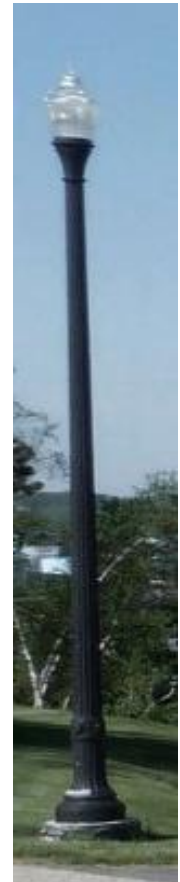
WESTERN PROM TRAIL PLAN
Red Indicates Lighted Section of Trail

The existing trail network that extends from Valley Street to the Western Promenade above includes one path that is illuminated by post lights that have luminaires with prismatic glass diffusers and high intensity discharge lamps. The spacing of the existing light posts is such that the resulting horizontal illuminance at grade is very uneven. There are numerous places along the path between light posts that have less than 0.2 footcandles of illuminance.

Because the post light luminaires utilize prismatic glass diffusers, the light that is directed side-to-side provides a significant degree of vertical illuminance which can be effective in lighting faces of oncoming pedestrians. Unfortunately, the relatively high brightness of the luminaires is such that once an approaching pedestrian passes in front of a post light, the luminaire brightness immediately behind the person casts them in silhouetted shadow.

The *Illuminating Engineering Society of North America (IESNA)* classifies exterior luminaires according to their potential for producing glare in the publication *IESNA TM-15-11*. The rating system is a numeric index for luminaires with a symmetrical optical distribution that ranges from zero (maximum of 660 zonal lumens directed between 60 and 80 degrees) to five (greater than 12,000 lumens directed between 60 and 80 degrees). The existing trail post light luminaires have a rating of three, which represents a high potential for excessive glare.

An additional consideration is that the existing post light luminaires direct a considerable amount of light skyward which contributes to astronomic light pollution. The *IESNA* publication *TM-15-11* also classifies exterior luminaires according to their potential for producing uplight. Similar to the rating system for potential glare, the uplight rating system is a numeric index that ranges from zero (no uplight) to five (greater than 5000 lumens direct upward). The existing trail post light luminaires have a rating of five.
