# **ATTACHMENT 3: VALLEY STREET TRAIL ASSESSMENT**

TO: Al Green, MMC  
FROM: David Senus, PE and Craig Sweet, PE  
DATE: August 17, 2018  
RE: MMC Staff Parking Garage | Valley Street Trail Condition Assessment

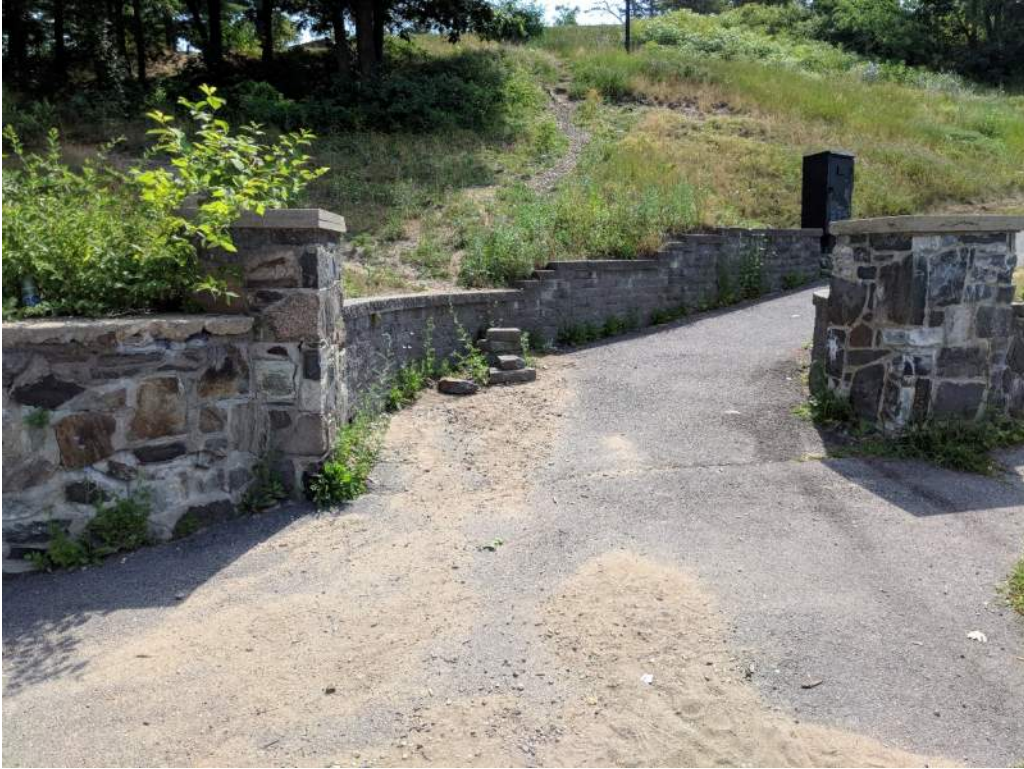
As stated above, the foot path connections show signs of erosion. This is due to the concentration of stormwater runoff funneled down these connector trails with no vegetation to control the rate of stormwater flow. Continued foot traffic compacts the surface further reducing its ability to grow vegetation and slow stormwater velocities. As stormwater flows down grade it begins to channelize within the foot path connectors, causing increased erosion. As the foot path connectors begin to erode the condition is exacerbated as the foot path deepens, further collecting and conveying fast flowing stormwater runoff. The combination of channelized stormwater runoff and the lack of ground cover results in noticeable, moderate erosion and sediment runoff conditions in several areas. The notable area of concern is the foot path connector located to the east of the Valley Street entrance, continuing along the norther edge of the trail towards Gilman Street. Large amounts of trail erosion was observed at the entrance of the Valley Street Trail as shown in Photographs 1 & 2.

**Photo 1: Erosion from retaining wall**

To address the drainage concerns at these foot paths we recommend that the foot path connectors be restored to their original intended conditions (field grass or planted trees/undergrowth). Additionally, a

series of stone berm check dams should be installed along the current foot path location to divert and/or slow stormwater flows and prevent further erosion. Please refer to the attached Valley Street Trail Possible Improvements Sketch for further detail.

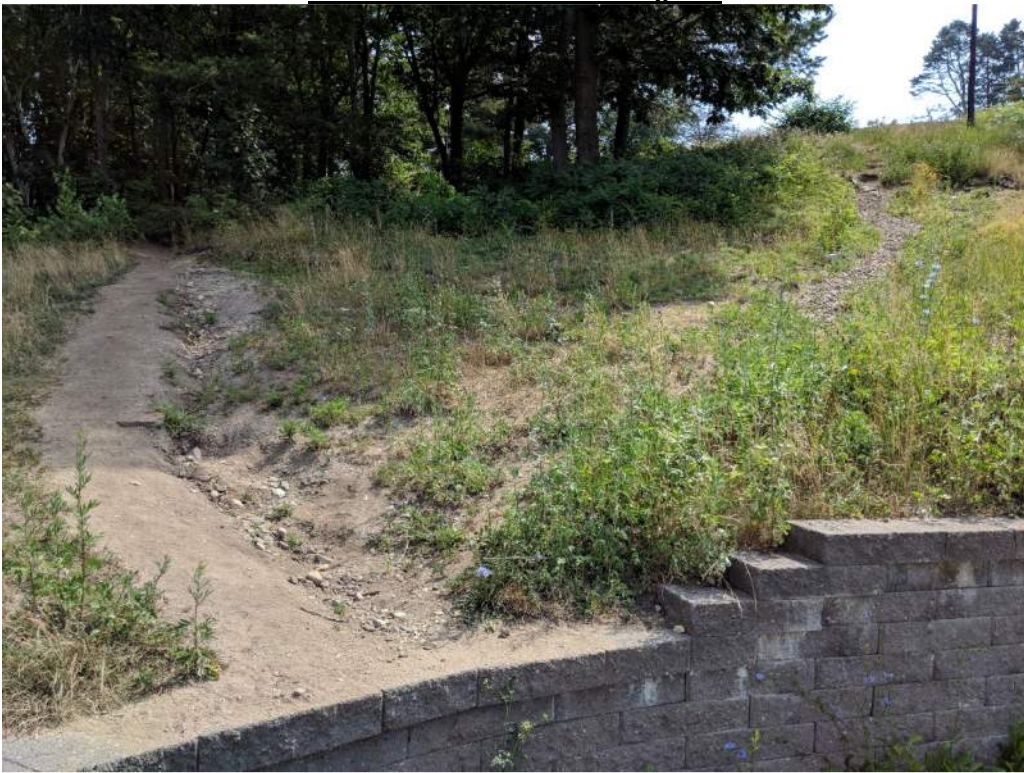
**Photo 2: Foot path connection at top of retaining wall**

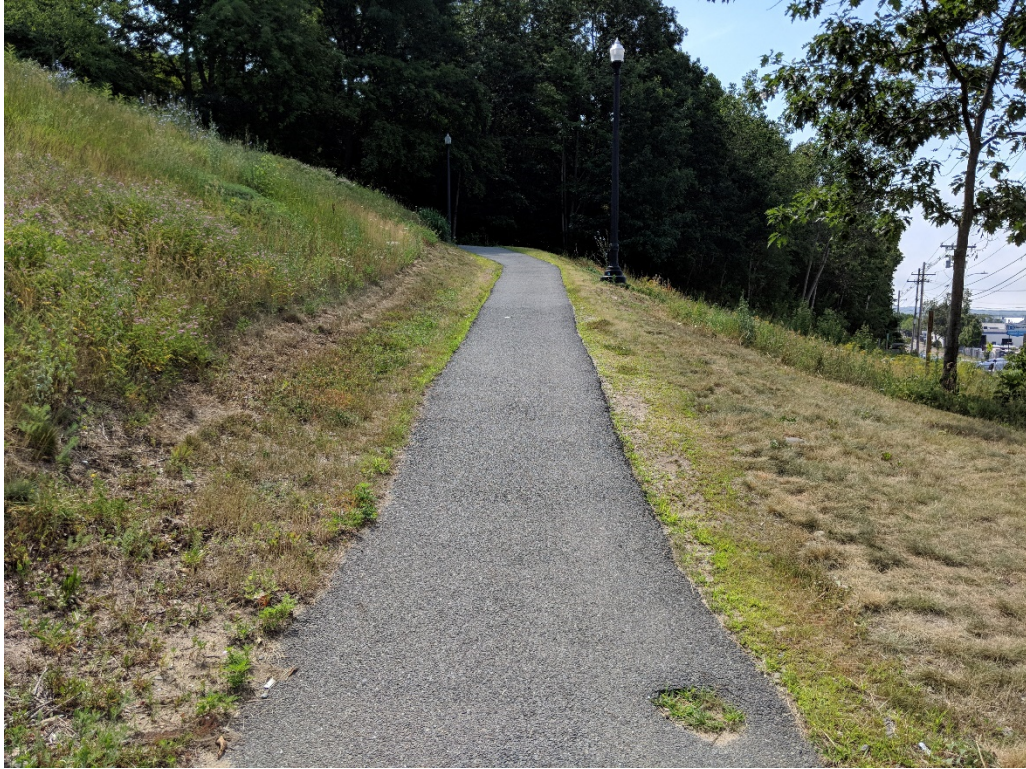
**Photo 3: Trail section in good condition**

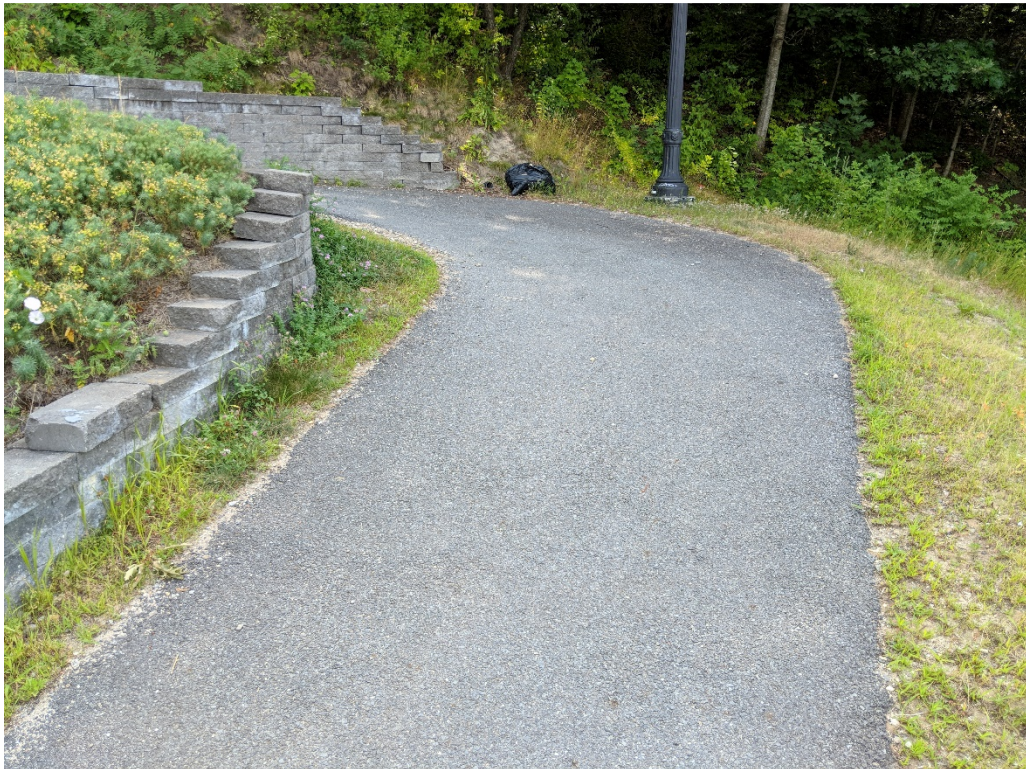
**Photo 4: Trail section in good condition**

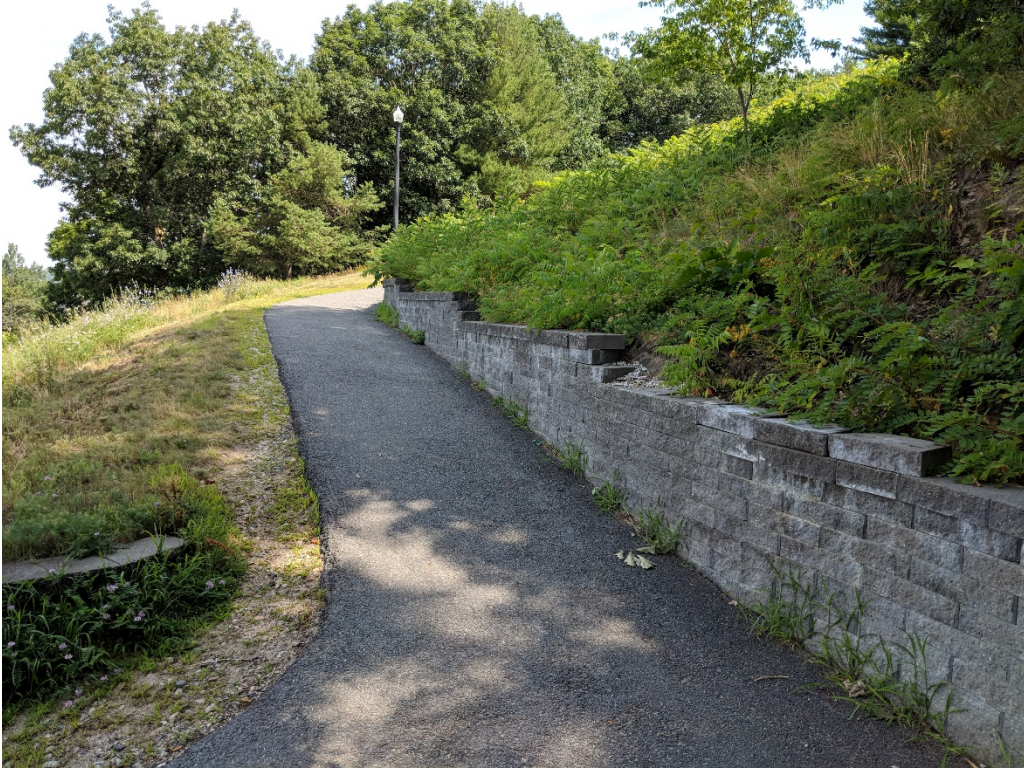
**Photo 5: Trail and retaining wall section in good condition**

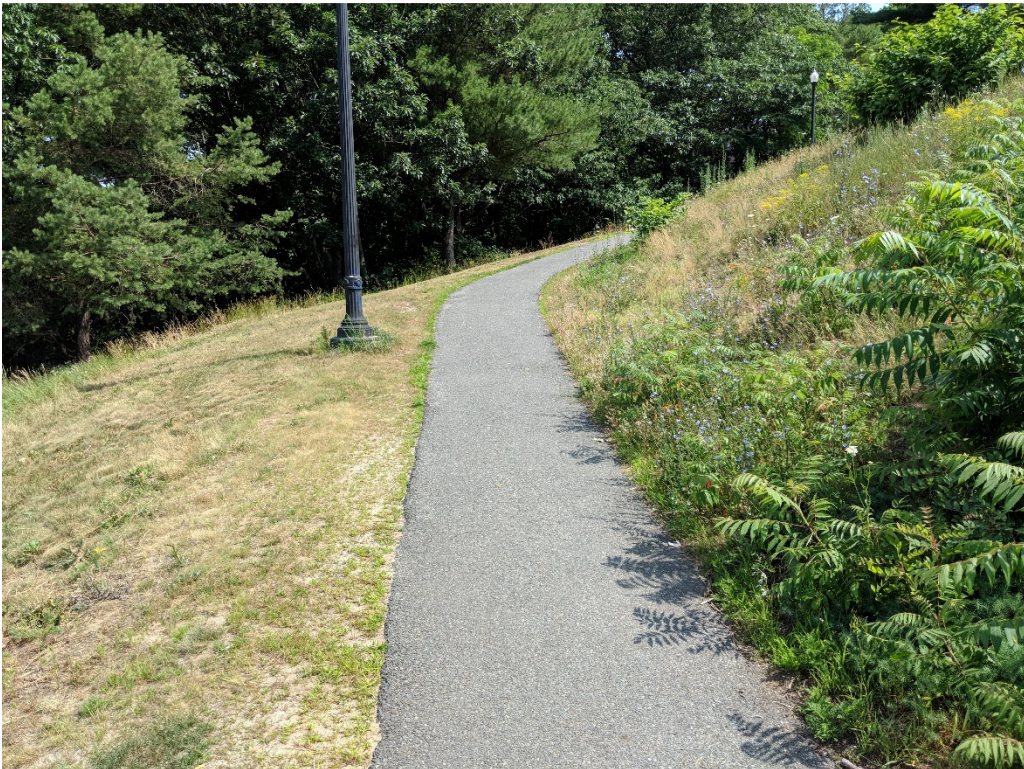
**Photo 6: Trail section in good condition**

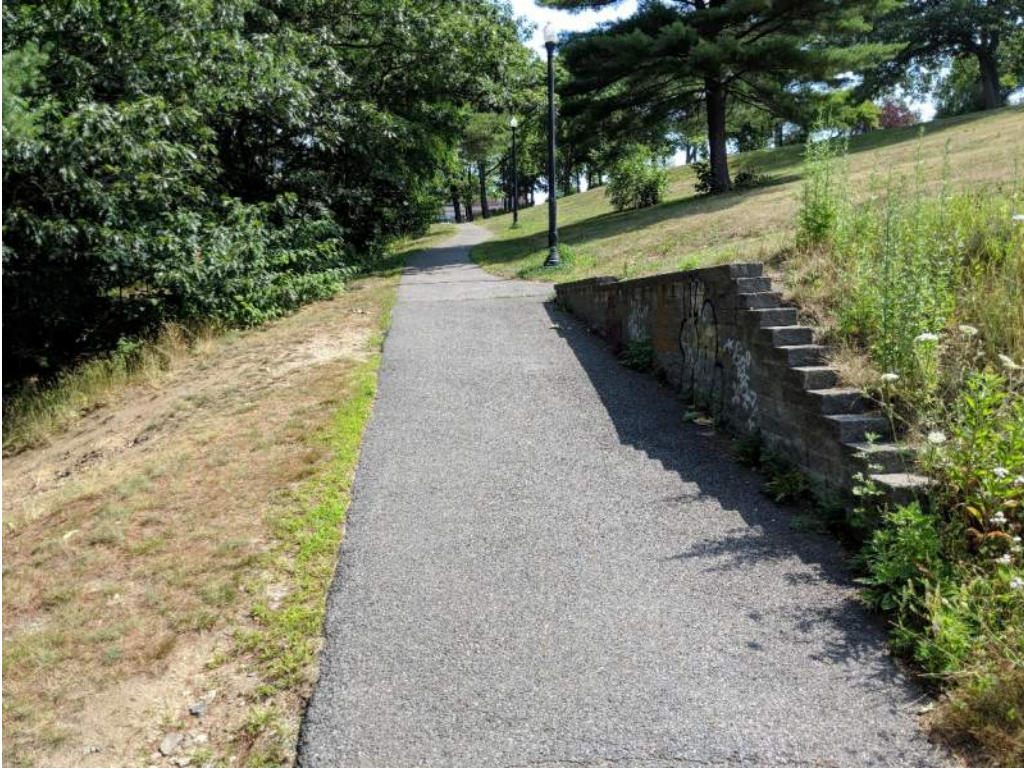
**Photo 7: Trail section in good condition**

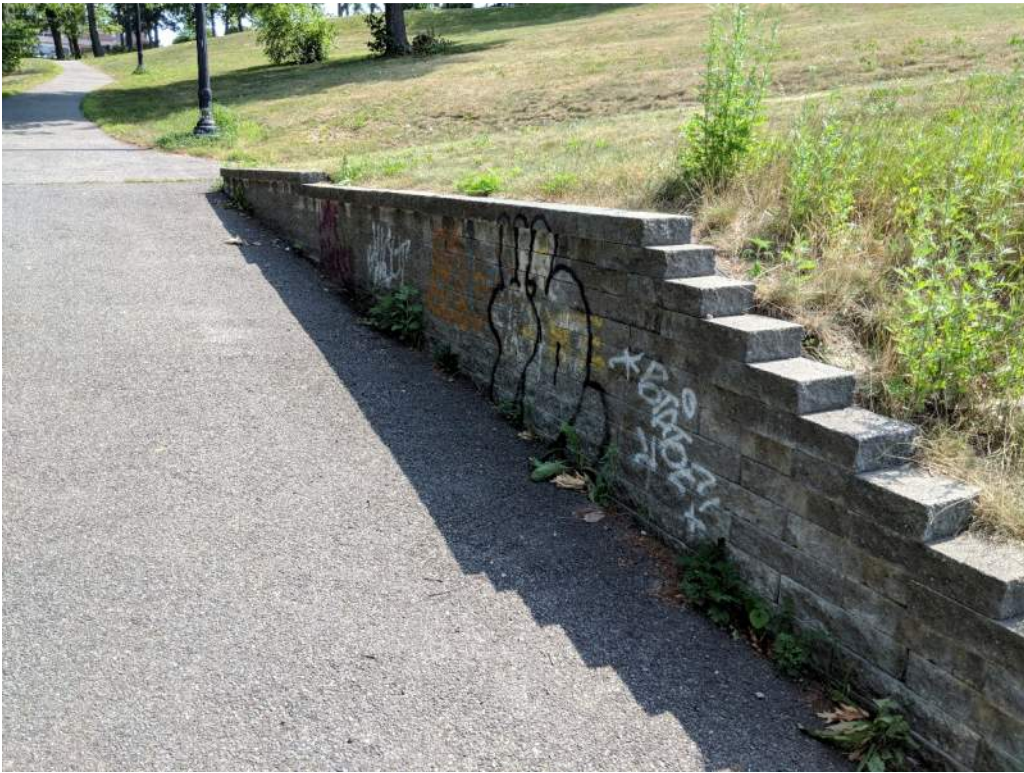
**Photo 8: Retaining wall in good condition,**

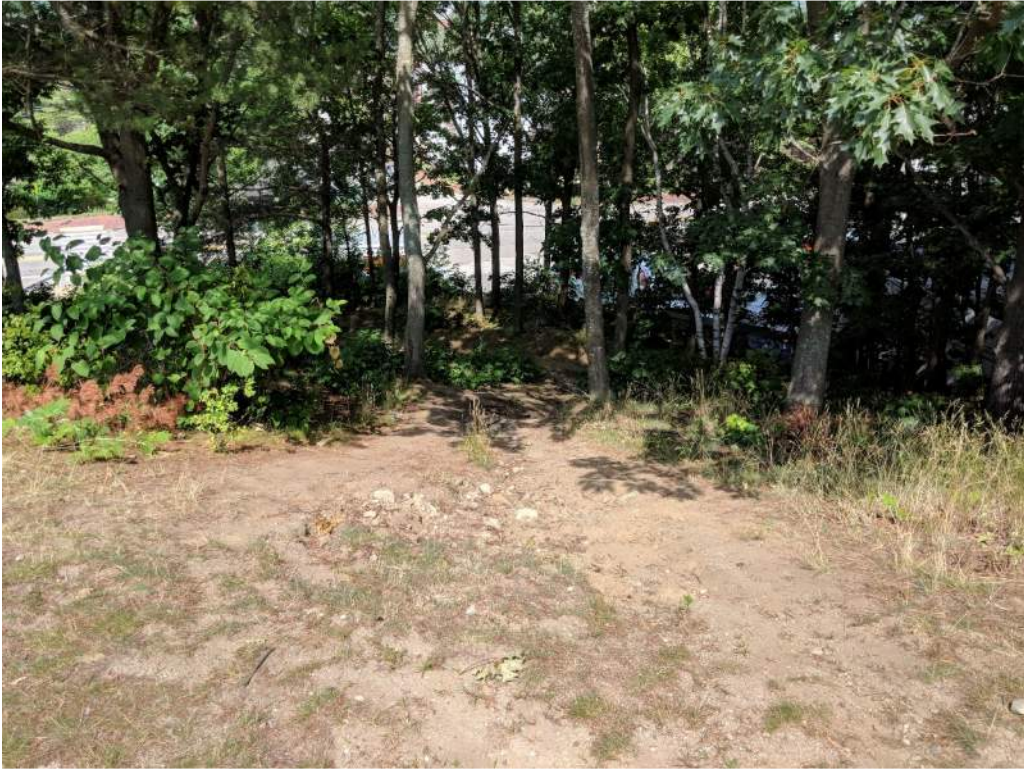
**Photo 9: Foot path connection at trail**

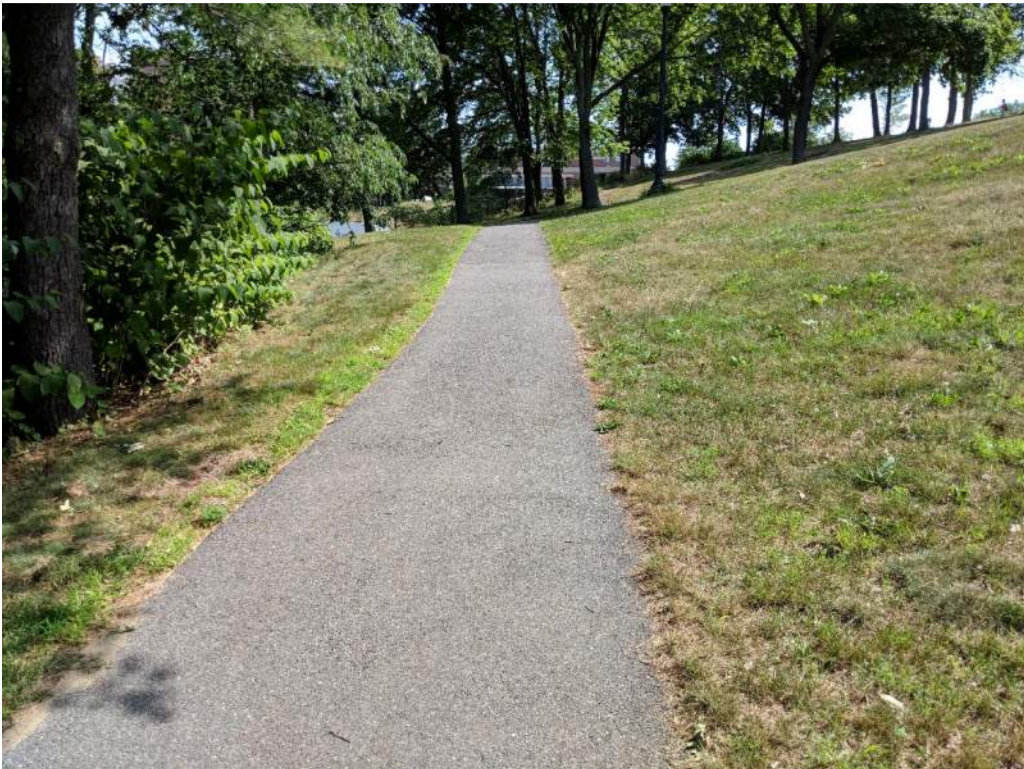
**Photo 10: Trail section in good condition**

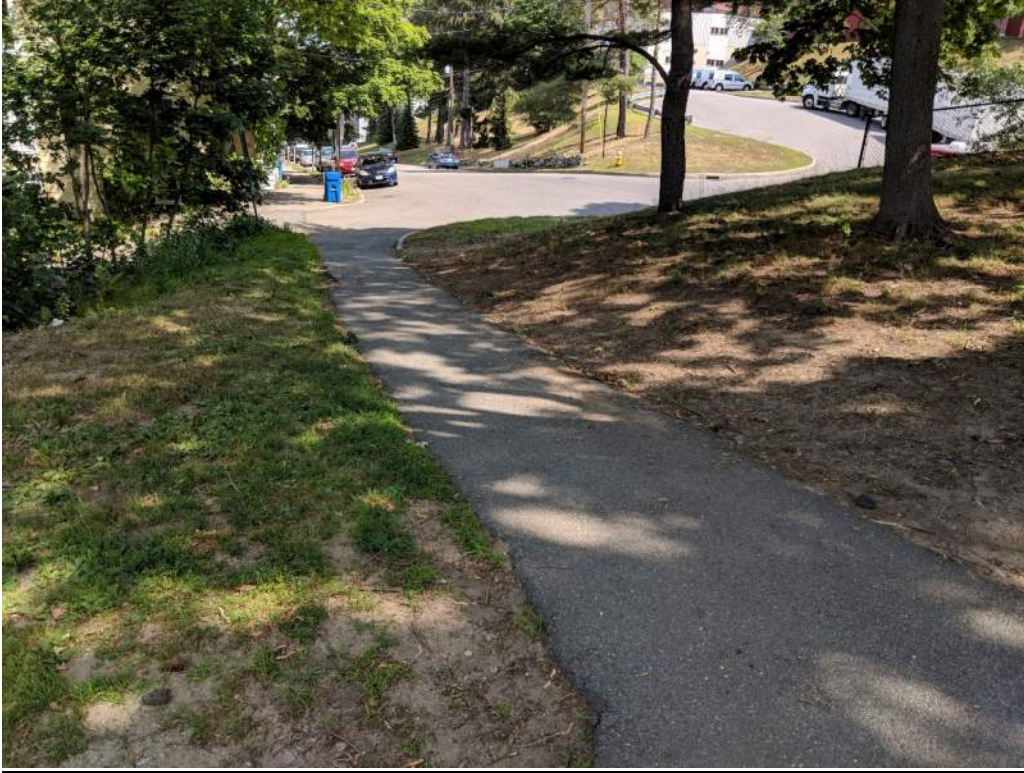
**Photo 11: Trail section in good condition**

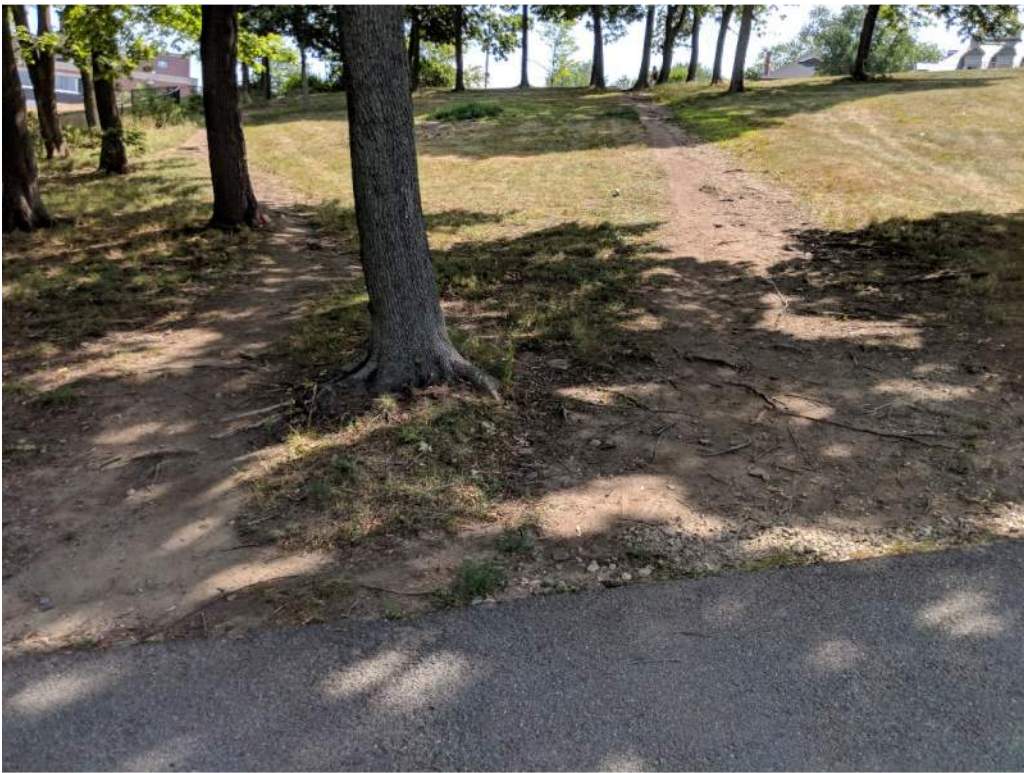
**Photo 12: Foot path connections at trail tee intersection**

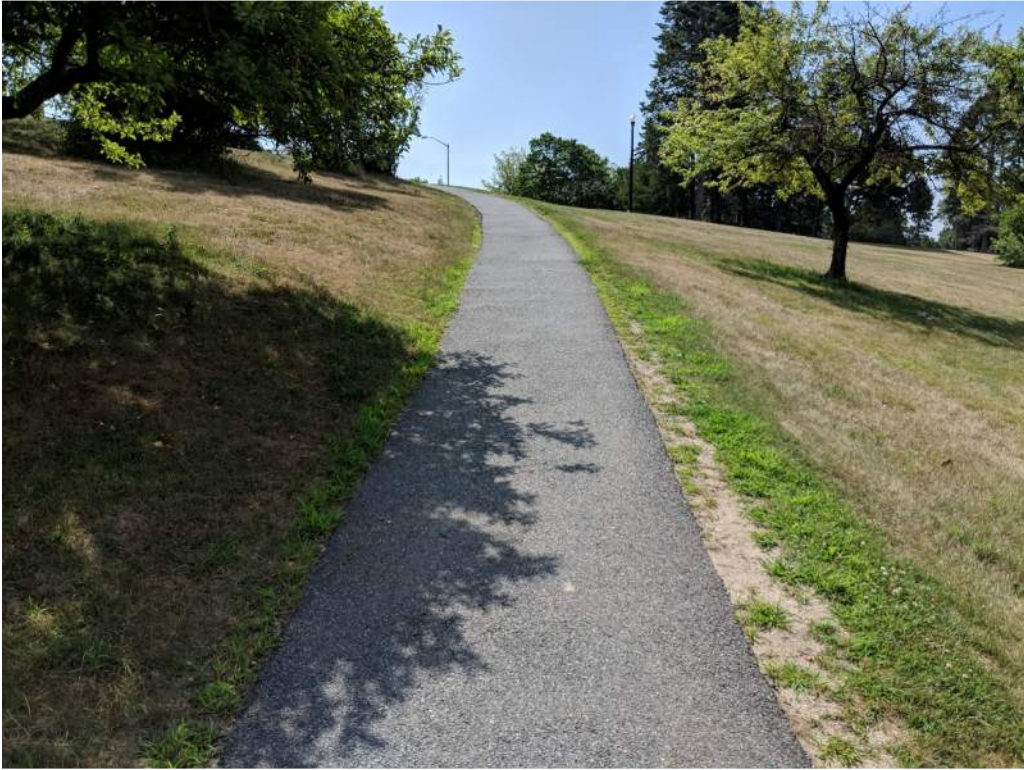
**Photo 13: Trail section in good condition**

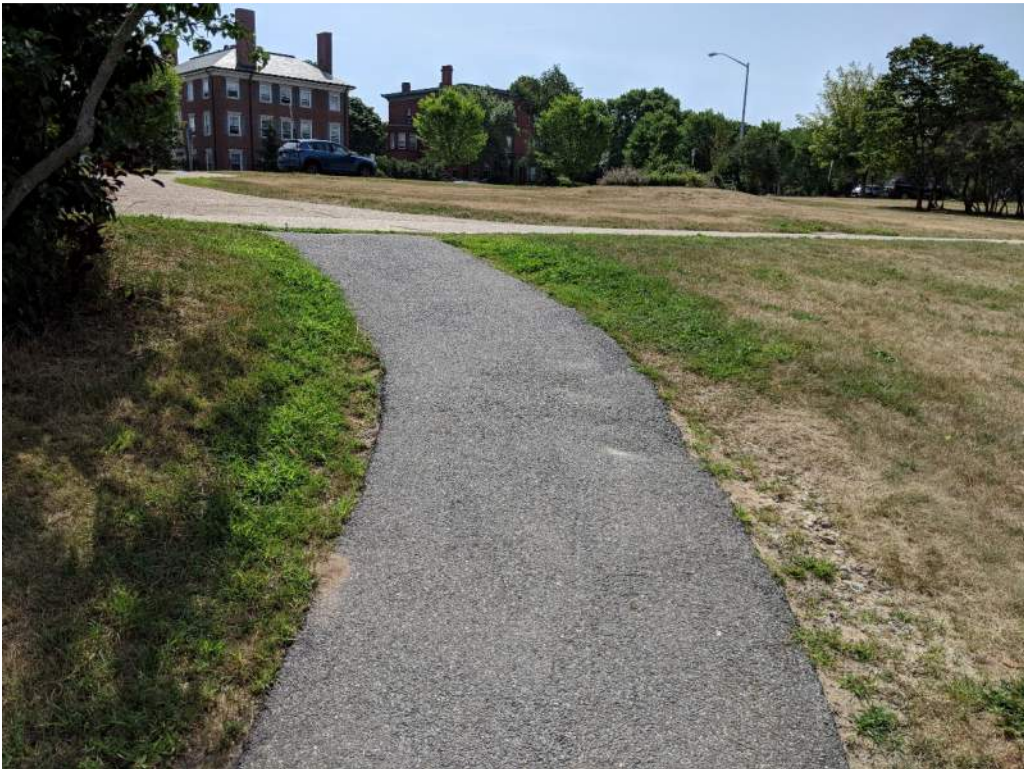
**Photo 14: Trail section in good condition**

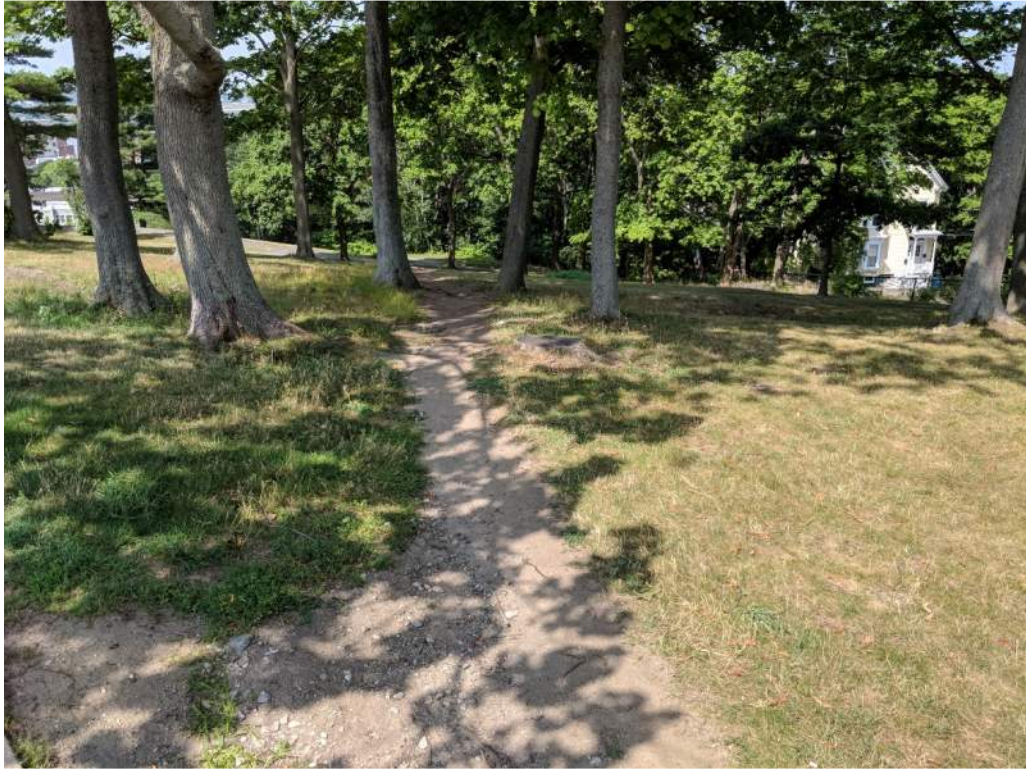
**Photo 15: Foot path connector at Western Promenade**

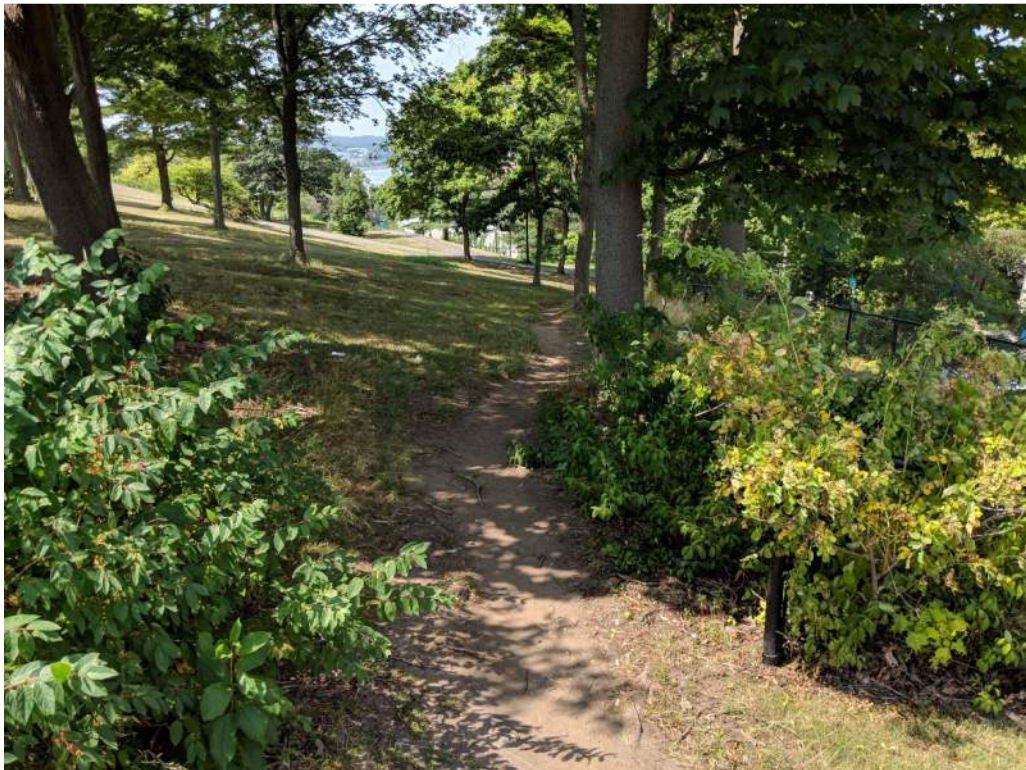
**Photo 16: Foot path connector at Western Promenade**

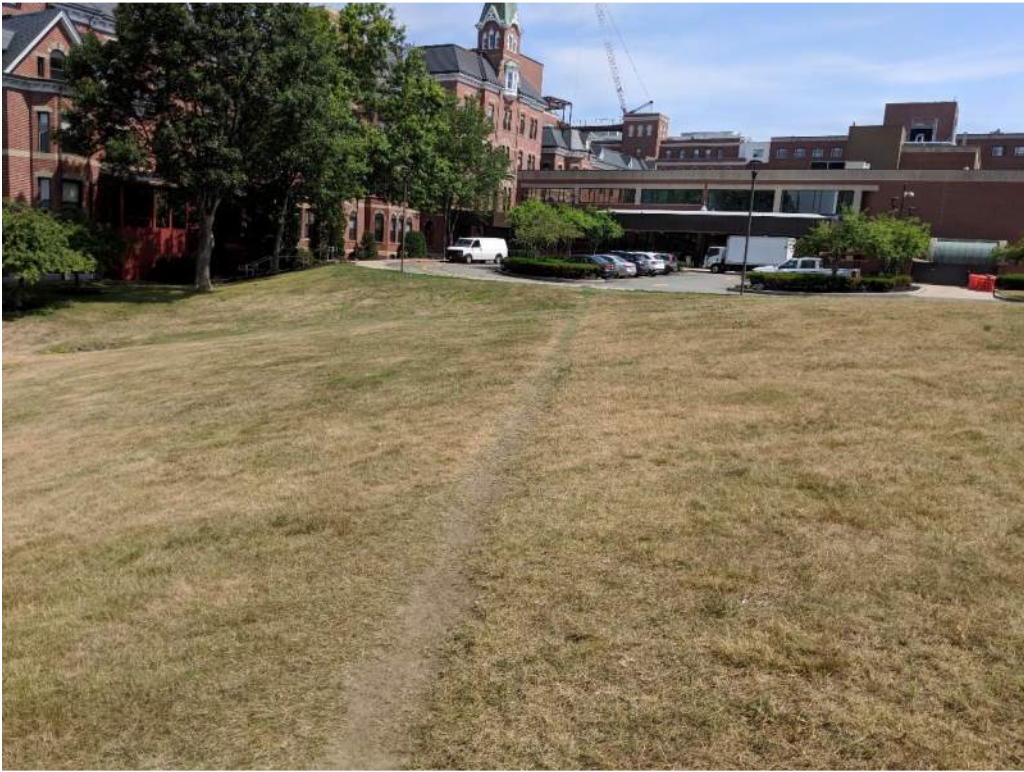
**Photo 17: Foot path connection to MMC campus**

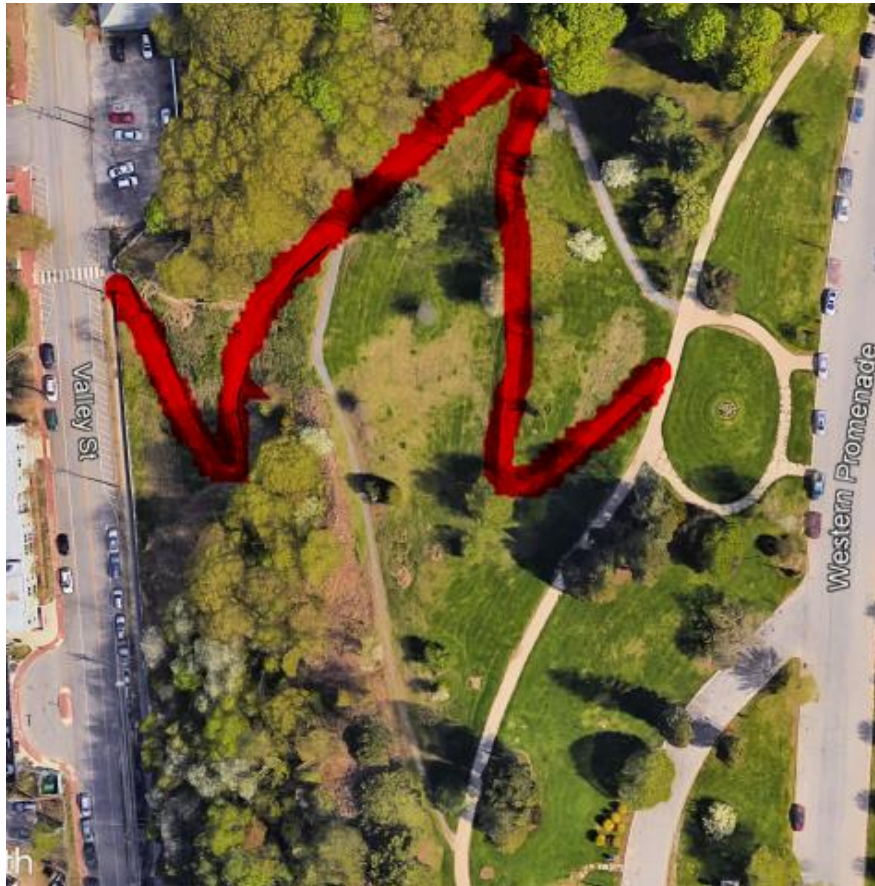
**WESTERN PROM TRAIL PLAN**  
Red Indicates Lighted Section of Trail

The existing trail network that extends from Valley Street to the Western Promenade above includes one path that is illuminated by post lights that have luminaires with prismatic glass diffusers and high intensity discharge lamps. The spacing of the existing light posts is such that the resulting horizontal illuminance at grade is very uneven. There are numerous places along the path between light posts that have less than 0.2 footcandles of illuminance.

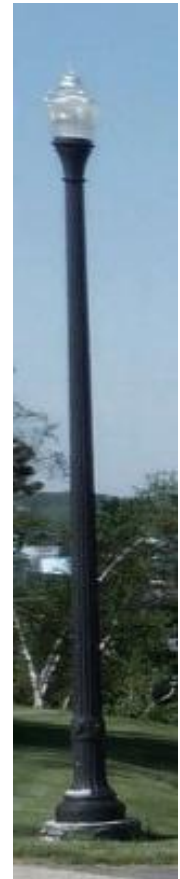
**TRAIL LIGHT POST**

Because the post light luminaires utilize prismatic glass diffusers, the light that is directed side-to-side provides a significant degree of vertical illuminance which can be effective in lighting faces of oncoming pedestrians. Unfortunately, the relatively high brightness of the luminaires is such that once an approaching pedestrian passes in front of a post light, the luminaire brightness immediately behind the person casts them in silhouetted shadow.

The *Illuminating Engineering Society of North America (IESNA)* classifies exterior luminaires according to their potential for producing glare in the publication *IESNA TM-15-11*. The rating system is a numeric index for luminaires with a symmetrical optical distribution that ranges from zero (maximum of 660 zonal lumens directed between 60 and 80 degrees) to five (greater than 12,000 lumens directed between 60 and 80 degrees). The existing trail post light luminaires have a rating of three, which represents a high potential for excessive glare.

An additional consideration is that the existing post light luminaires direct a considerable amount of light skyward which contributes to astronomic light pollution. The *IESNA* publication *TM-15-11* also classifies exterior luminaires according to their potential for producing uplight. Similar to the rating system for potential glare, the uplight rating system is a numeric index that ranges from zero (no uplight) to five (greater than 5000 lumens direct upward). The existing trail post light luminaires have a rating of five.
