## **SPECIAL INSPECTIONS INTERIM FIELD REPORT**

### **Report No. 2017-166.01**

**Date:** October 31, 2017  
**Project:** 12 Weymouth St., Portland, Maine  
**Project Number:** 2017-166  
**Owner:** Grantwey Apartments, LLC  
**Architect/Designer of Record:**  
**Structural Engineer of Record:**  
**Time at Site:** 9:15am – 9:55 am  
**Weather:** Sunny 55°F  
**Present at Site:** Christopher Ray, P.E. (DSC), Johan Siepmann (Property Manager), Mathew Sarapas (Code Enforcement Officer).

#### **Exterior Wood Egress Stair Framing Review**

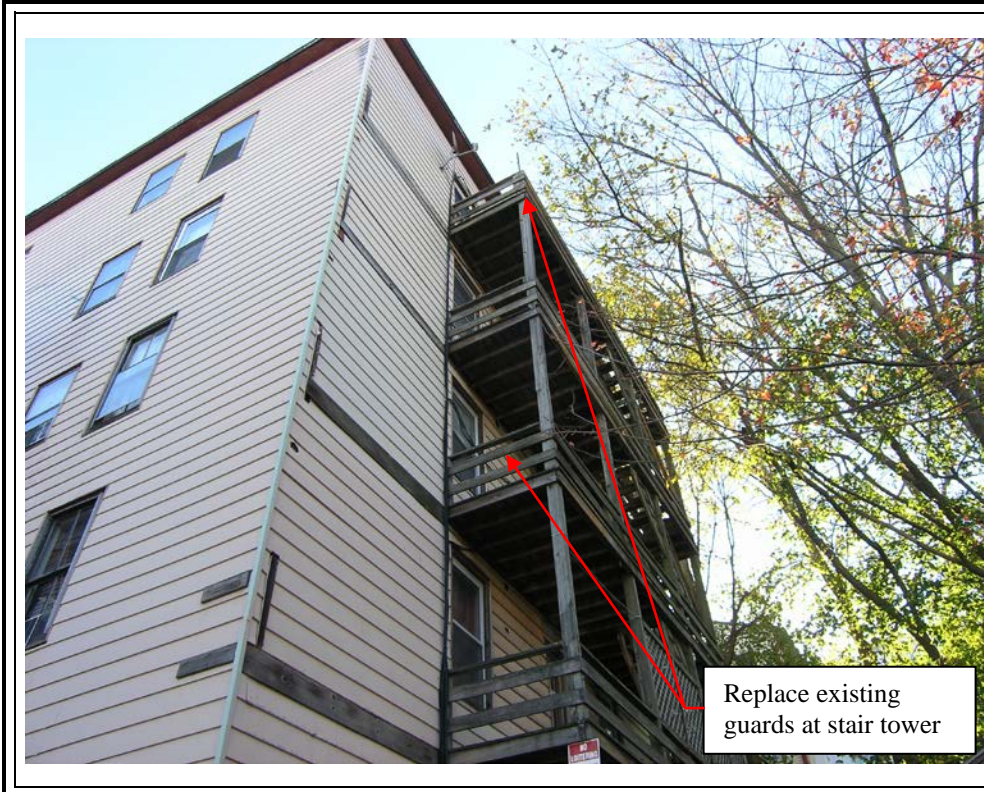
**Number 1.**

The property is a five story, 26-unit apartment building constructed in 1910 and features approximately 11500-square foot of living space. Located along the rear of the building is a four story wood framed accessible means of egress stair tower (Refer to Photos 1 and 2).

Exterior Rear Building  
Egress Stair.

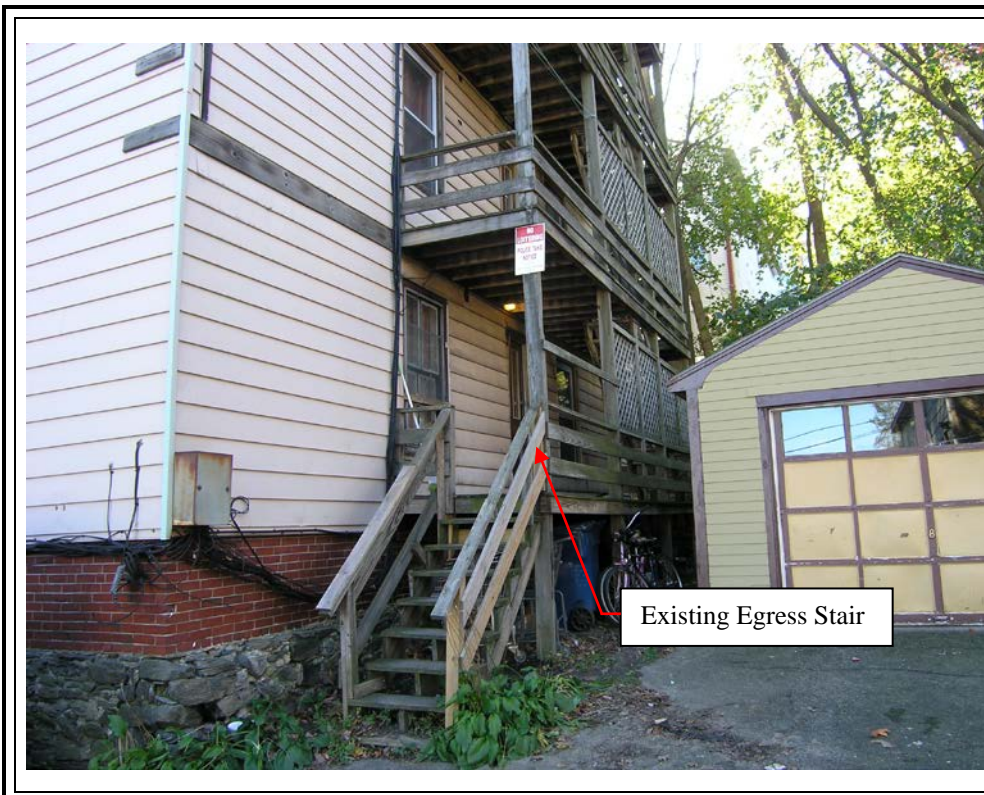
**Number 2.**

Exterior Rear Building  
Egress Stair.

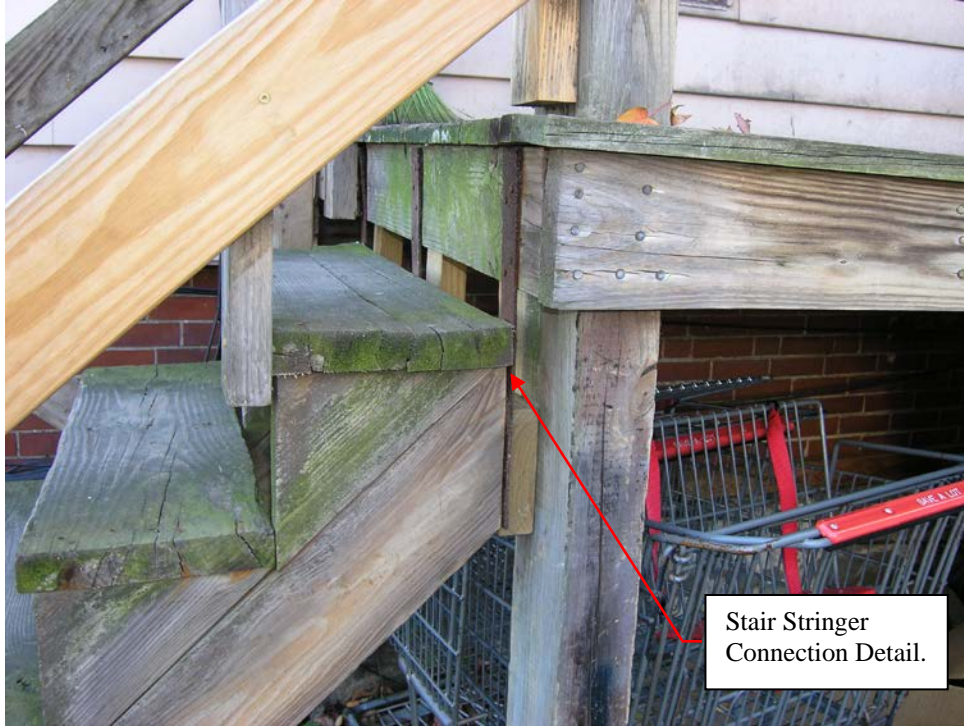
**Number 3.**

- B. Wood stairs are constructed between each floor level. The stairs are erected with 2x stringers supported with thin walled steel straps nailed to wood headers (Refer to Photos 3, 4, 5 and 6). *The steel straps are in fair condition and we recommend replacement with galvanized steel sloped face mounted hangers properly supported on wood headers. The stair treads in many areas are in fair condition and will likely require replacement. We also noticed stair risers are not provided and we believe this should be considered as part of a stair replacement plan. In addition the stair riser and tread dimensions exceed the allowable dimensions by Code and will need to be reviewed later by the governing Code Official of The City of Portland.*

Existing Stair Stringer  
Connection Detail.

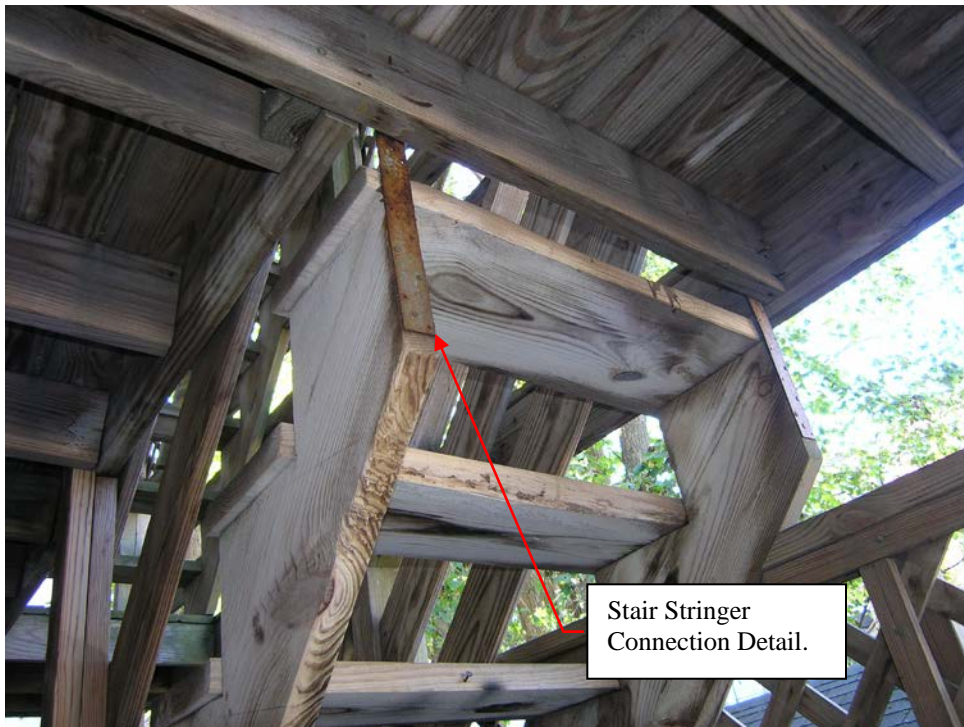
**Number 4.**

- C. The ledger board is a structural element supporting half of the deck platforms loads and is nailed to the building structure with common nails equally spaced (Refer to Photo 7). The floor joist framing is comprised of 2x6 joist toenailed to the floor beams (Refer to Photos 4 and 7). *We recommend adding an additional 1/4" diameter galvanized Structural Wood Screw Fastener through the ledger board and into the building structural framing a minimum of 24-inches on center. Also provide galvanized face mounted hangers at each joist connection location.*

Existing Stair Stringer  
Connection Detail.

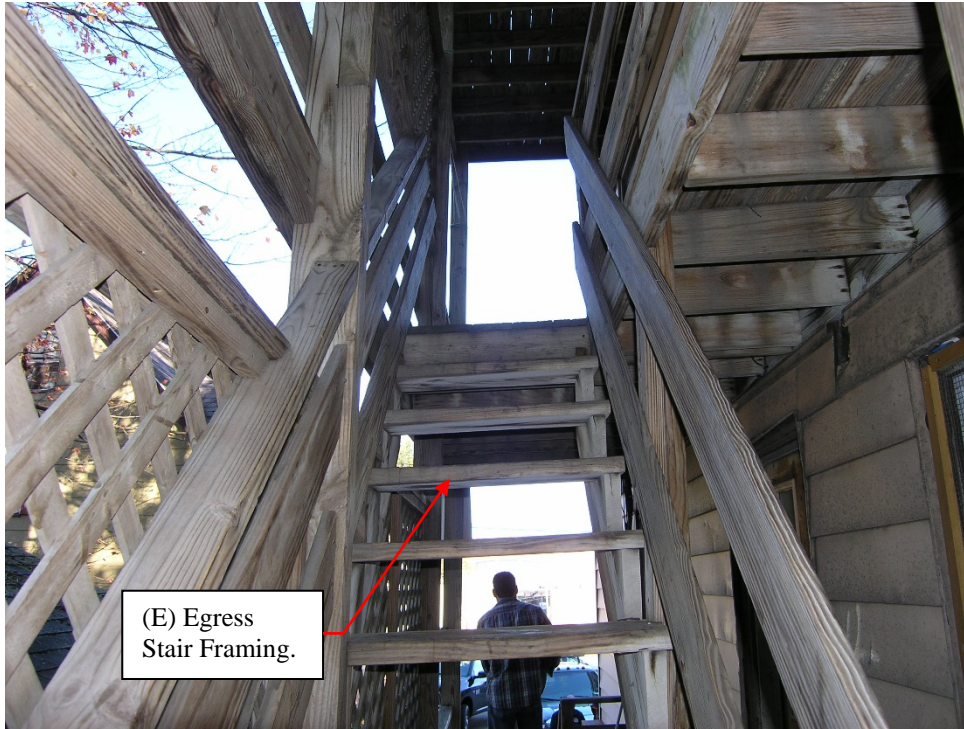
**Number 5.**

(E) Egress  
Stair Framing.

Existing Egress Stair  
Framing.

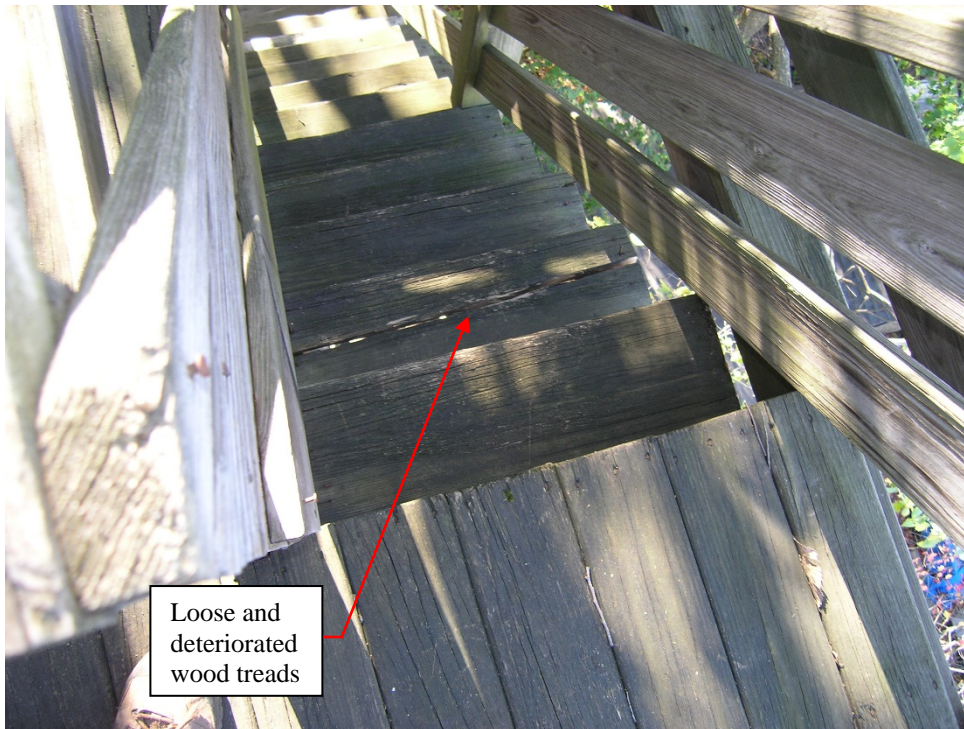
**Number 6.**

Loose and  
deteriorated  
wood treads

Existing Fourth Floor  
Stair Framing.

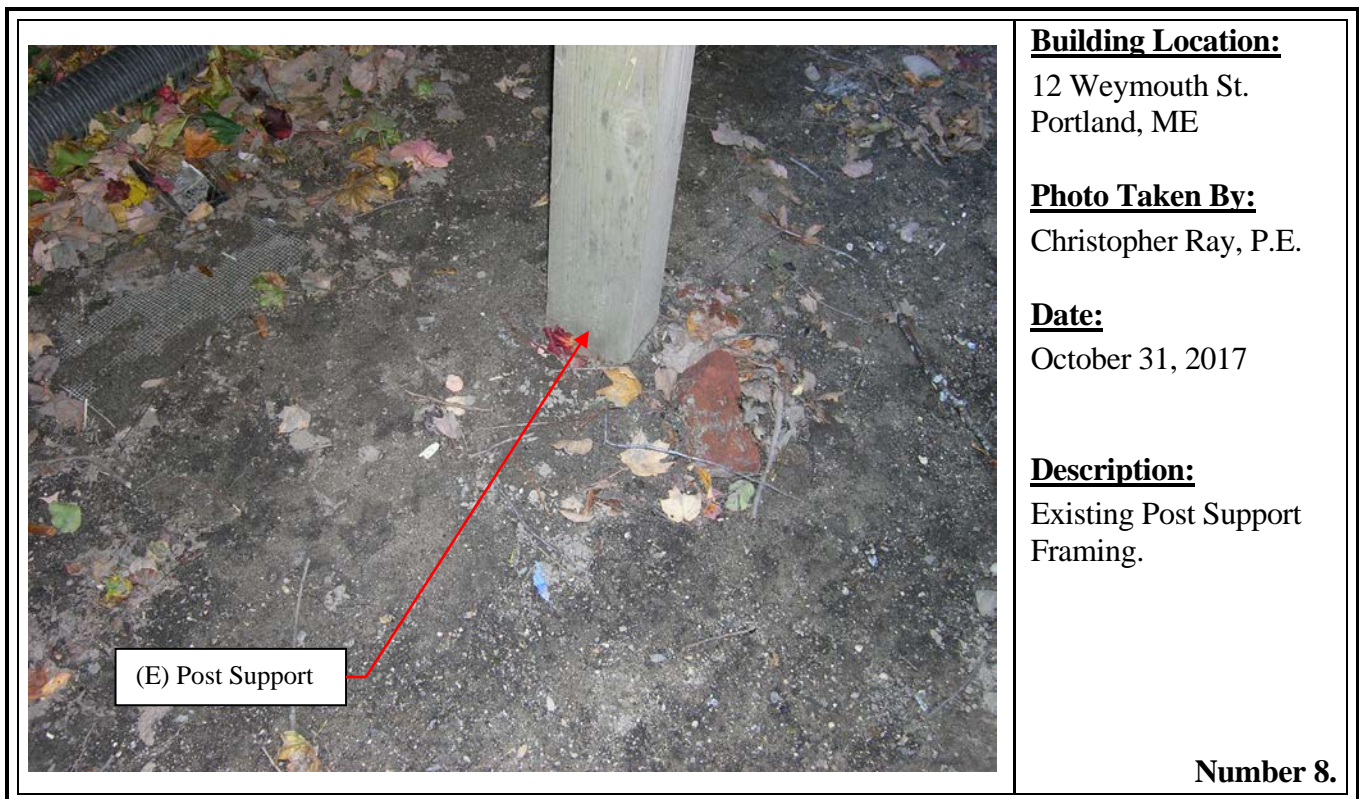
- D. We did not observe concrete piers supporting the stair tower posts (Refer to Photo 8). *We recommend installing reinforced concrete piers placed below frost depth and supporting each tower post with the required hold down anchorage.*

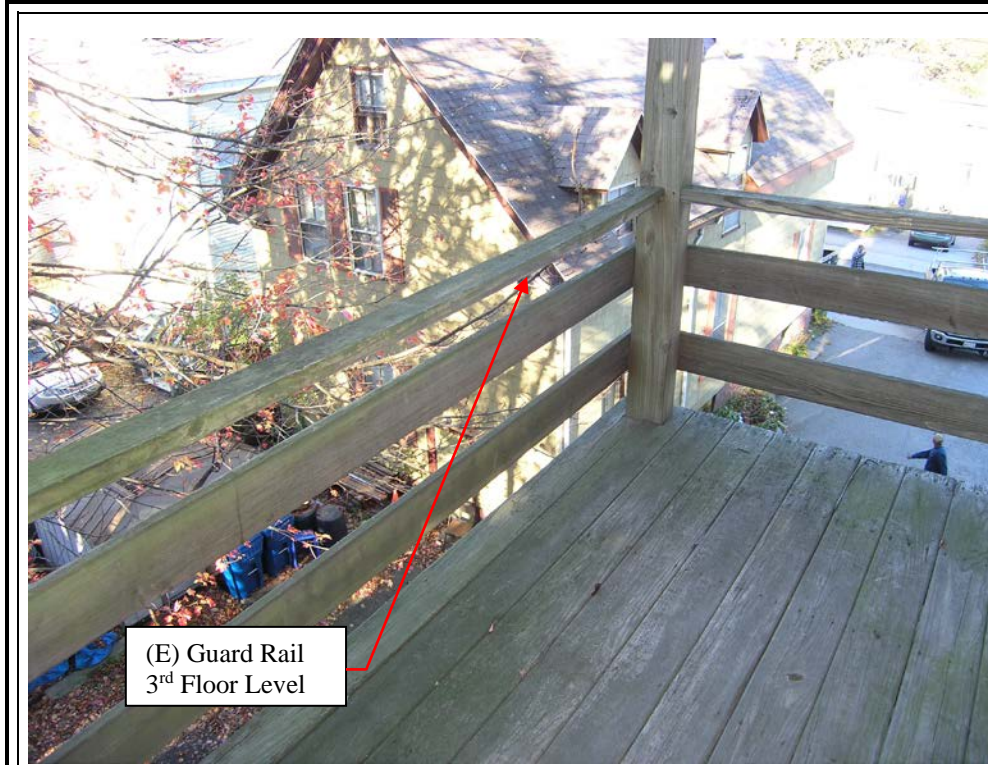
**Number 9.**

- E. Guards shall be located along open-sided stairways, platforms and ramps that are located more than 30-inches above finished grade (Refer to Photos 9 and 10). *Based on our review the height of many of the guard rails is less than 36-inches. We believe this is an urgent issue and should be repaired and constructed according to the latest building code and construction industry standards (Refer to photo 10).*

(E) Guard Rail  
3<sup>rd</sup> Floor Level

Existing Platform:  
Egress Stair Framing.

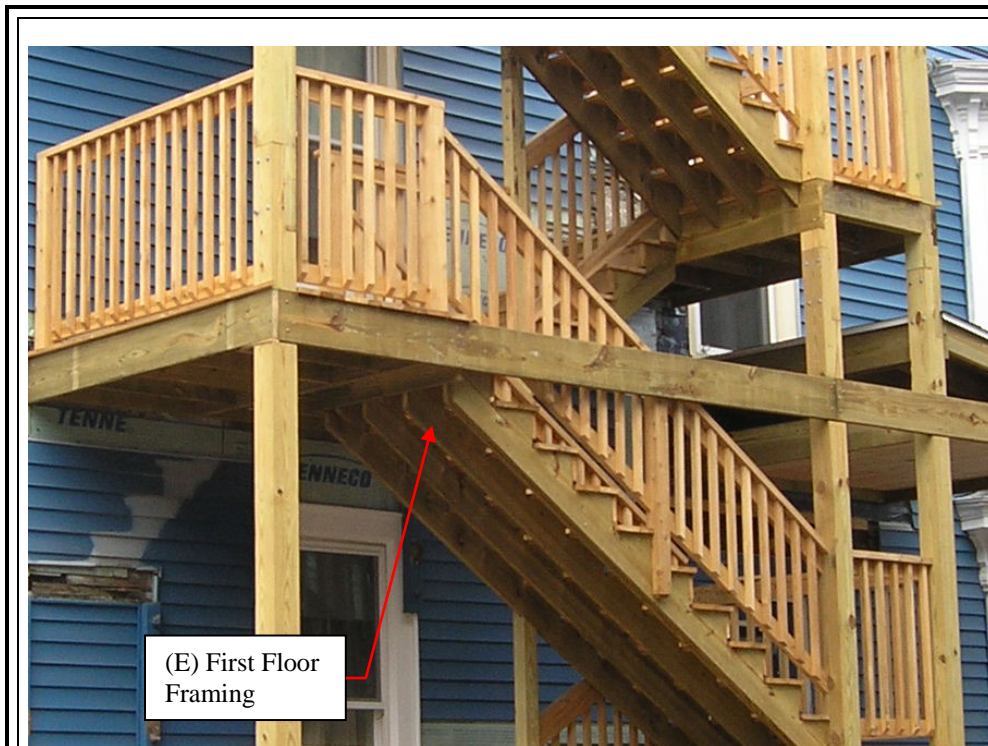
**Number 10.**

(E) First Floor  
Framing

Proposed Guard and  
Handrail Design  
Framing.
