SPECIAL INSPECTIONS INTERIM FIELD REPORT

Report No. 2017-166.01

Exterior Wood Egress Stair Framing Review

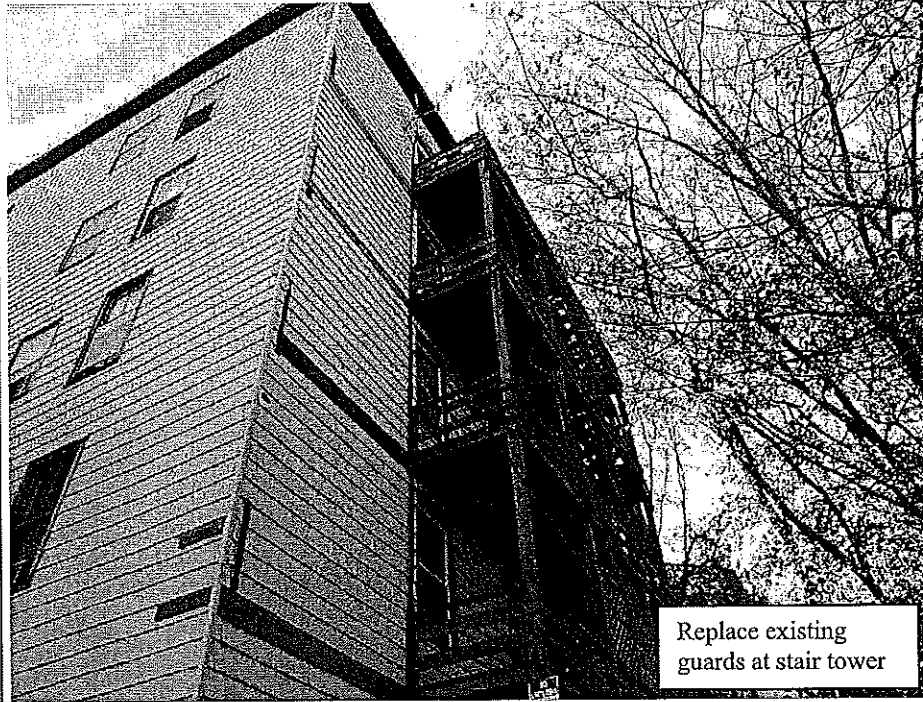
Number 1.

The property is a five story, 26-unit apartment building constructed in 1910 and features approximately 11500-square foot of living space. Located along the rear of the building is a four story wood framed accessible means of egress stair tower (Refer to Photos 1 and 2).

Exterior Rear Building
Egress Stair.

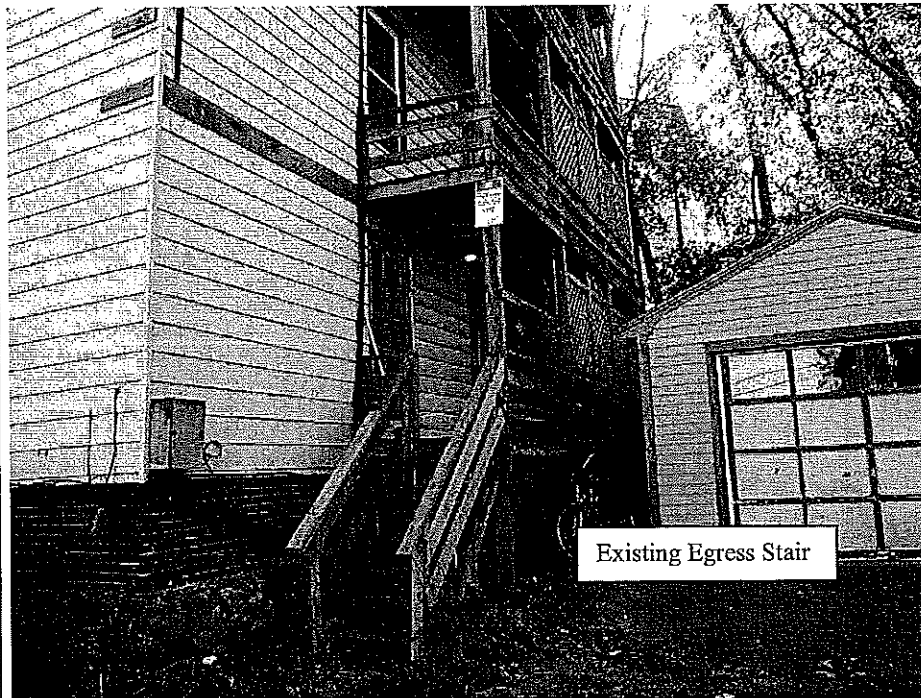
Number 2.

Exterior Rear Building
Egress Stair.

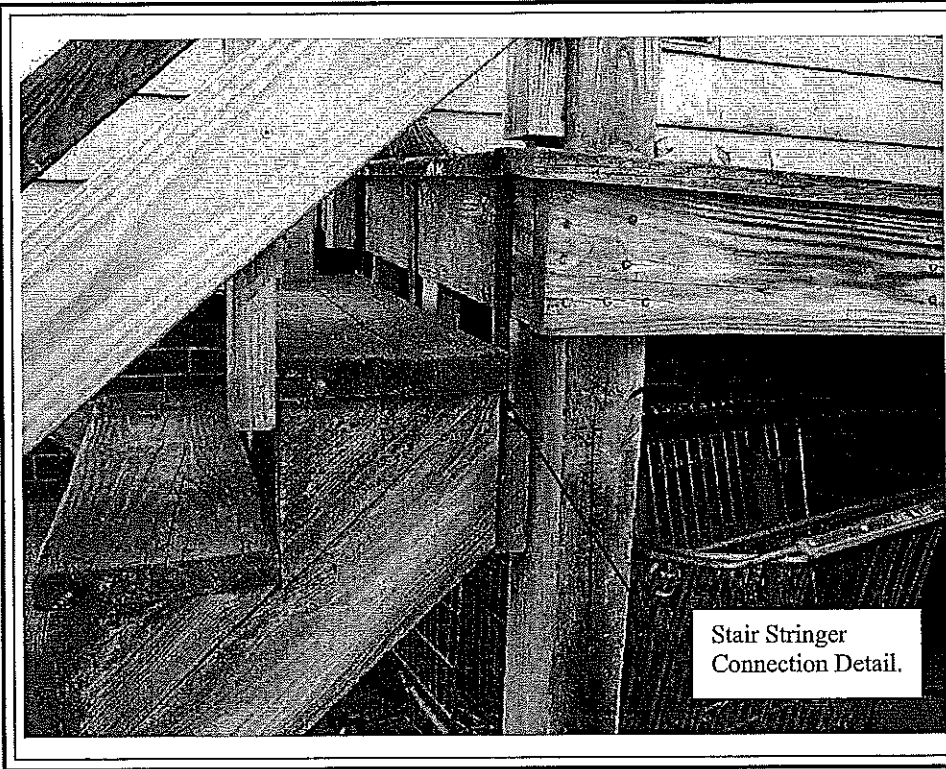
Number 3.

- B. Wood stairs are constructed between each floor level. The stairs are erected with 2x stringers supported with thin walled steel straps nailed to wood headers (Refer to Photos 3, 4, 5 and 6). *The steel straps are in fair condition and we recommend replacement with galvanized steel sloped face mounted hangers properly supported on wood headers. The stair treads in many areas are in fair condition and will likely require replacement. We also noticed stair risers are not provided and we believe this should be considered as part of a stair replacement plan. In addition the stair riser and tread dimensions exceed the allowable dimensions by Code and will need to be reviewed later by the governing Code Official of The City of Portland.*

Existing Stair Stringer
Connection Detail.

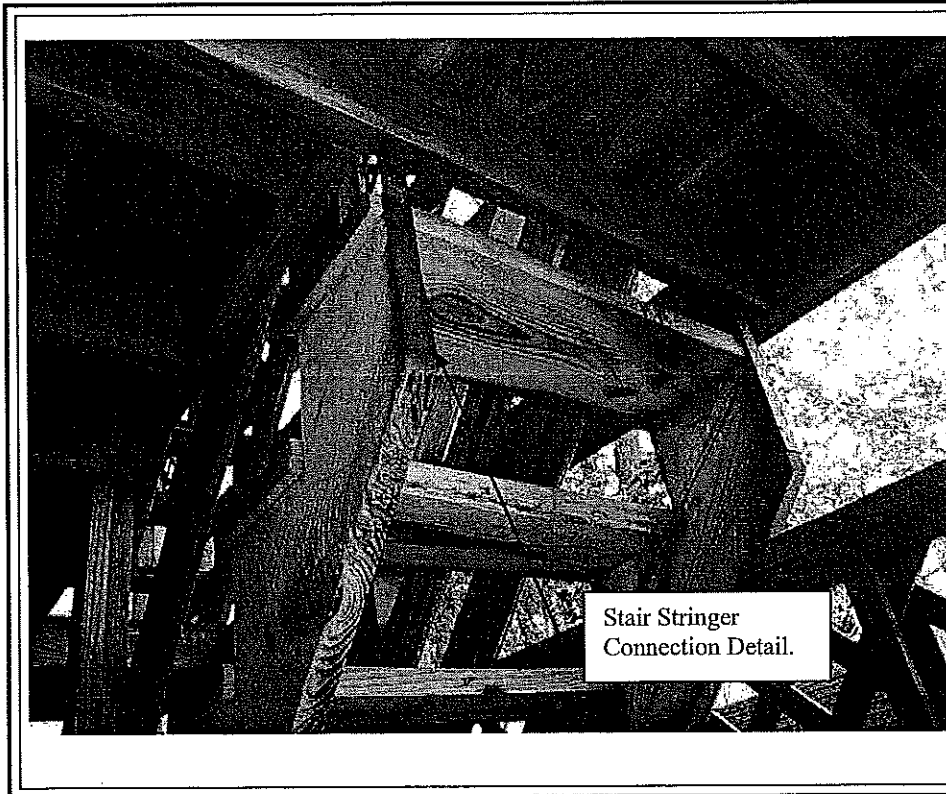
Number 4.

- C. The ledger board is a structural element supporting half of the deck platforms loads and is nailed to the building structure with common nails equally spaced (Refer to Photo 7). The floor joist framing is comprised of 2x6 joist toenailed to the floor beams (Refer to Photos 4 and 7). *We recommend adding an additional 1/4" diameter galvanized Structural Wood Screw Fastener through the ledger board and into the building structural framing a minimum of 24-inches on center. Also provide galvanized face mounted hangers at each joist connection location.*

Existing Stair Stringer
Connection Detail.

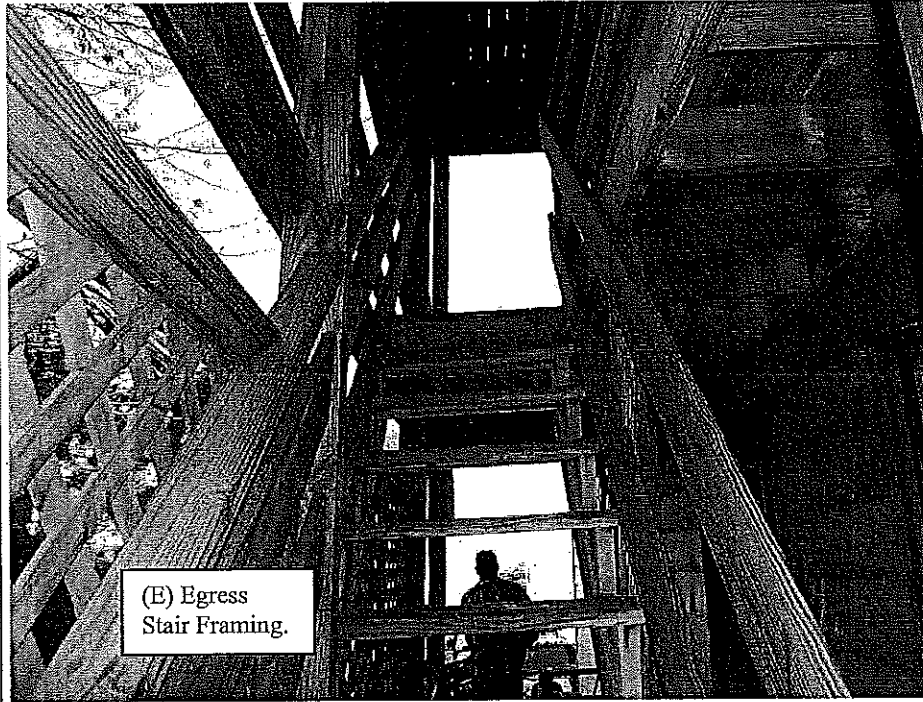
Number 5.

(E) Egress
Stair Framing.

Existing Egress Stair
Framing.

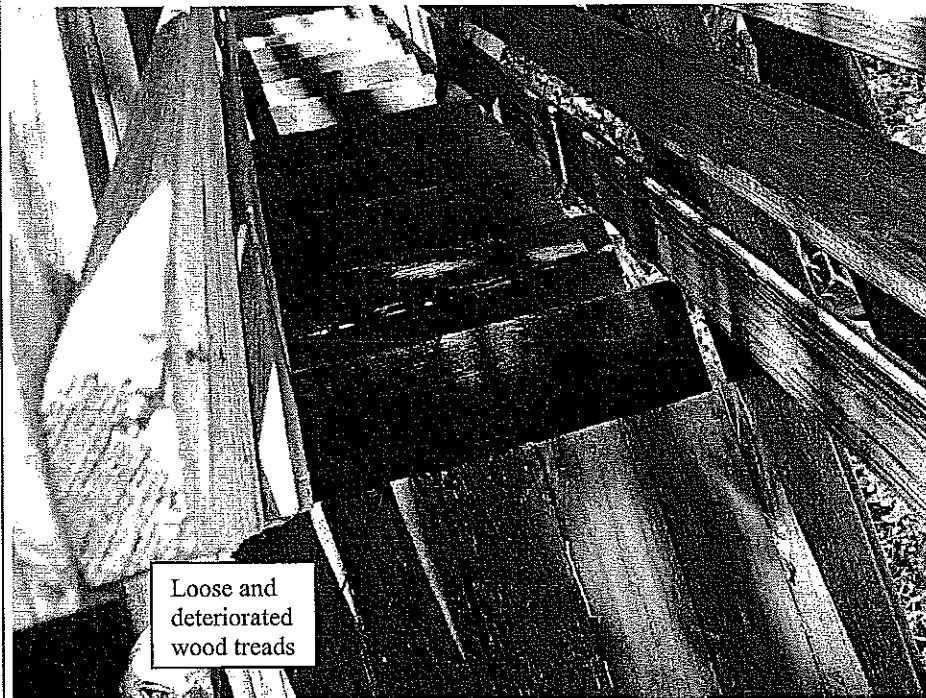
Number 6.

Loose and
deteriorated
wood treads

Existing Fourth Floor
Stair Framing.

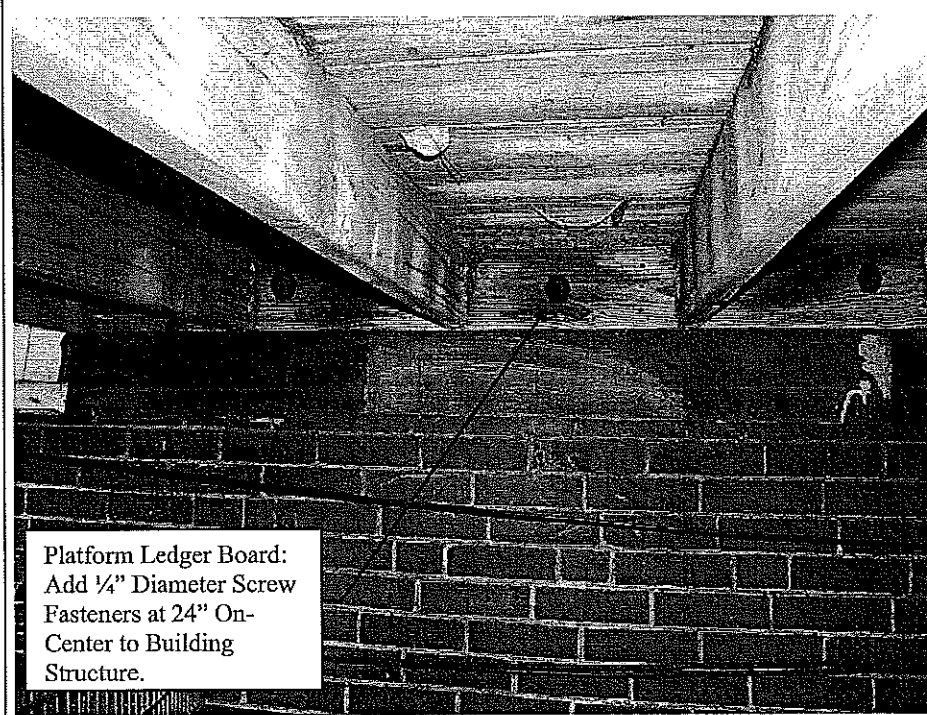
Number 7.

(E) Deck Platform
Framing.

Platform Ledger Board:
Add 1/4" Diameter Screw
Fasteners at 24" On-
Center to Building
Structure.

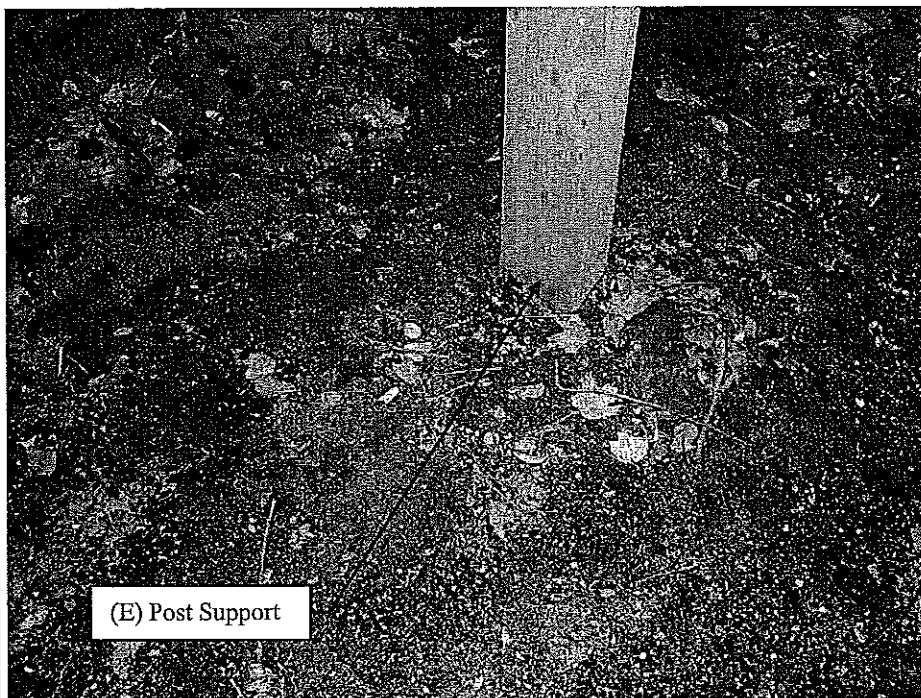
Number 8.

- D. We did not observe concrete piers supporting the stair tower posts (Refer to Photo 8). *We recommend installing reinforced concrete piers placed below frost depth and supporting each tower post with the required hold down anchorage.*

(E) Post Support

Existing Post Support
Framing.

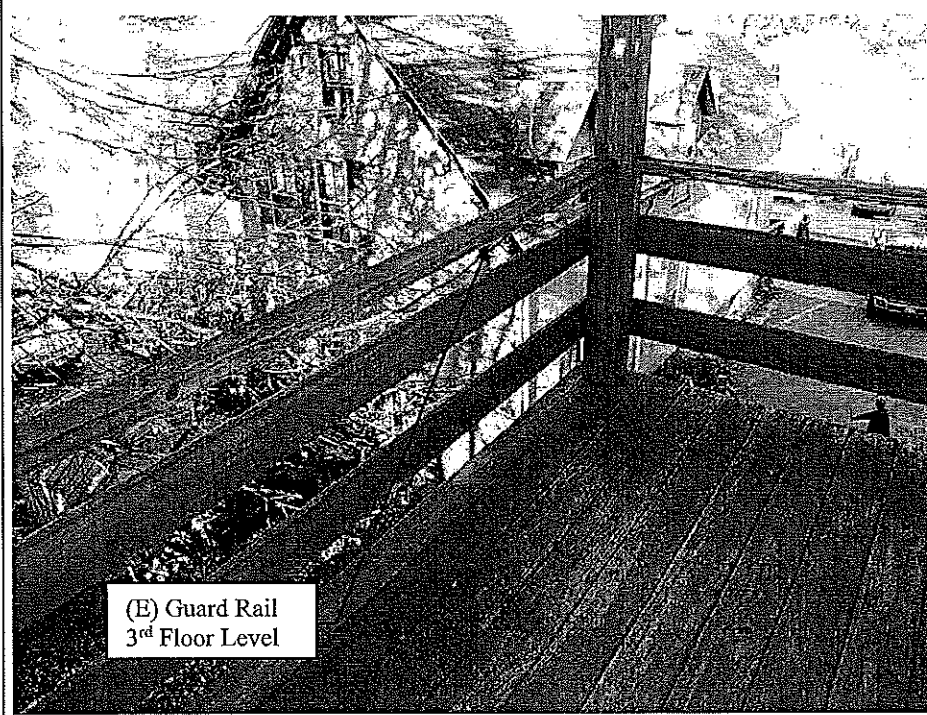
Number 9.

- E. Guards shall be located along open-sided stairways, platforms and ramps that are located more than 30-inches above finished grade (Refer to Photos 9 and 10). *Based on our review the height of many of the guard rails is less than 36-inches. We believe this is an urgent issue and should be repaired and constructed according to the latest building code and construction industry standards (Refer to photo 10).*

(E) Guard Rail
3rd Floor Level

Existing Platform:
Egress Stair Framing.

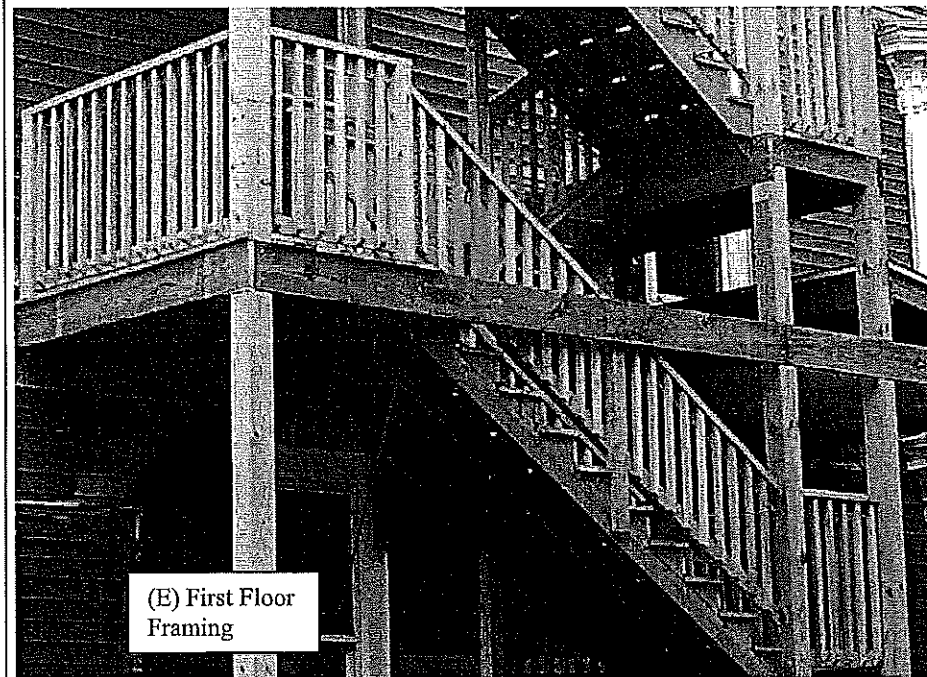
Number 10.

(E) First Floor
Framing

Proposed Guard and
Handrail Design
Framing.
