BUILDING PERMIT

Location/Address of Construction: <u>696 CONGRESS STREET</u>		
Total Square Footage of Proposed Structure/Area <u>1,814 sq ft</u>	Square Footage of Lot <u>0.78 ACRES</u>	Number of Stories <u>3</u>
Tax Assessor's Chart, Block & Lot Chart# <u>55</u> Block# <u>E</u> Lot# <u>32</u>	Applicant * <u>must be owner, Lessee or Buyer</u> * Name <u>MGO PROPERTIES LLC</u> Address <u>PMB 299 SO MARKET ST</u> City, State & Zip <u>S. PORTLAND 04106</u>	Telephone: <u>207-799-7502</u>
Lessee/DBA (If Applicable)	Owner (if different from Applicant) Name Address City, State & Zip	Cost Of Work: \$ <u>20,000⁰⁰</u> C of O Fee: \$ _____ Total Fee: \$ <u>220⁰⁰</u>
Current legal use (i.e. single family) <u>MIXED / OFFICE</u> Number of Residential Units <u>FOUR</u>		
If vacant, what was the previous use? _____		
Proposed Specific use: <u>SAME</u>		
Is property part of a subdivision? _____ If yes, please name _____		
Project description: <u>REPAIRS TO INTERIOR / EXTERIOR DUE TO VEHICLE COLLISION. EGRESS CHANGES PER PFD.</u>

Subject: Building located at 696 Congress Street, Portland, Maine
Damage to Building Resulting from Automobile Accident

designed by: JHL	696 CONGRESS STREET PORTLAND, MAI

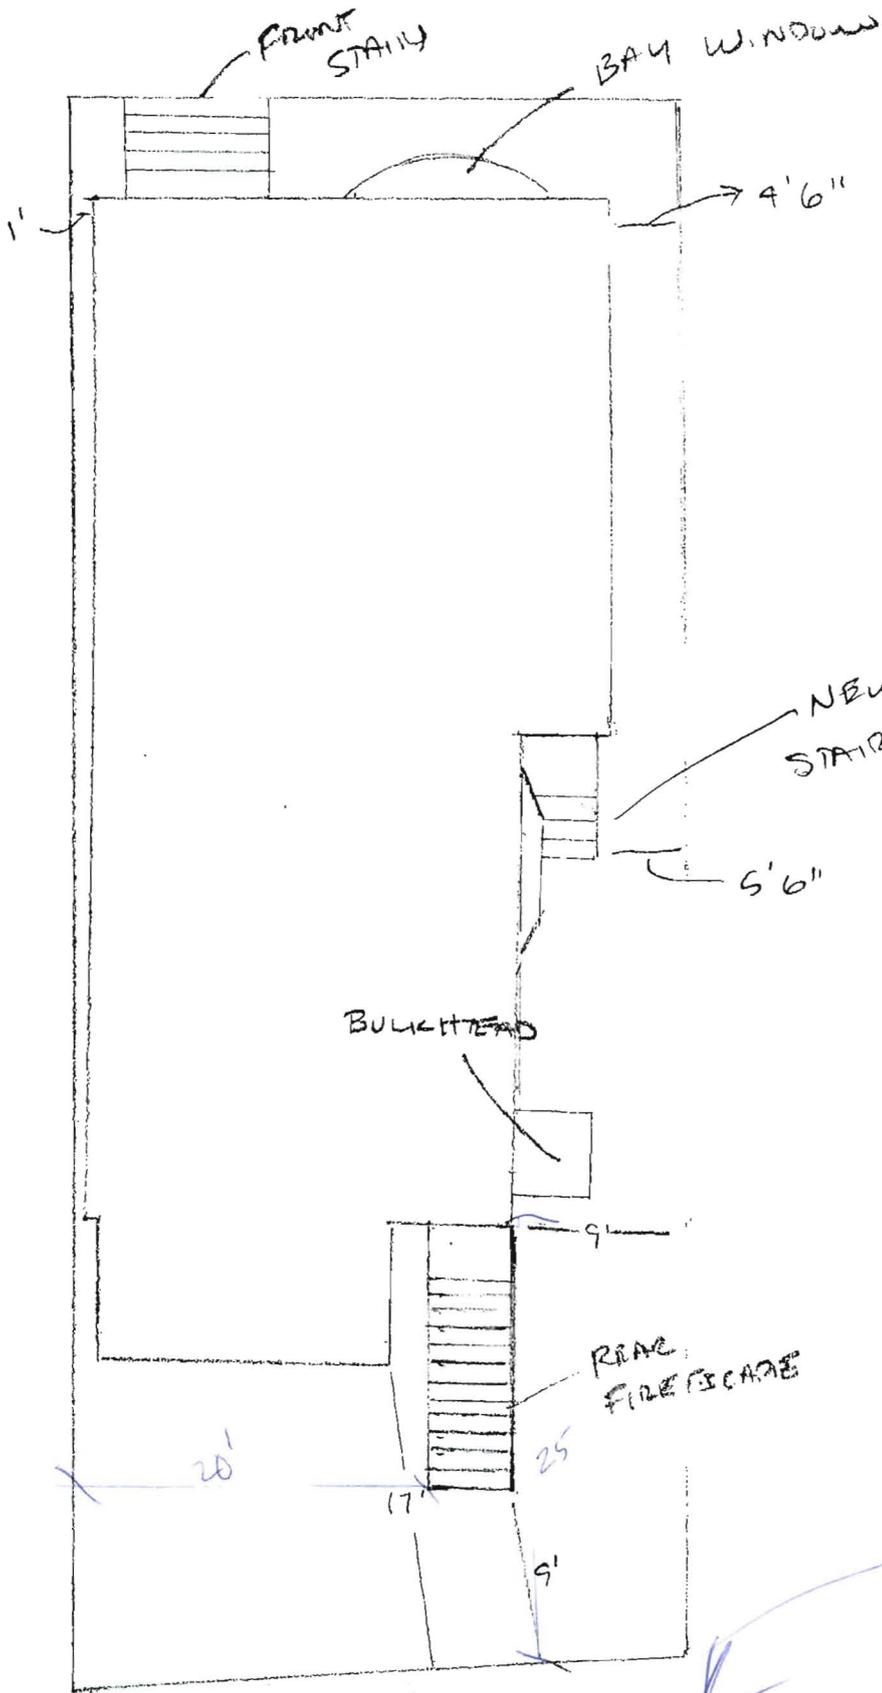
696 CONGRESS ST.
PLOT PLAN

B2b egress doesn't need to be enclosed

NEW PLATFORM PER HISTORIC & PFD

5' side yd Reg ok
5'6" shown

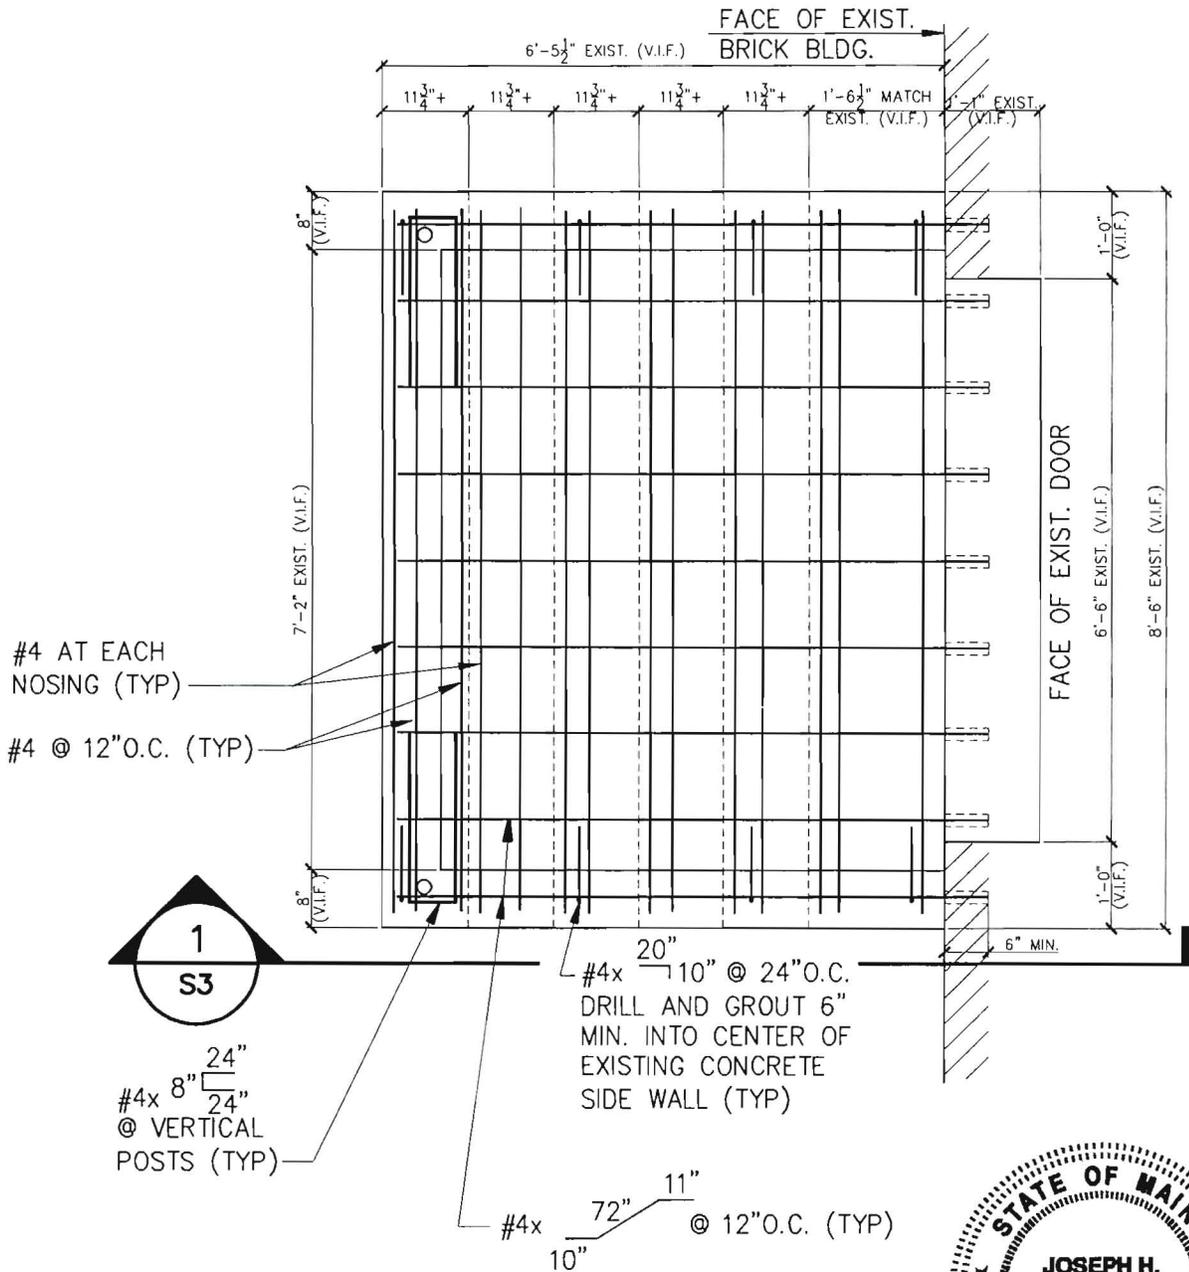
FRONT ENTRY STAIR-CONCRETE PLAN

2. The existing concrete stair and steel railings at the front of the building has been compromised. Some of the concrete treads and portions of the concrete side walls have been cracked, completely broken or shifted laterally or rotated from the original position. In addition, the steel side rails have been bent and dislodged from the concrete embedment that structurally supported the railings. The original concrete stair and steel railings do not meet the current building code requirements for an egress stair entry. The entire stair system shall be either replaced or the effected concrete treads, concrete side walls and steel railings shall be repaired or replaced. In either case, the reconstruction of the stair to meet the current building code requirements would violate the standards of the Maine Historic Society and force the stair system to be located over the property line into the existing sidewalk. This is obviously unacceptable. Hence, a variance from the City of Portland shall be pursued to repair and/or replace the stair system to match the original condition. In addition, the repair and/or replacement of the "historic" steel handrails on both sides of the stair, which do not currently meet the building code requirements, may potentially be modified to enhance the safety by installing a bottom rail and balusters which will violate the standards of the Maine Historic Society. This shall be pursued with the City of Portland Building Department and the Maine Historic Society. The replacement of the entire stair system shall be implemented utilizing a reinforced concrete stair and side wall construction that matches the original stair to be designed upon your request. Otherwise, the compromised concrete treads shall be replaced with concrete treads reinforced with 3-#5 reinforcing bars longitudinally (one located near the stair nosing and two located at the center of the depth) and doweled into the repaired concrete side walls at both ends with 2-#4 hooked L-shaped bars drilled and grouted vertically 6" minimum into the repaired concrete side walls and embedded 15" minimum into the center of the new concrete stair tread. In addition, 2-#4 U-shaped reinforcing bars shall be installed at the end of the treads where the repaired steel vertical posts of the railings shall be embedded. The U-shaped bars shall be installed at the top and bottom of the treads at the ends wrapped around the vertical steel post (with 2" minimum concrete cover around the vertical steel post and around the reinforcing bar on all sides) and extend 15" minimum into the tread longitudinally. The steel side rails shall be repaired and /or replaced to match the original rails, potentially modified as previously discussed, and anchored as previously anchored.

The front steps will be rebuilt according to engineering plans, and the railings, stored in the basement, will be re-installed.

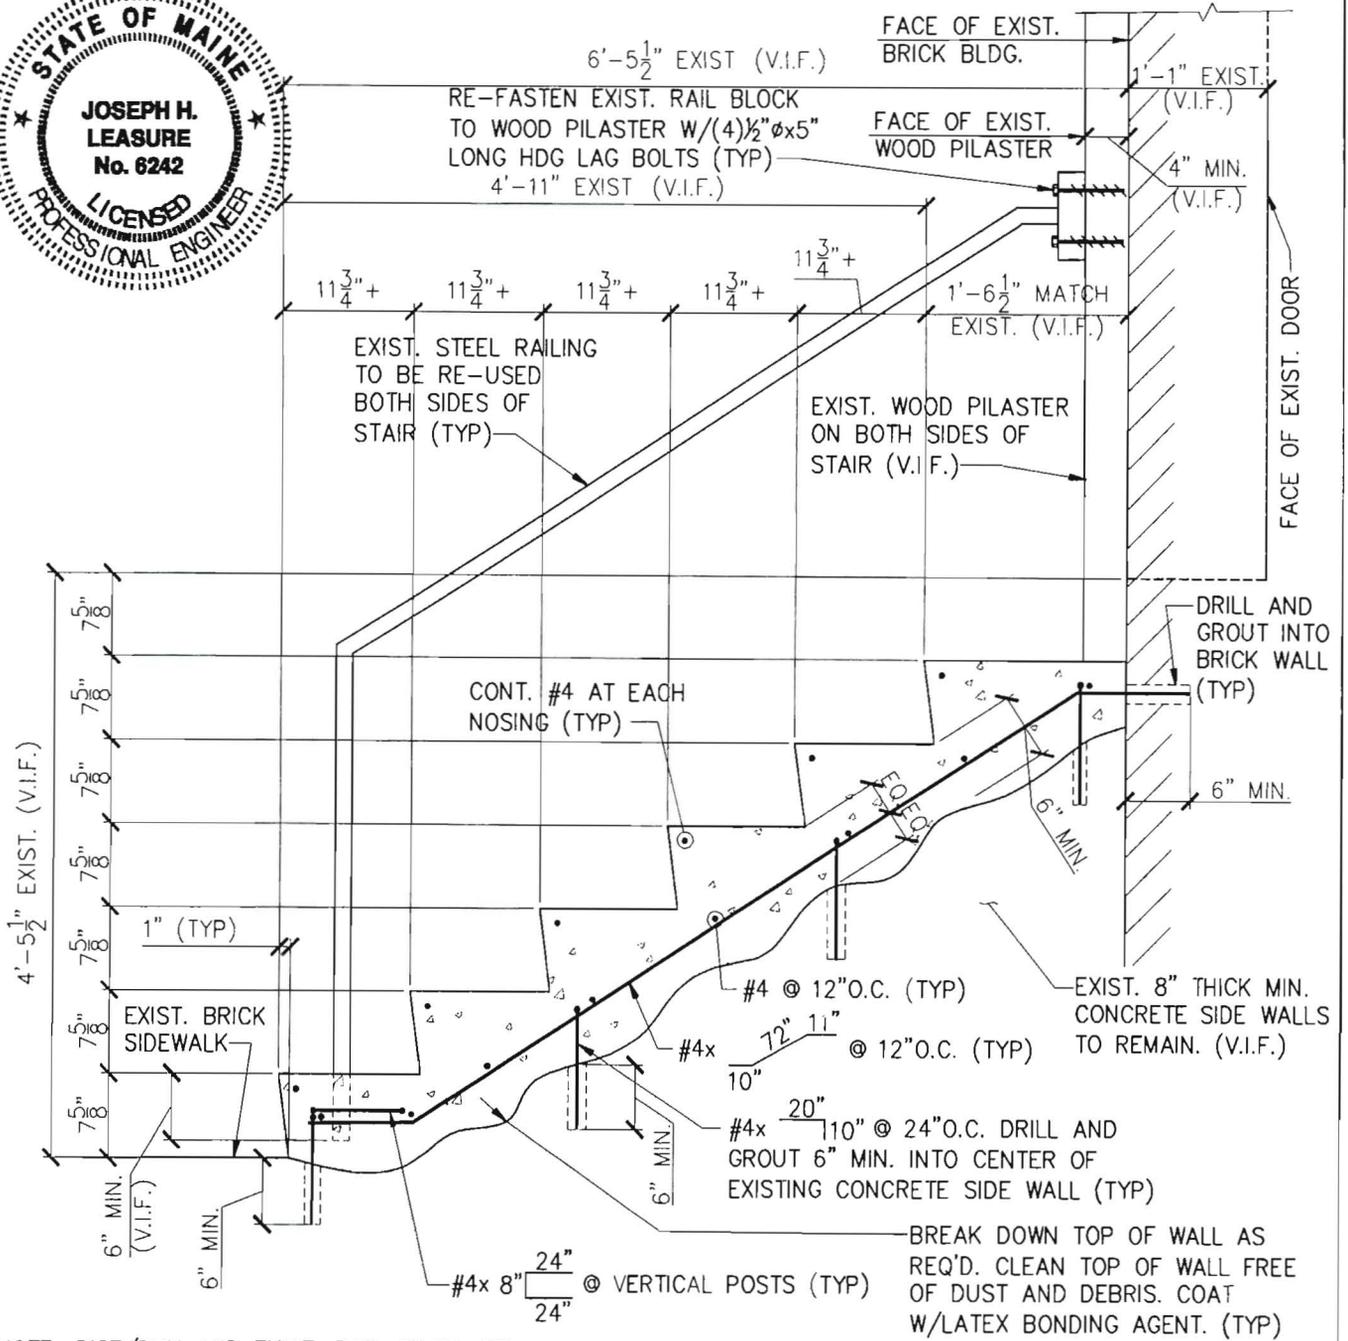
FRONT ENTRY STAIR-SECTION
 $\frac{3}{4}'' = 1'-0''$

NOTE: RISE/RUN AND EXIST. RAIL SHALL BE RE-CONSTRUCTED OR RE-USED TO MATCH EXIST. CONDITIONS DUE TO HISTORIC BUILDING REQUIREMENTS. BUILDING CODE REQUIREMENT HAVE BEEN WAIVED ON RISE/RUN AND RAIL REQUIREMENTS BY THE CITY OF PORTLAND TO ALLOW CONFORMANCE WITH THE HISTORIC REQUIREMENTS.

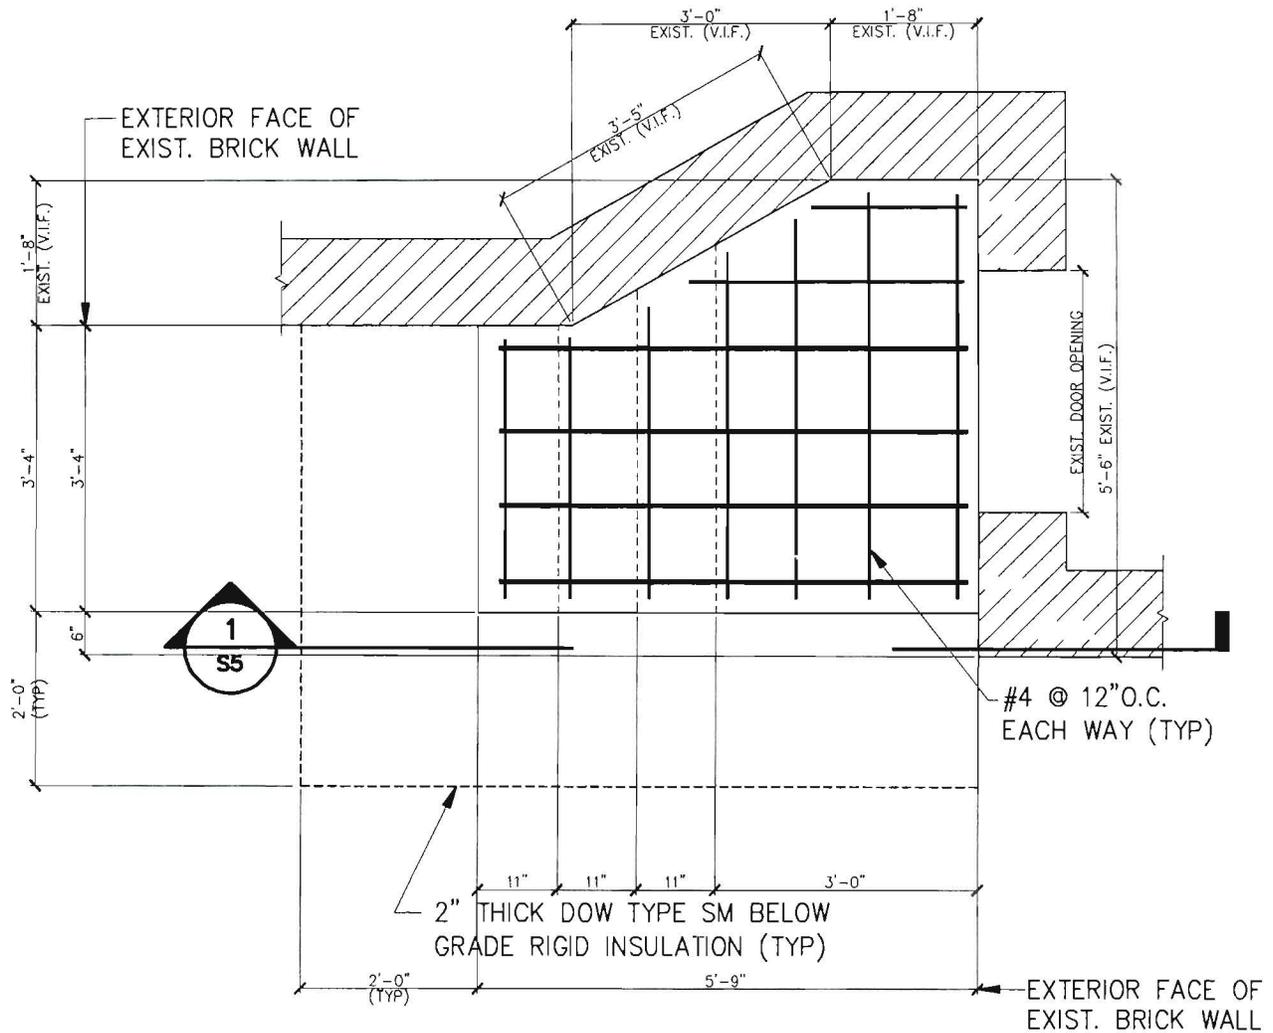
REAR ENTRY STAIR-CONCRETE PLAN

NOTE: GUARD RAILS AND HANDRAILS TO BE DESIGNED AND CONSTRUCTED IN ACCORDANCE WITH CODE BY OTHERS (TYP)

*3/3/11 OK w/ Deb A.
outboard (one side)
36" Pipe rail for handrail
Am B*
