# General Building Permit Application

Re: 696 Congress Construction /Repairs due to Accident.

Subject: Building located at 696 Congress Street, Portland, Maine  
Damage to Building Resulting from Automobile Accident

designed by: JHL	696 CONGRESS STREET PORTLAND, MAINE  FRONT ENTRY STAIR REPAIR AND NEW REAR ENTRY STAIR  GENERAL NOTES	L & L STRUCTURAL ENGINEERING SERVICES, INC. SIX Q STREET SOUTH PORTLAND, MAINE 04106  PHONE: (207) 767-4830 FAX: (207) 799-5432	S1
drawn by: AKB			
checked by: JHL			
scale: NONE			
date: 10-28-10

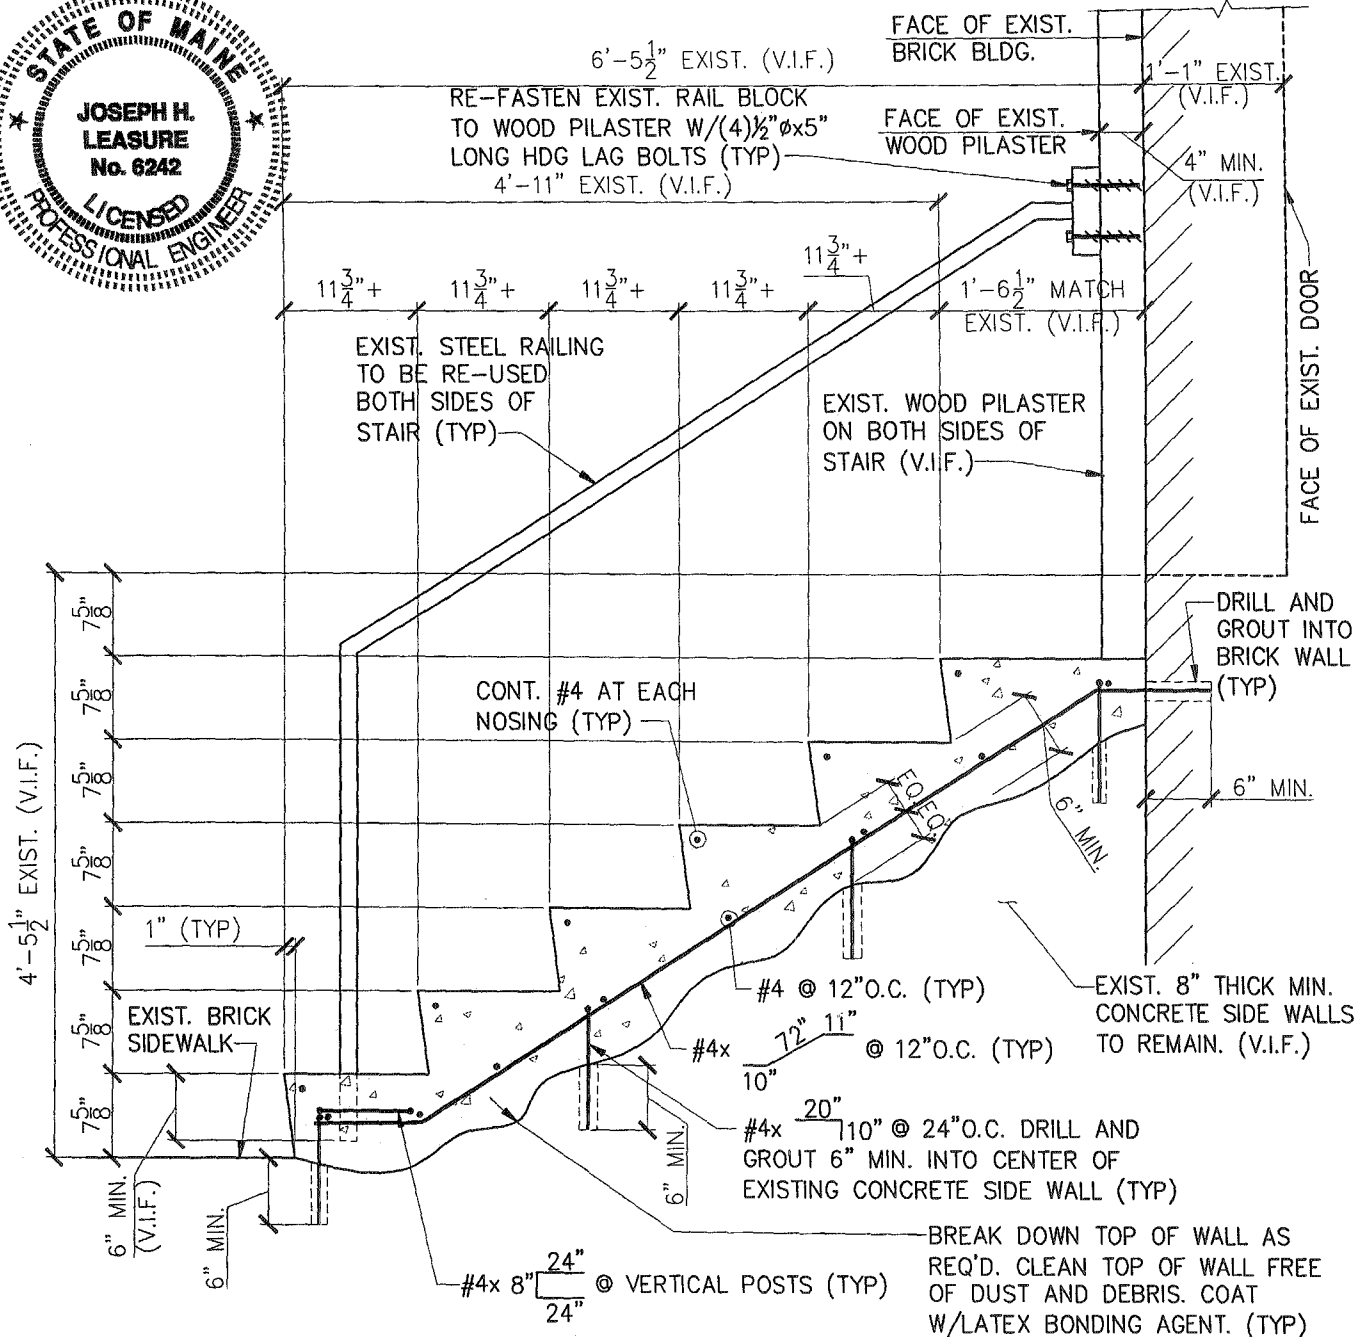
**FRONT ENTRY STAIR-SECTION**  
3/4" = 1'-0"

NOTE: RISE/RUN AND EXIST. RAIL SHALL BE RE-CONSTRUCTED OR RE-USED TO MATCH EXIST. CONDITIONS DUE TO HISTORIC BUILDING REQUIREMENTS. BUILDING CODE REQUIREMENT HAVE BEEN WAIVED ON RISE/RUN AND RAIL REQUIREMENTS BY THE CITY OF PORTLAND TO ALLOW CONFORMANCE WITH THE HISTORIC REQUIREMENTS.
