7 Cushman Street Elevation Views #1 Foundation Repair Project

7 Cushman Street Plan view Foundation Repair Project

7 Cushman Street
Foundation Wall Repair

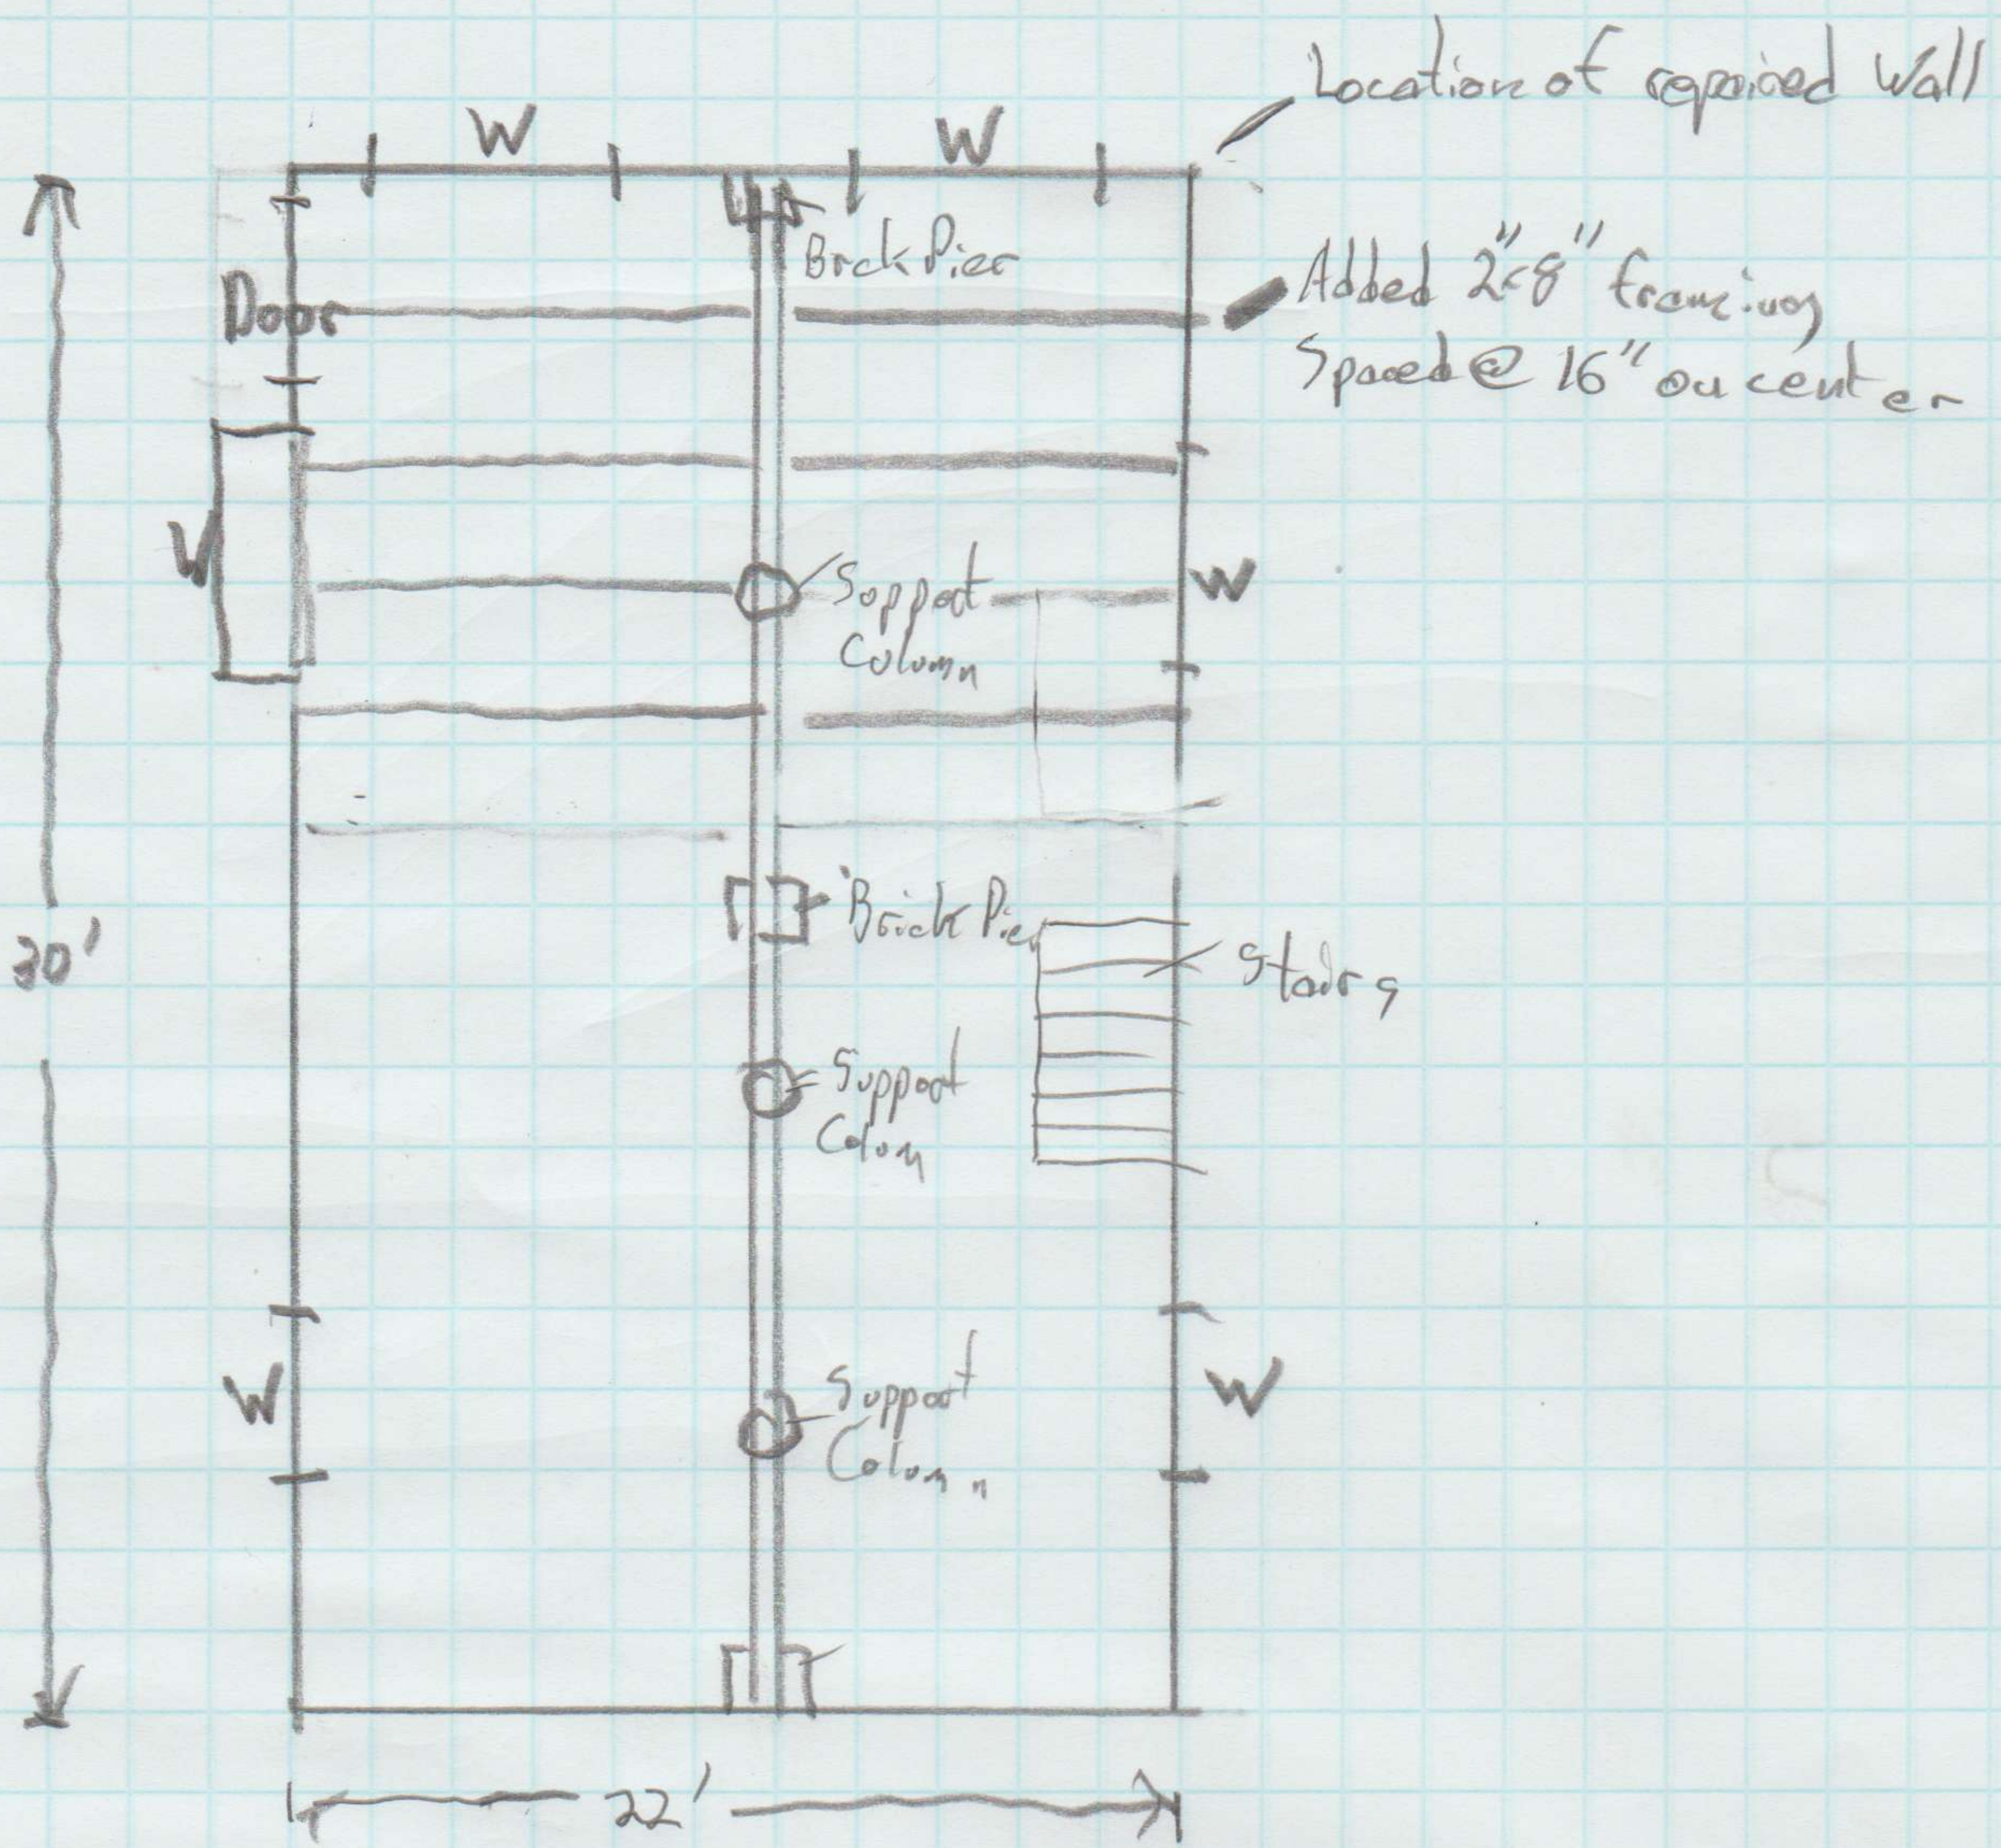
work consisted of Rear
foundation wall Repair + Installation
of

- ① 8 2x8 joists added w/ hanger
- ② Addition of 3 support columns
- ③ Installation of 6 new windows
