168 Clark street
Original layout of
second floor

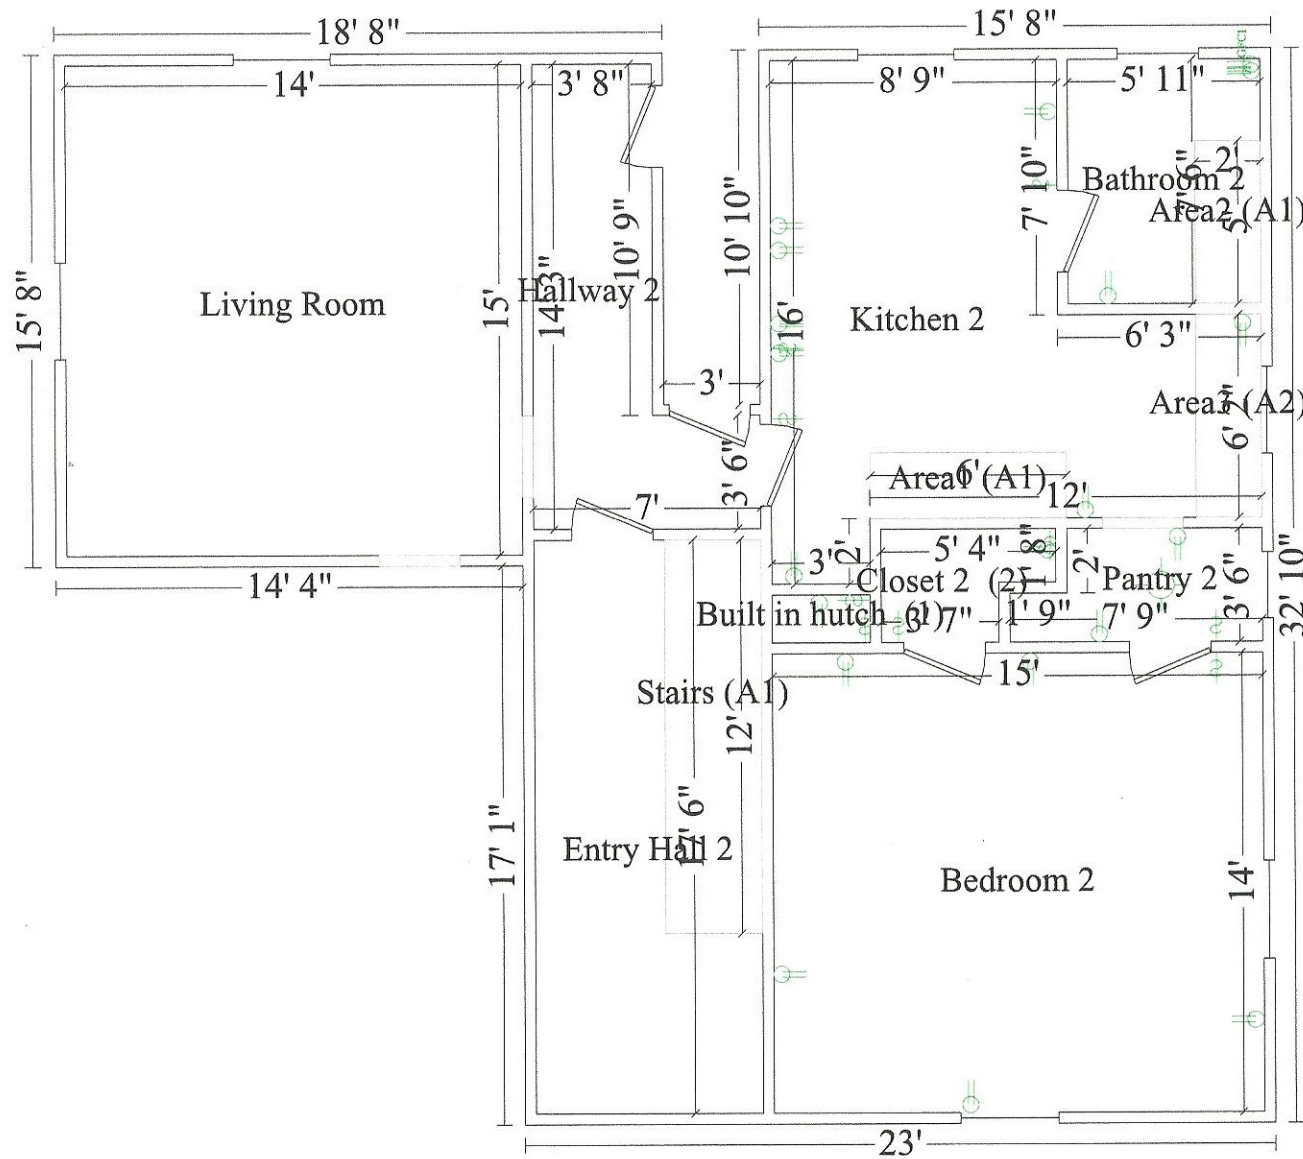
N
↑
2nd Level

before water
damage.
Demolition was
done by Servpro
on exterior walls
approximately 3
feet from floor.
Plaster and lads.
Kitchen, bathroom
and bedroom. All
flooring in this
diagram was
removed to
subfloor. Removed
interior bathroom
walls and walls
around the pantry.
These walls are
not load bearing
walls.
