Final Report of Special Inspections

Project: *Addition and Renovations*
Location: *214 Danforth Street, Portland, ME*
Owner: *Shalom House, Inc.*
Owner's Address: *106 Gilman Street*
Portland, ME 04102

JOB NAME: 214 Danforth Street
JOB NO.: 14005
DATE OF VISIT: Sep 09, 2014
TIME: 1:00 P.M.
WEATHER: 70°, clear
CLIENT: Shalom House
OBSERVERS: David Tetreault, SDC

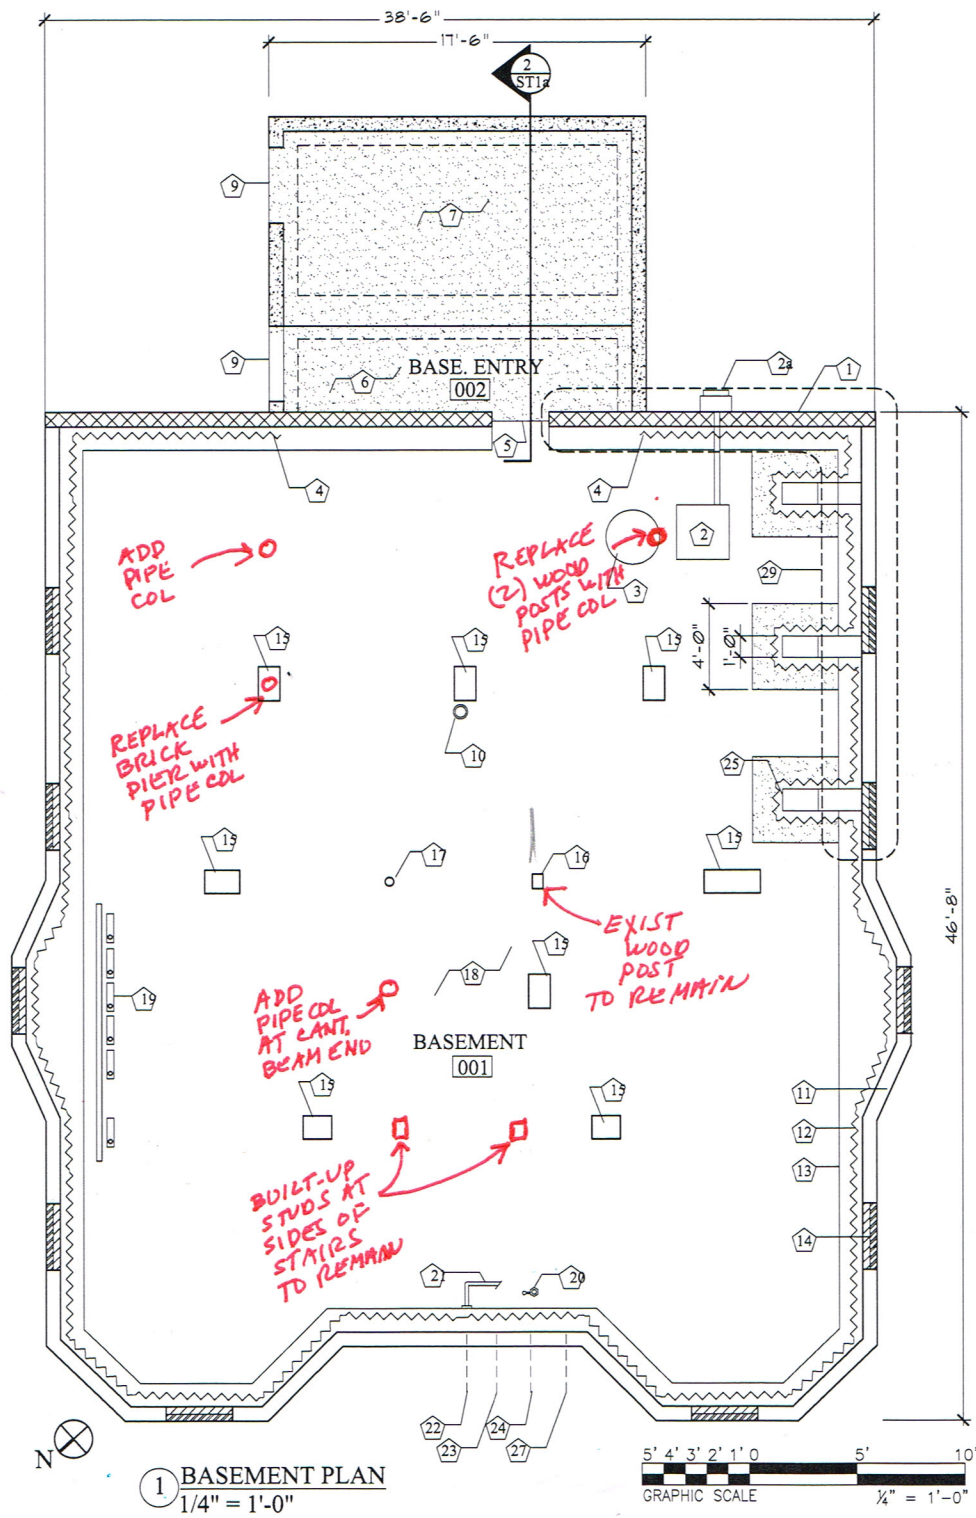
1 BASEMENT PLAN
1/4" = 1'-0"

Demolition of finishes has been substantially completed. Several areas that have been exposed in the basement require revisions from the Contract Documents. See the attached Basement Plan.
