PROJECT: Portland Yacht  
SUBJ: New Yard  
ITEM: Legacy Bldg

Bldg Fabrication  
Bolt Tension  
Seismic & Wind Categories

## CONSTRUCTION OBSERVATION REPORT

**Project:** Portland Yacht Services  
**Client:** New Yard, LLC  
**Client's Rep.:** Phineas Sprague, Jr.

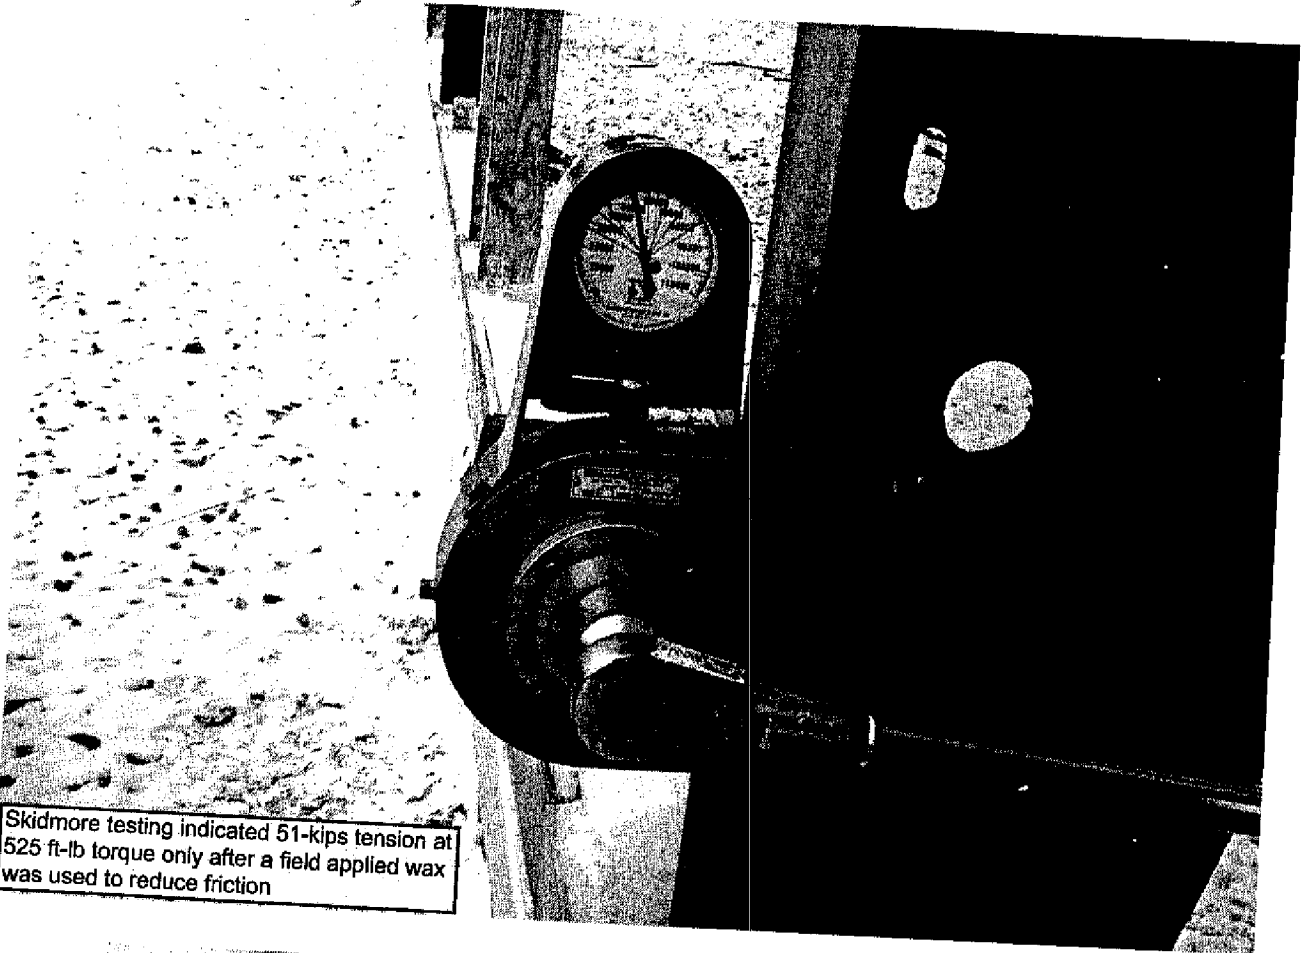
Skidmore testing indicated 51-kips tension at 525 ft-lb torque only after a field applied wax was used to reduce friction

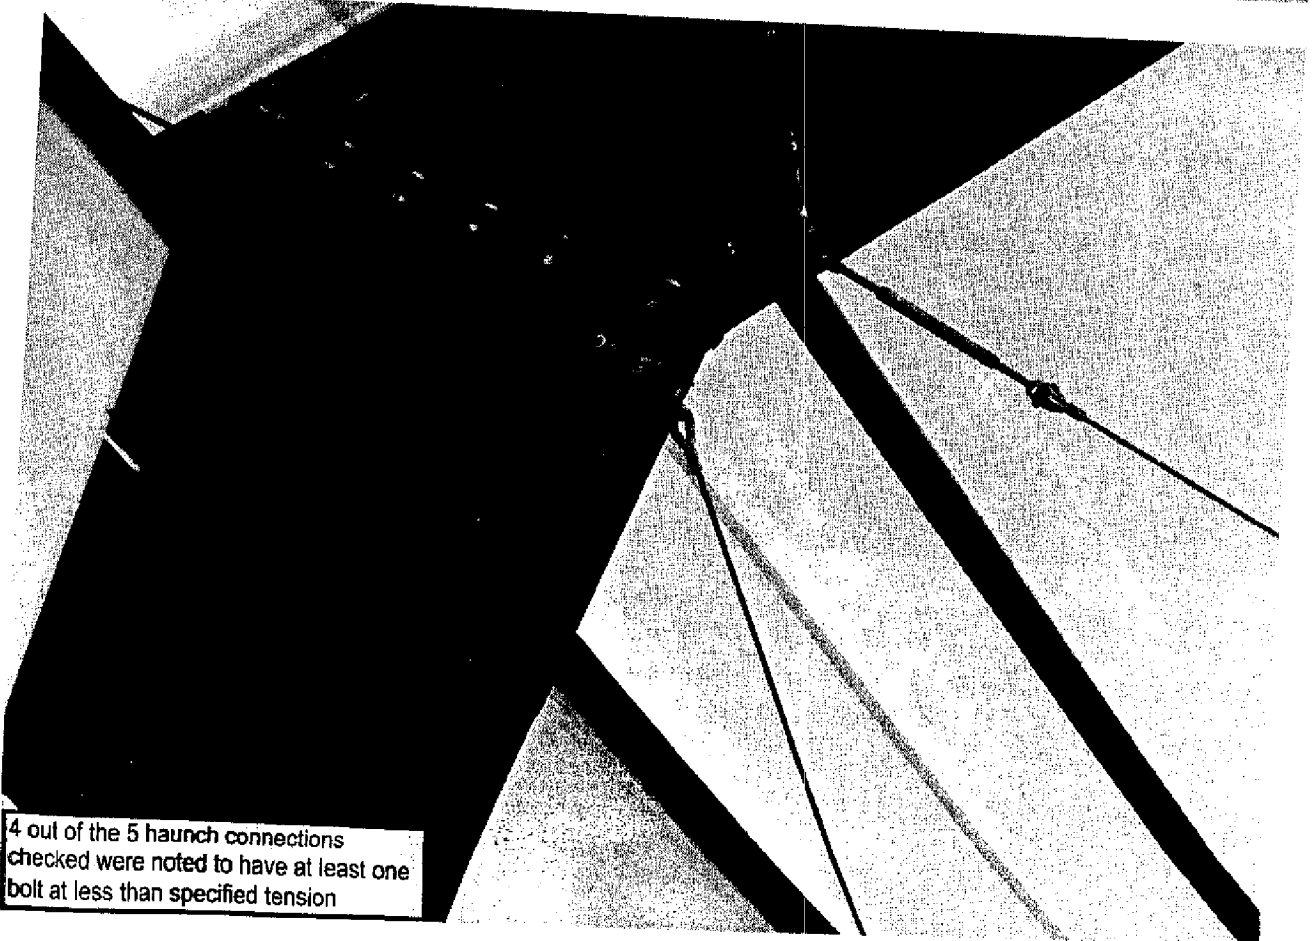
On 12-2-13, we returned to the site for in-situ testing on a percentage of the connections. Two of the intermediate splices in the rafter sections were checked and found to be between 525 and 550 ft-lbs. Two of the peak splices were also checked and found to be between 525 and 550 ft-lbs. At the peak connection, the uppermost bolt could not be accessed with a torque wrench; we understand that this bolt was hand tightened and we could not access to check tensioning. At the first haunch connection we checked, one of the bolts was loose (less than 350 ft-lbs) and after it was properly tensioned subsequent bolts in the same connection were found to have insufficient tension. Four out of five of the haunch connections we checked while on site were found to have at least one bolt that was insufficiently tensioned. We recommended that Legacy re-check all of the haunch connections.

4 out of the 5 haunch connections checked were noted to have at least one bolt at less than specified tension

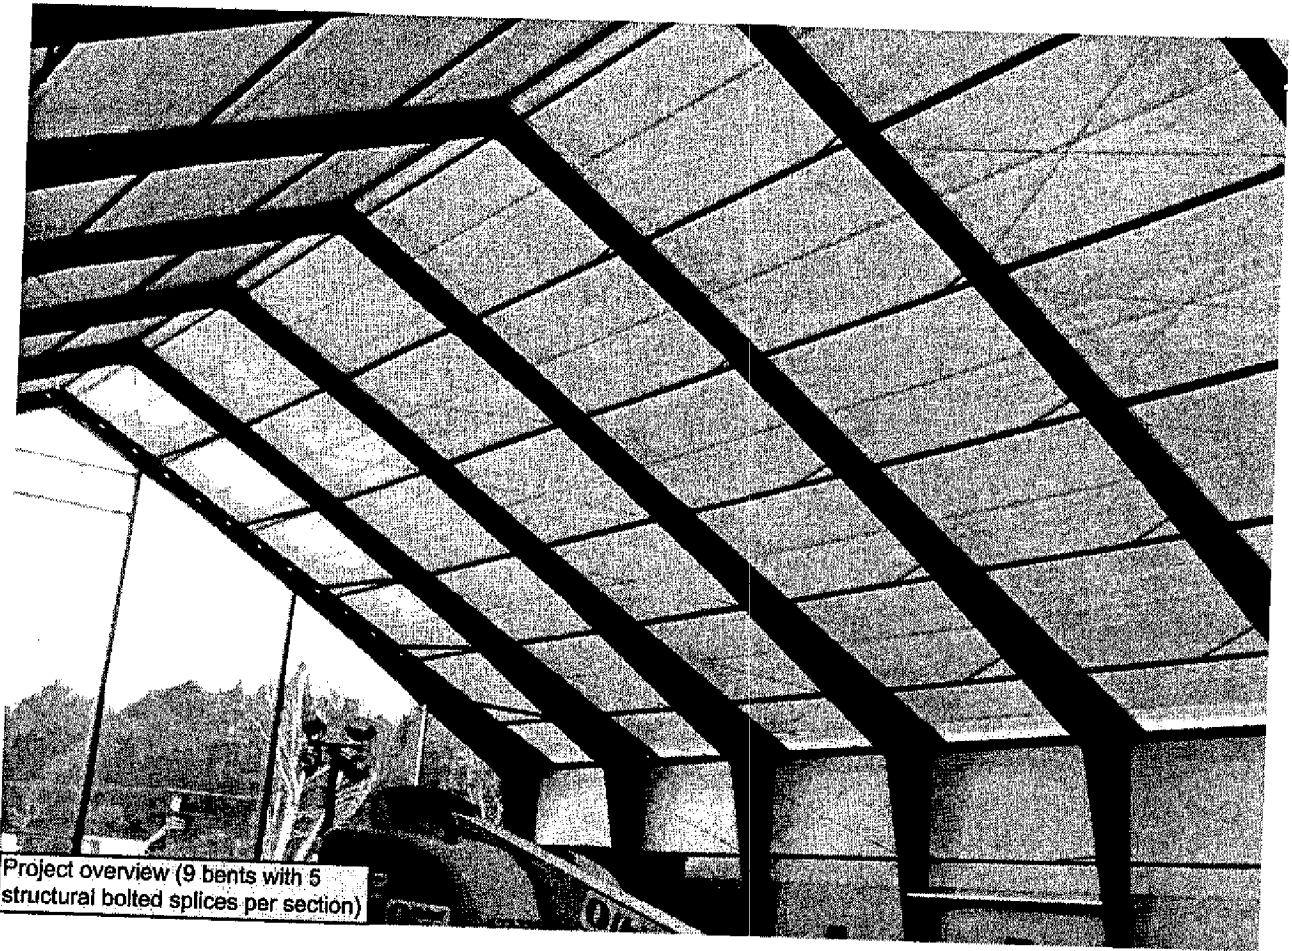
Project overview (9 bents with 5 structural bolted splices per section)

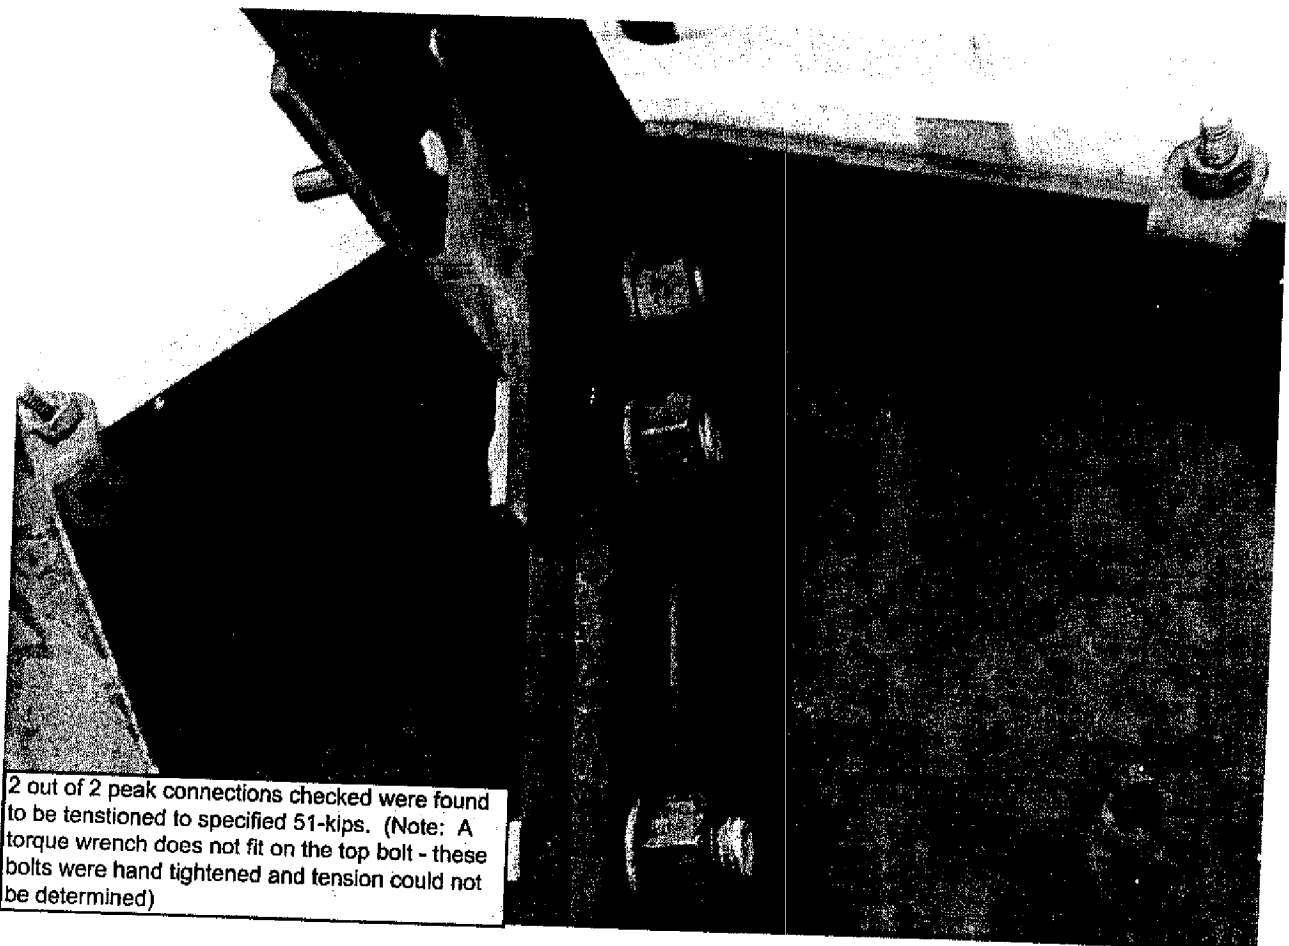
2 out of 2 peak connections checked were found to be tensioned to specified 51-kips. (Note: A torque wrench does not fit on the top bolt - these bolts were hand tightened and tension could not be determined)
