July 6, 2011

RE: 29 Bowdoin Street  
Portland, Maine

REVISED PART PLAN - SF-102

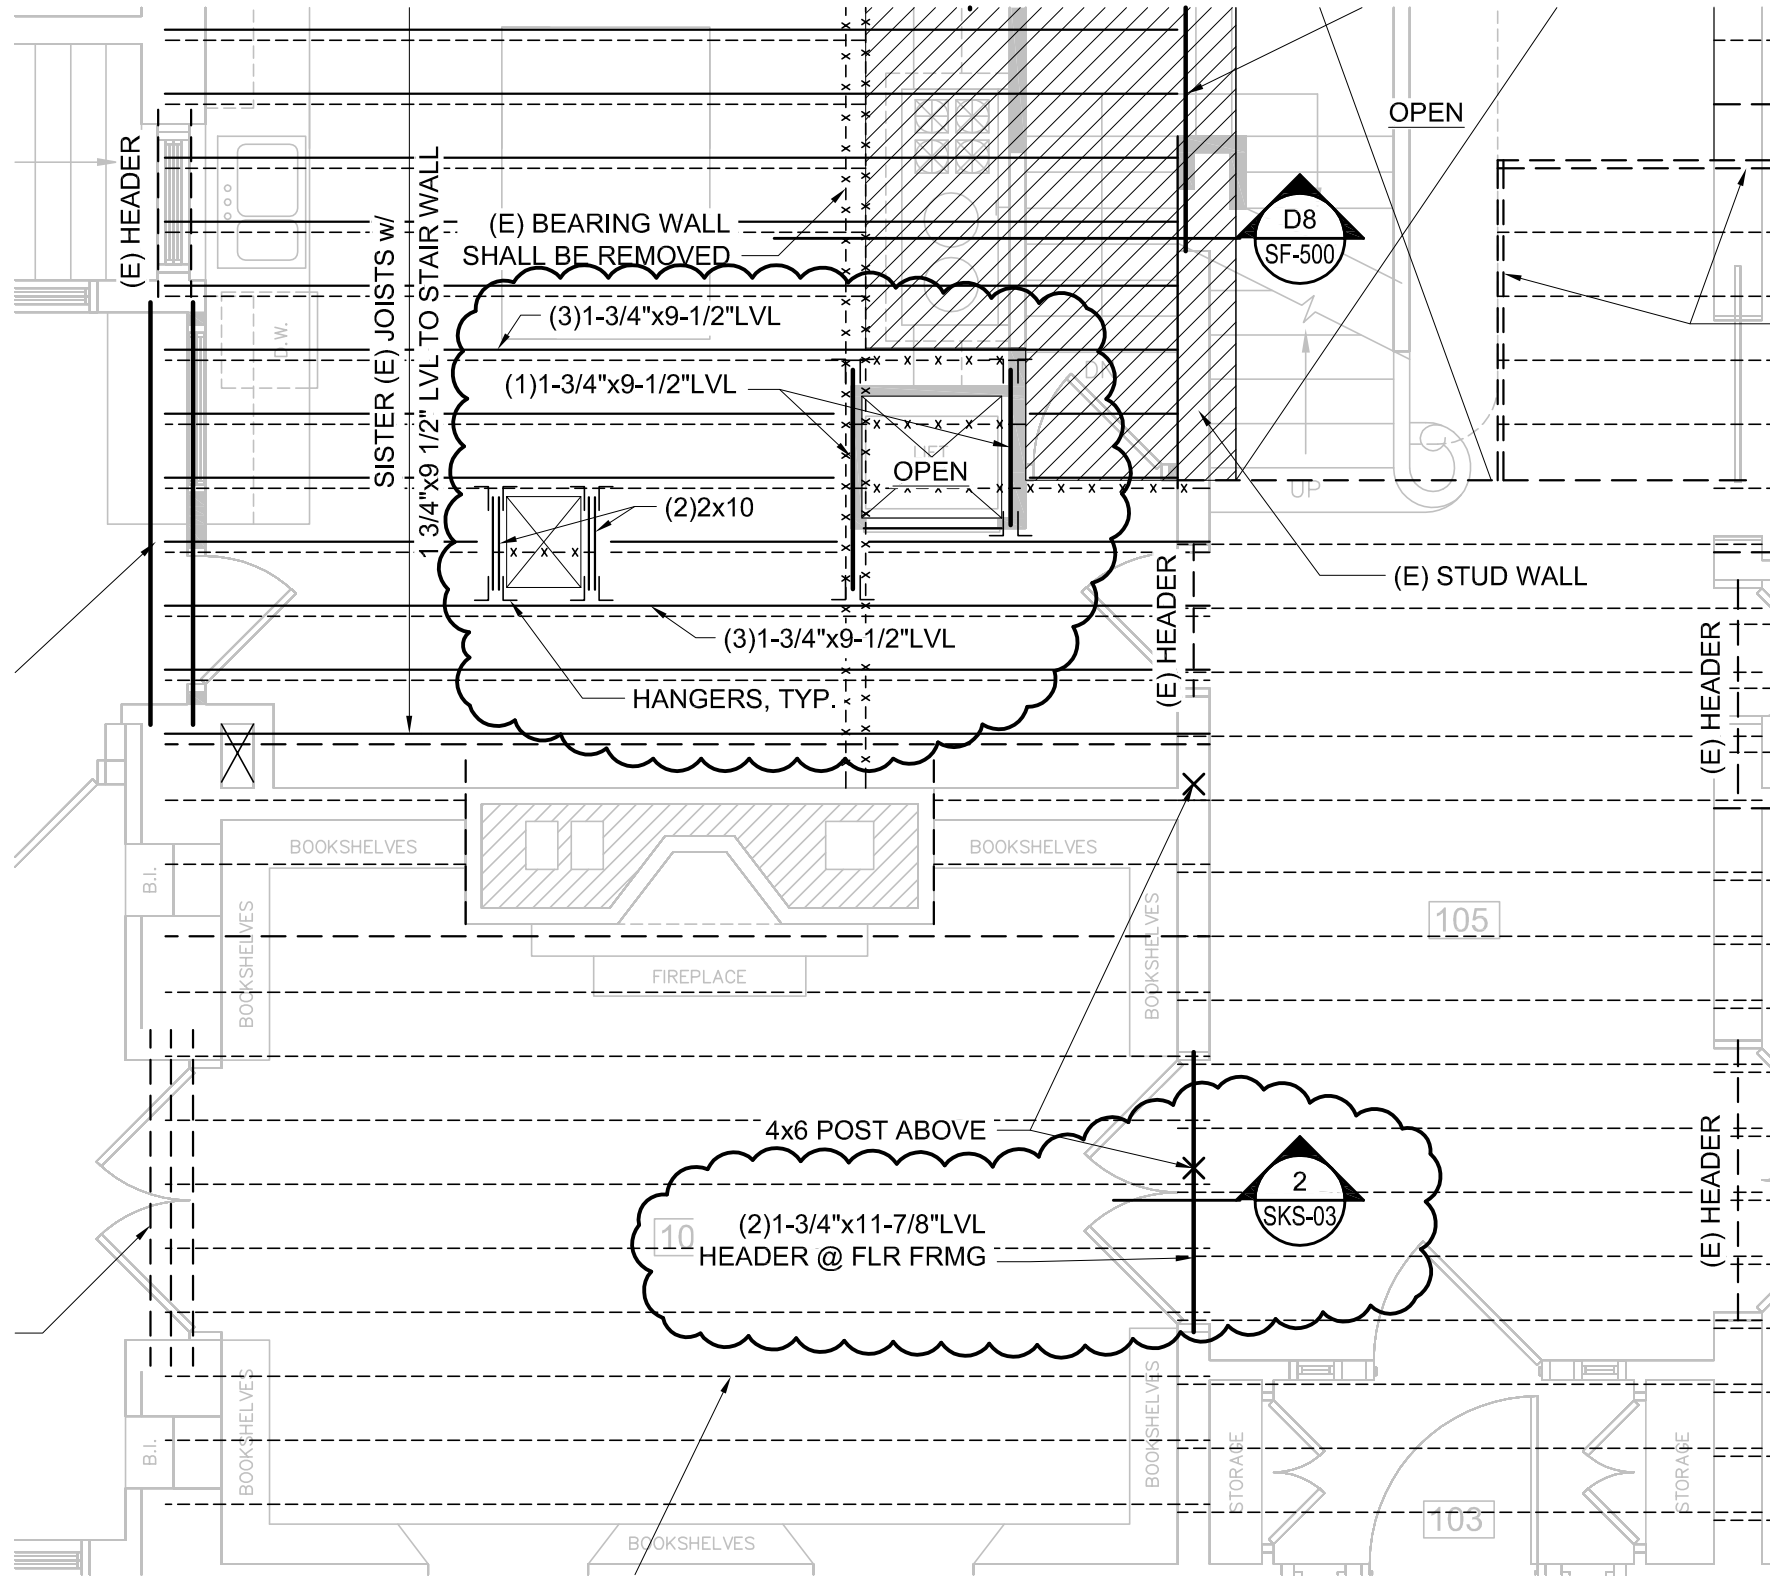
SKS-02

2. Second Floor Shaft Opening Header: The second floor framing above the kitchen has two openings with headers and was not completed as detailed (see attached sketch SKS-02). My solution is to turn the wood stud shaft wall into a supporting wall by adding one more 2 x 4 stud sistered to the existing stud at both the basement and first floor level. This will satisfy the small load on this wall.
