SOUTHERN MAINE FORESTRY SERVICES, INC.

Addendum to Forest Management Plan

Old Growth Stand

Diamond Cove Home Owners Association

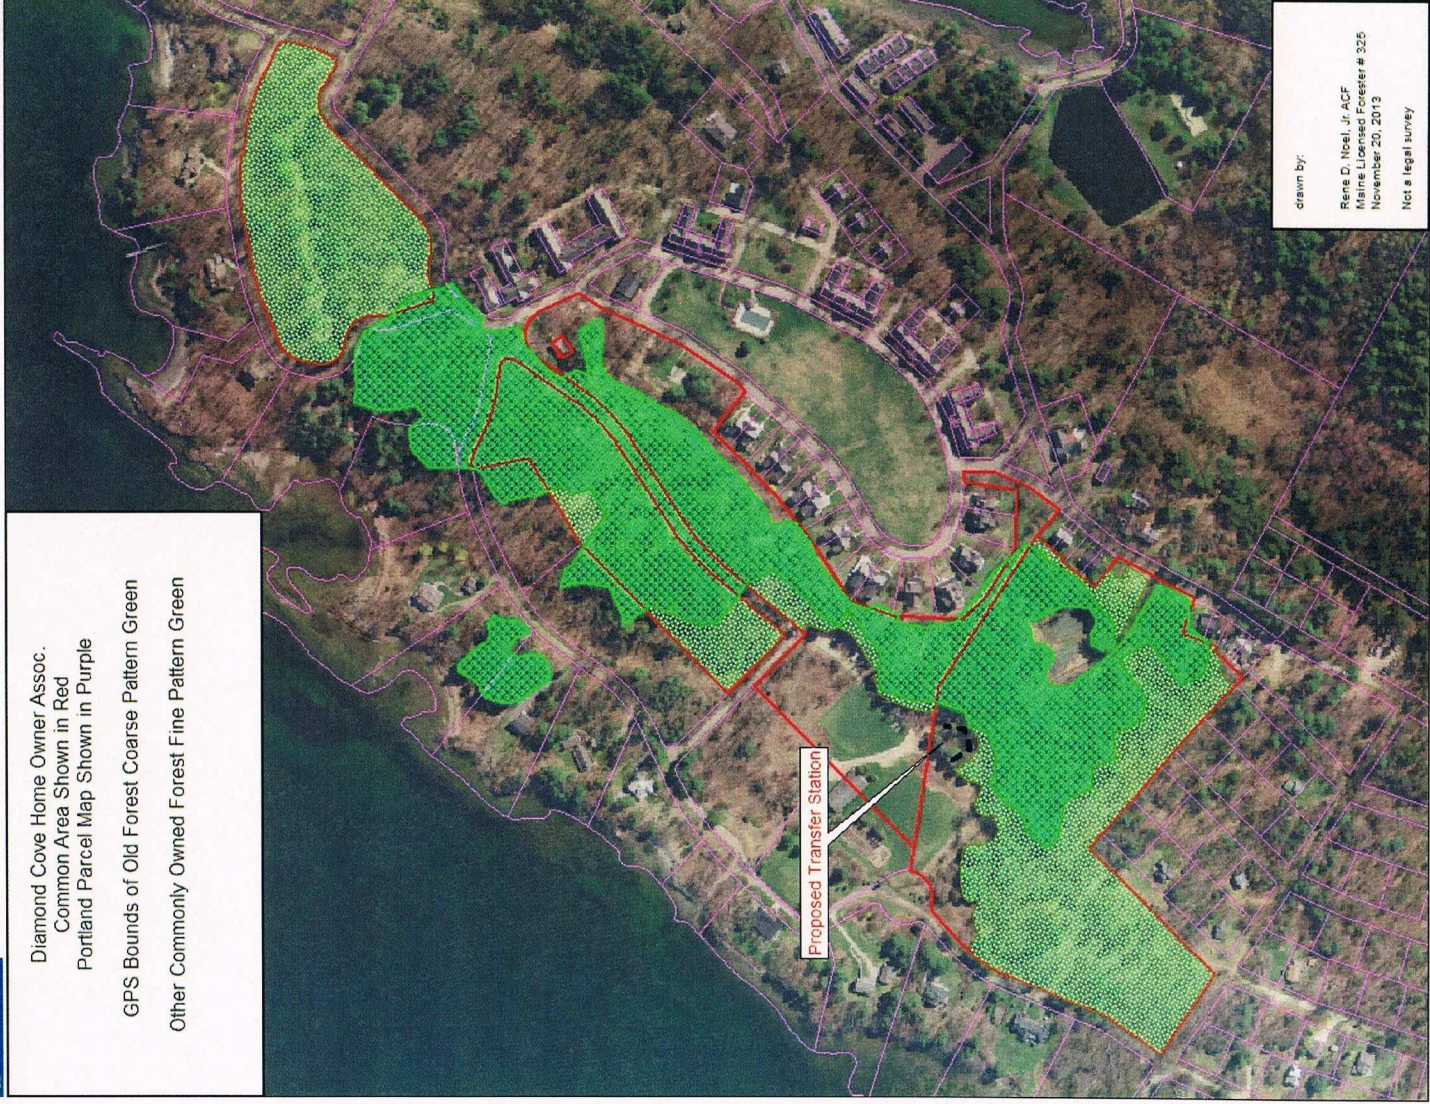
Proposed Transfer Station

Most of the proposed site is in an area which appears to have not been forested 24-27 years ago when the original work for the forest management plan was undertaken. However, one corner will encroach on the old growth stand and will require the removal of one large hemlock tree. This tree is not in good condition because of adelgid feeding. As I envision the propose construction work less than 500 square feet within the old growth stand will need to be disturbed. The effect on the stand will not be noticeable. I suggest as a mitigation that buffer area to the west be expanded by a similar area. There are some large hardwood stems in this area that are 40 or 50 years younger than the oldest trees. With the anticipated loss of the hemlock due to adelgid damage these will be a natural expansion of a stand with old growth characteristics.

- 1 infested hemlock should be removed (page 16)
 - Add 500 square feet of area to the west of Compartment B to offset any disturbance and harmonize existing Old Growth area with large hardwoods within this new area (page 16)

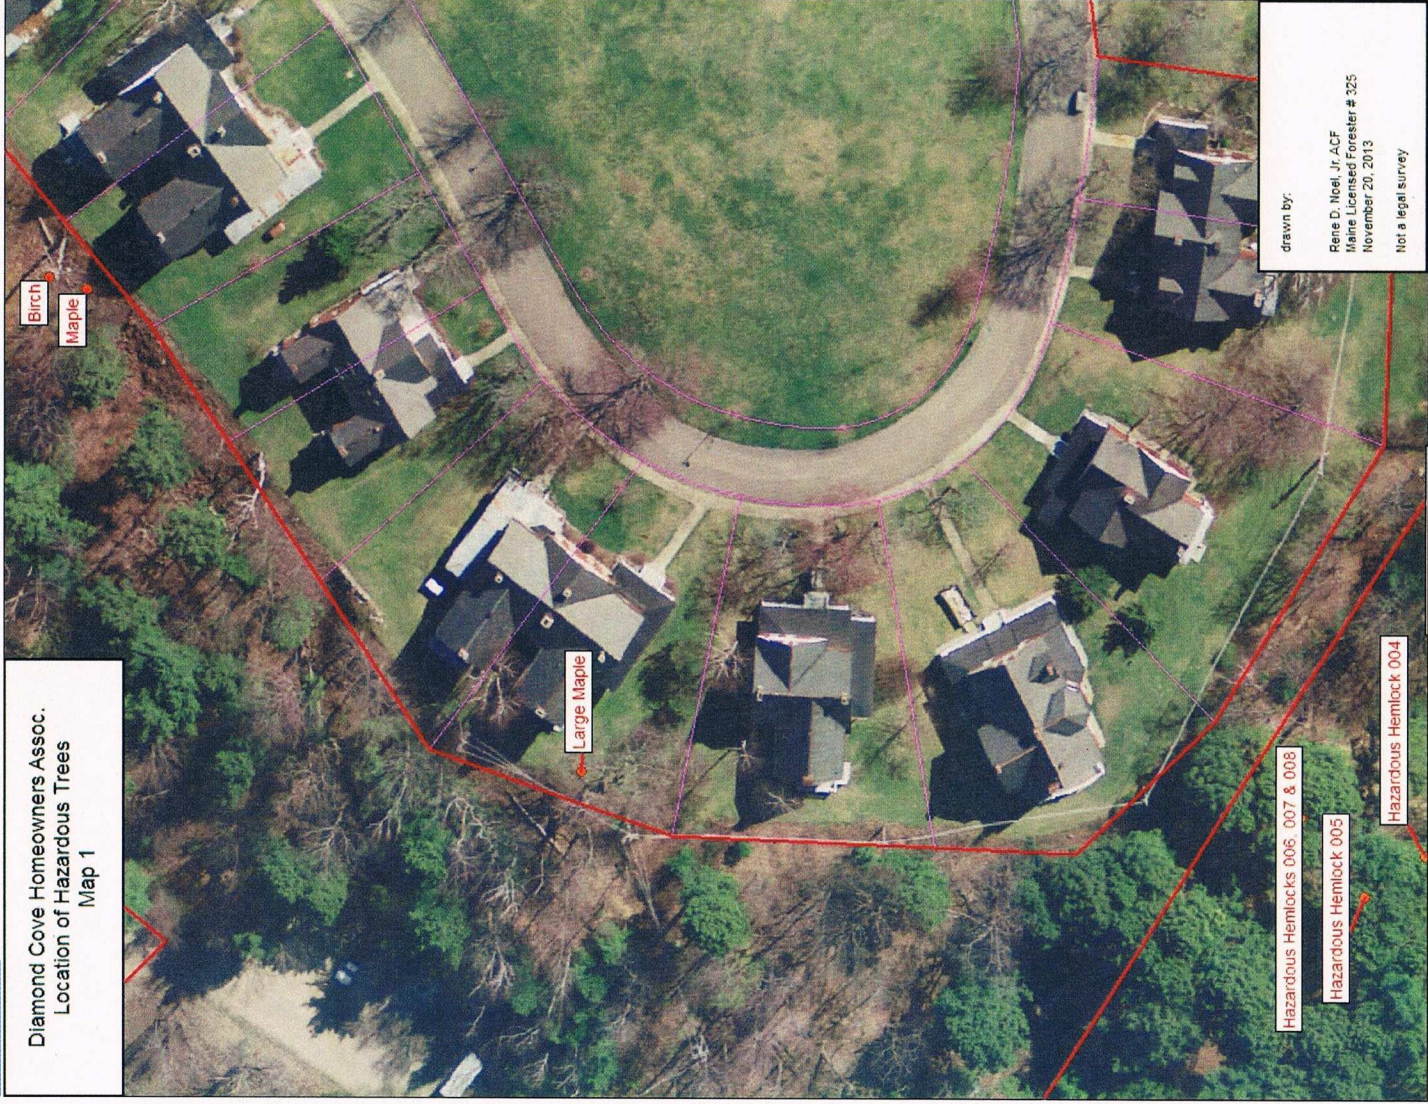
Diamond Cove Homeowners Assoc.
Location of Hazardous Trees
Map 1

Fourteen stems, 3 hardwoods and 13 hemlock were judge as currently being hazardous and located where they could damage people or property should they fail. They are marked with orange flagging. I did not get an estimate from arborists on the cost of dropping and treating these stems.

The three hardwoods are the most difficult to remove. A white birch, a red maple and a large sugar maple located at the eastern edge of Compartment C are all fairly close to residential buildings and are not easy to remove. The large sugar maple is located between two buildings and contains a considerable amount of rot. It will be somewhat of a challenge to remove. The weight of the large limbs indicate they are likely to fall towards the building to the trees north.

I did not get estimates from arborists on the cost of removing these stems but I would estimate a mainland cost in the \$5,000 to \$10,000 range. My experience with transporting men and equipment is it adds significantly to the cost.

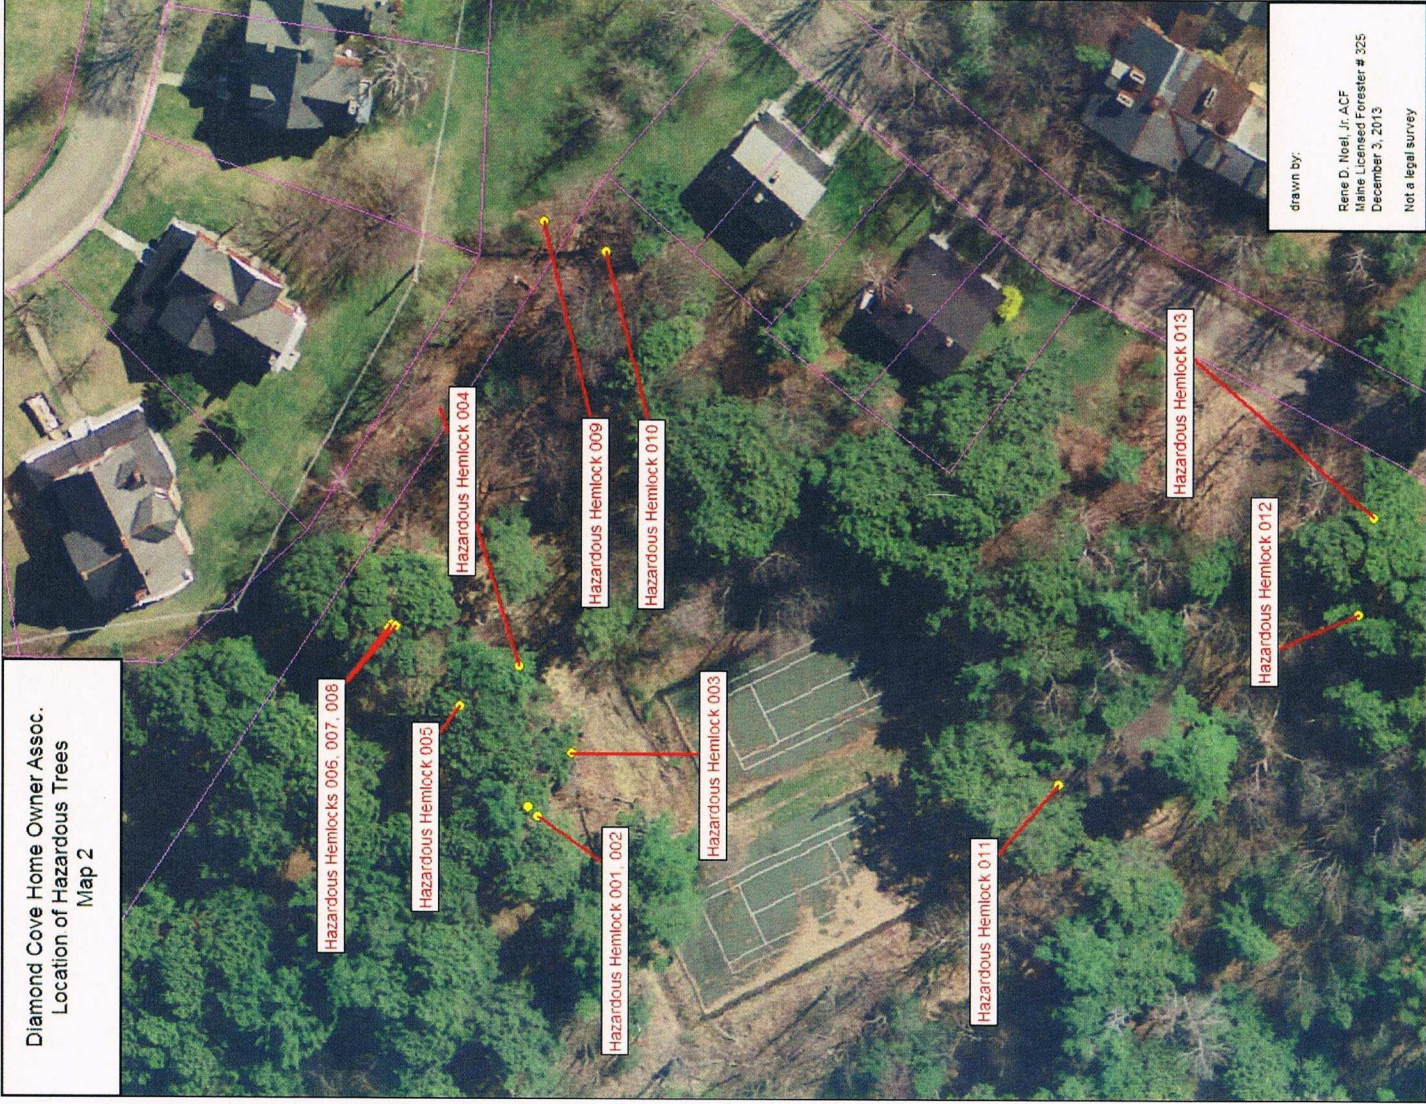
Diamond Cove Home Owner Assoc.
Location of Hazardous Trees
Map 2

The hemlocks are located that they can likely be felled away from improvements.

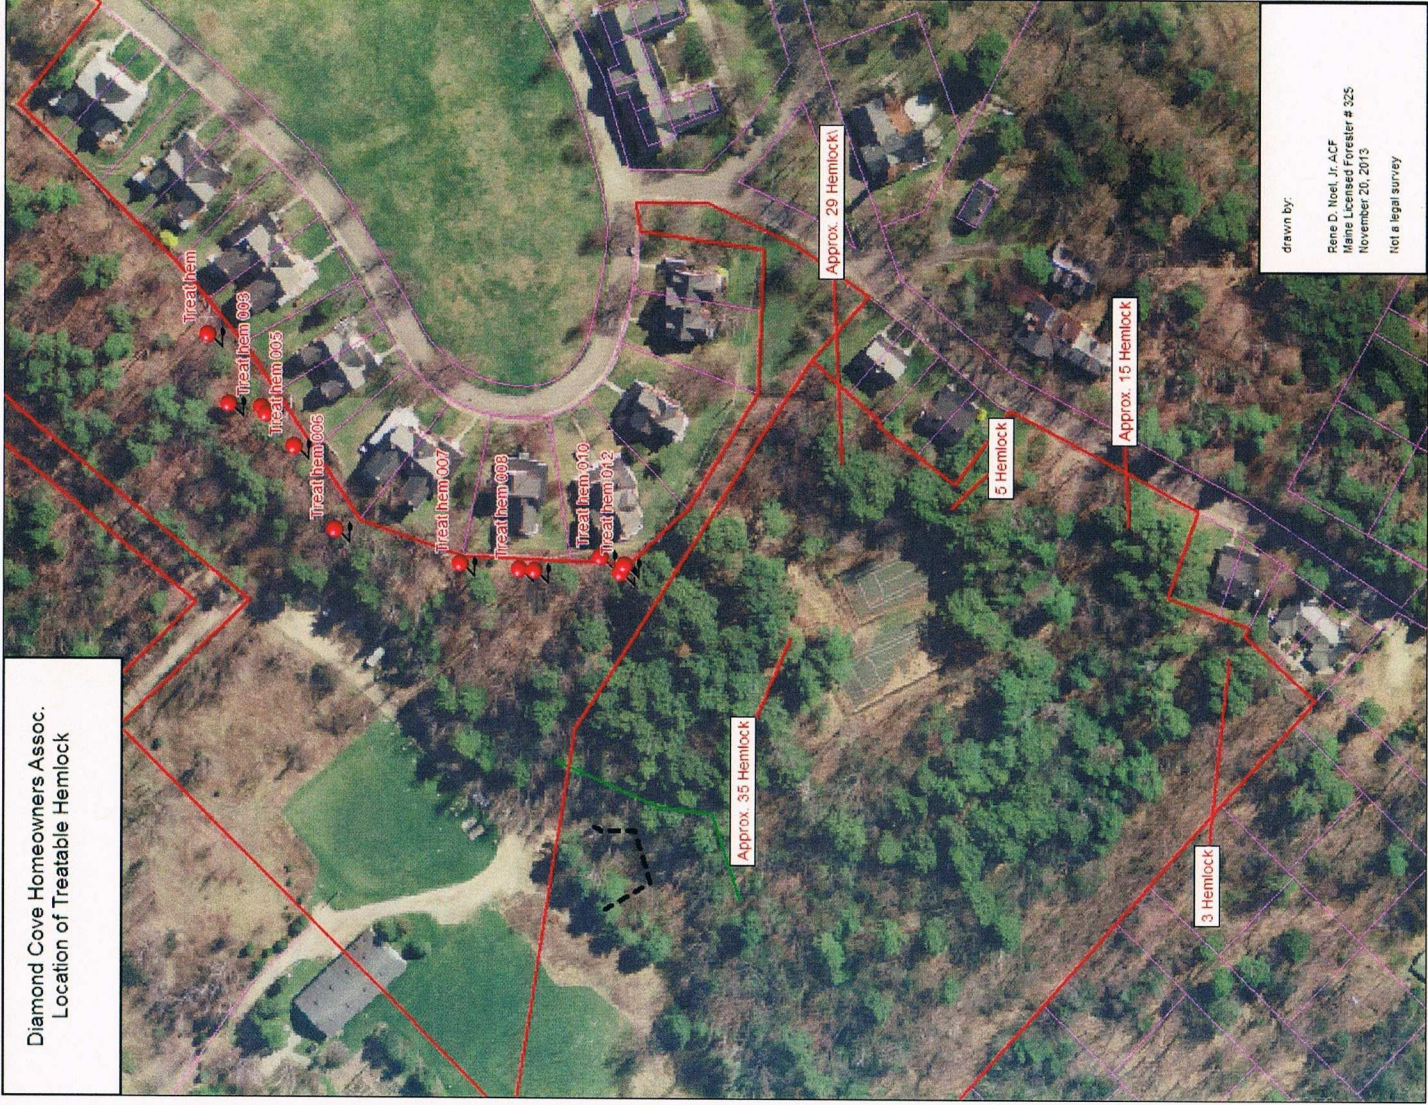
Diamond Cove Homeowners Assoc.
Location of Treatable Hemlock

The forest between McKinley Court and West Side Drive and west of Diamond Avenue and around the tennis court have 99 hemlocks that contribute greatly to the forest of that residential area. Systemic insecticides containing the active ingredient imidacloprid are effective in controlling the insect for a number of years following application. Some research has shown treatments every three or four years may be effective. Other products are in development/label phases and current product recommendations should be checked when treatments are planned.

This sort of treatment is fairly low tech. Backpack sprayers are used to either apply the chemicals to the ground or stem or granules are spread on the ground. It is necessary for the tree to absorb the chemical and translocate it to the needles. I estimate it would take a two man crew a full day to do the treatment. Depending on the cost of chemical at the time I estimate the cost of treatment to be in the \$2,000 range.
