**Aquion Energy**

**Abuse Testing**

**TEST REPORT**

**MGA REPORT NO.:** C14T1-010  
**TESTS PERFORMED ON:** December 5, 2013 - March 3, 2014  
**TEST DESCRIPTION:** Abuse Testing  
**ITEM DESCRIPTION\*:** Salt Water Batteries  
**PROCEDURE NUMBER:** TP002-02, TP007-08, TP016-10, TP018-11, TP020-09,  
TP027-05, TP030-02, TP031-03, TP032-06, TP033-04

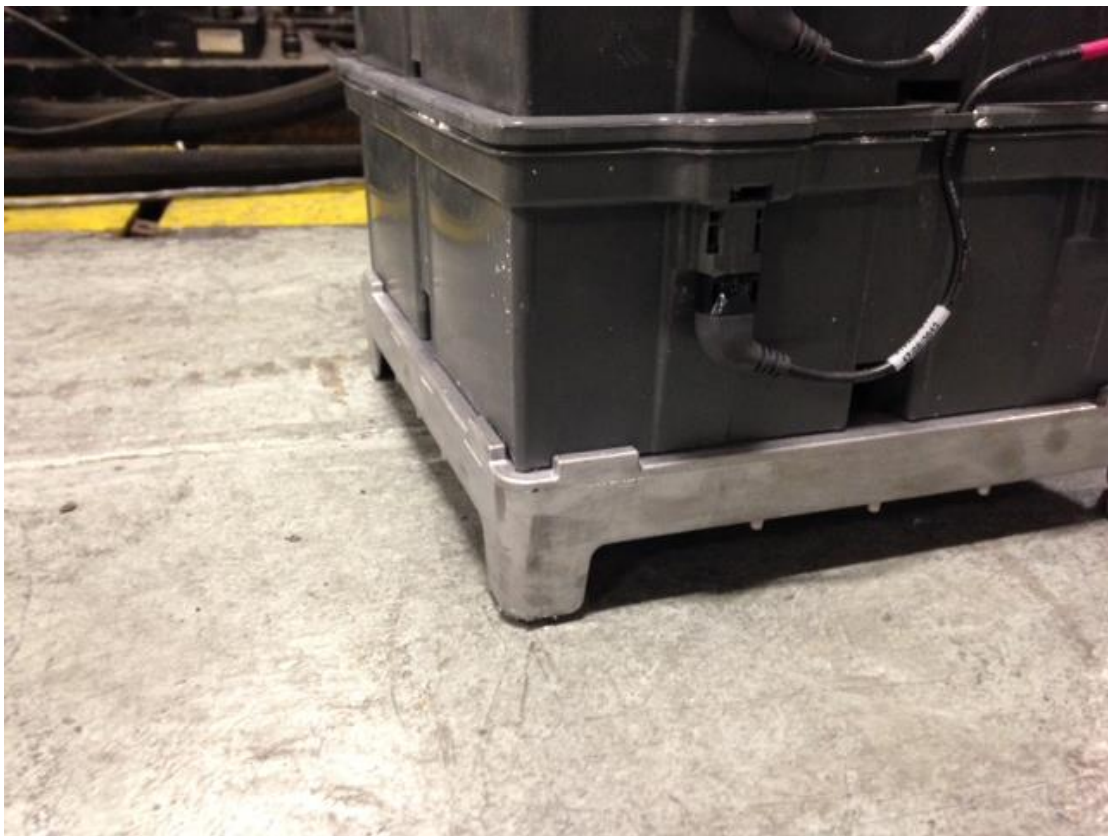
**Drop – Post-Test**

There was minor damage on the bottom-left corner of stack. There was no loss of voltage during the test. It did not leak, vent, disassemble, rupture or catch fire as a result of the testing.

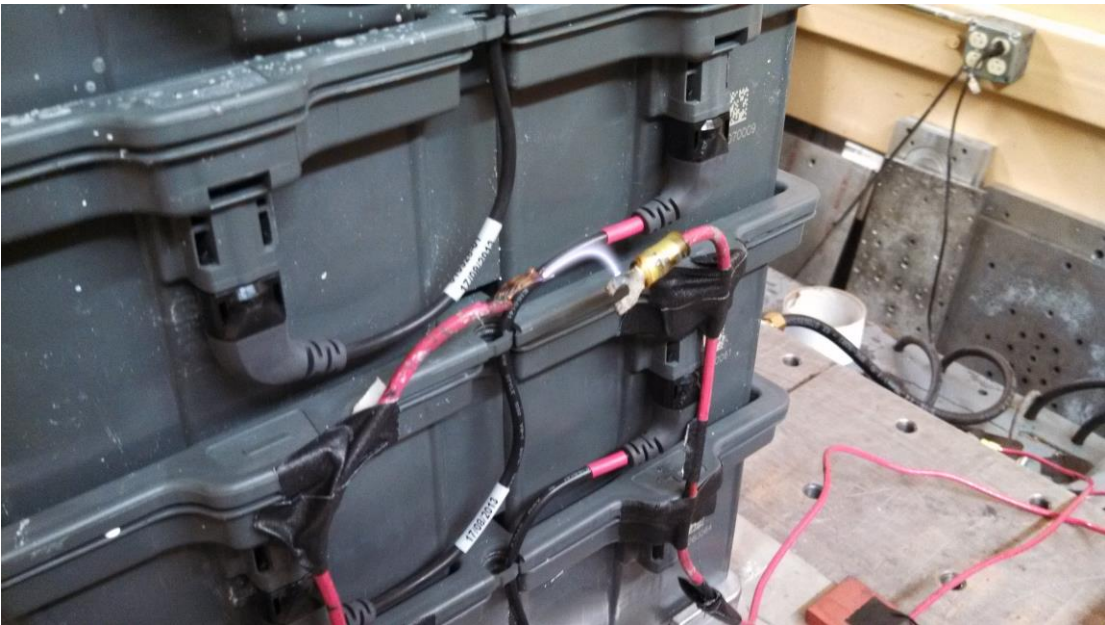
**Vibration – Post-Test (Spark)**

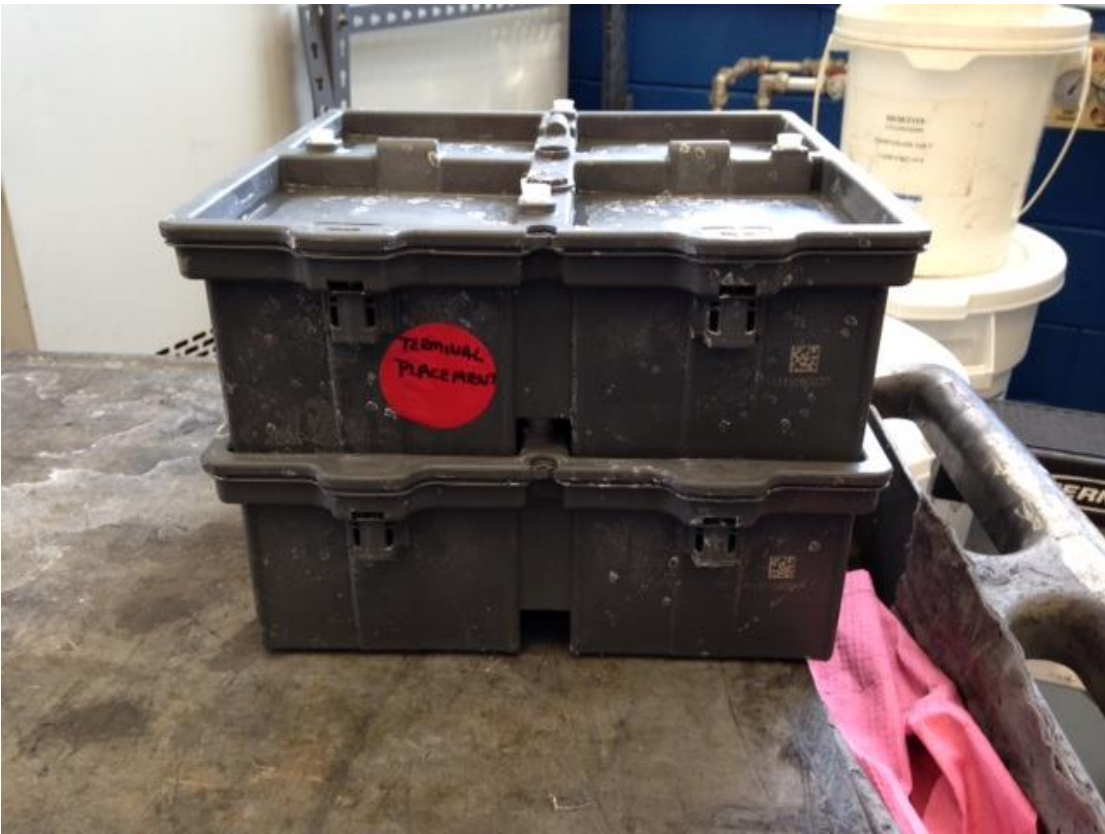
**Salt Fog - Post-Test**

Minor voltage loss was observed in both cells. Some swelling of the cells was observed.

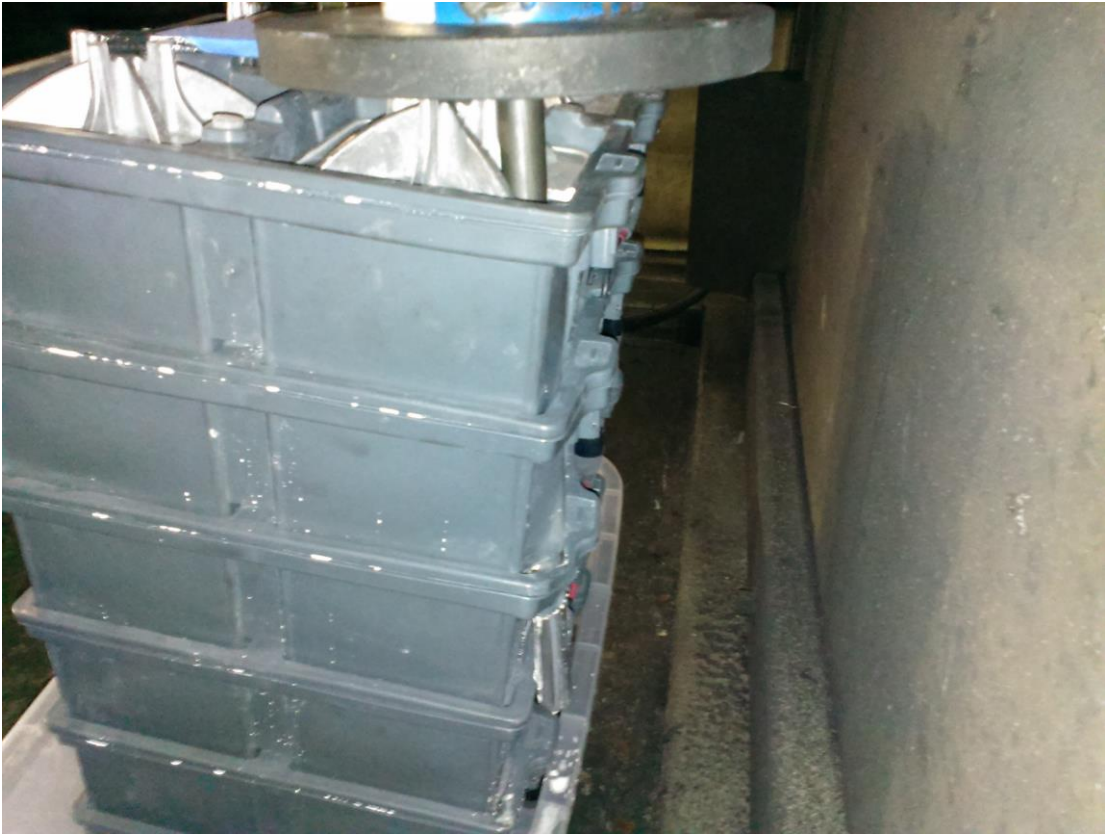
**Nail Penetration – Post-Test (Battery Stack)**

During penetration, the nail bent inside the battery stack and protruded from the side of the third cell. Both the battery stack and the nail experienced slight leaking and significant voltage loss as a result of the penetration.

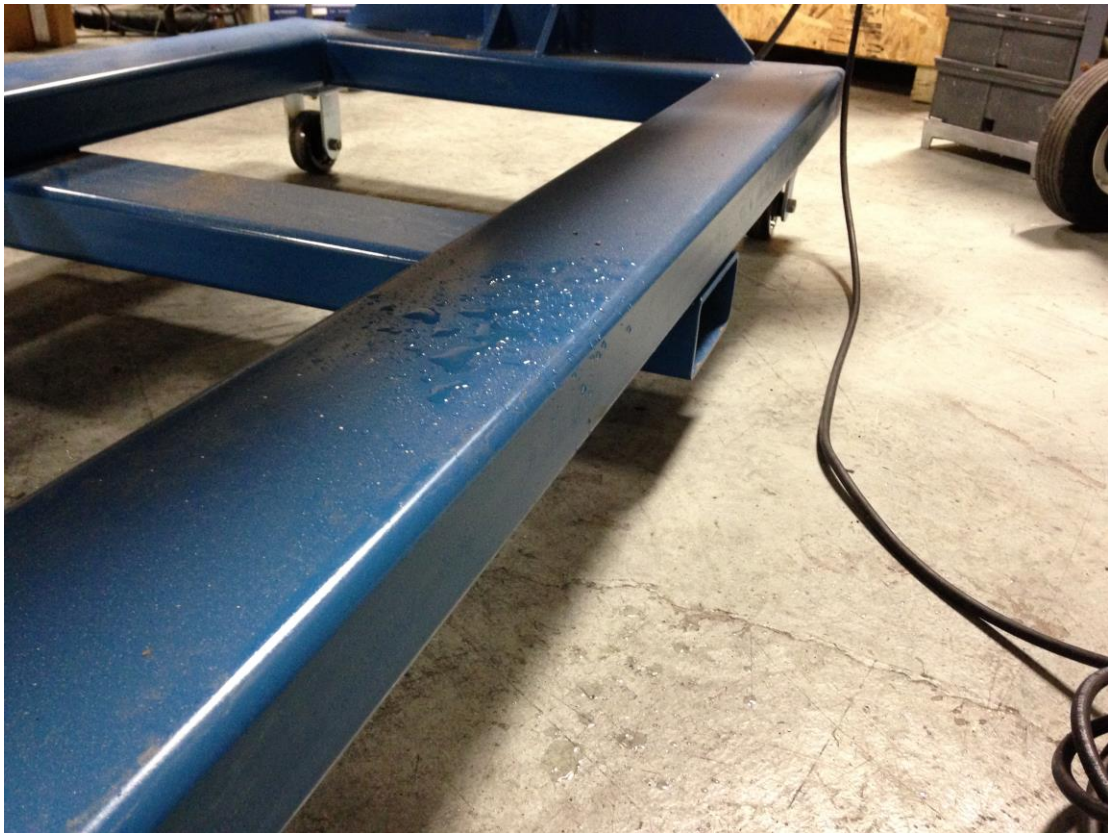
**Roll-over – Post-Test (Battery Stack Leak)**

The cells had minor voltage loss. Slight leaking was observed from the stack. No visual damage, loss of voltage, or events were observed.
