PN: 11-3215

September 29, 2011

Re: Asbestos Demolition Impact Survey, Lead-Based Paint Determination, and Hazardous Materials Assessment for the Former Arby's Restaurant Located on Forest Avenue in Portland, Maine.

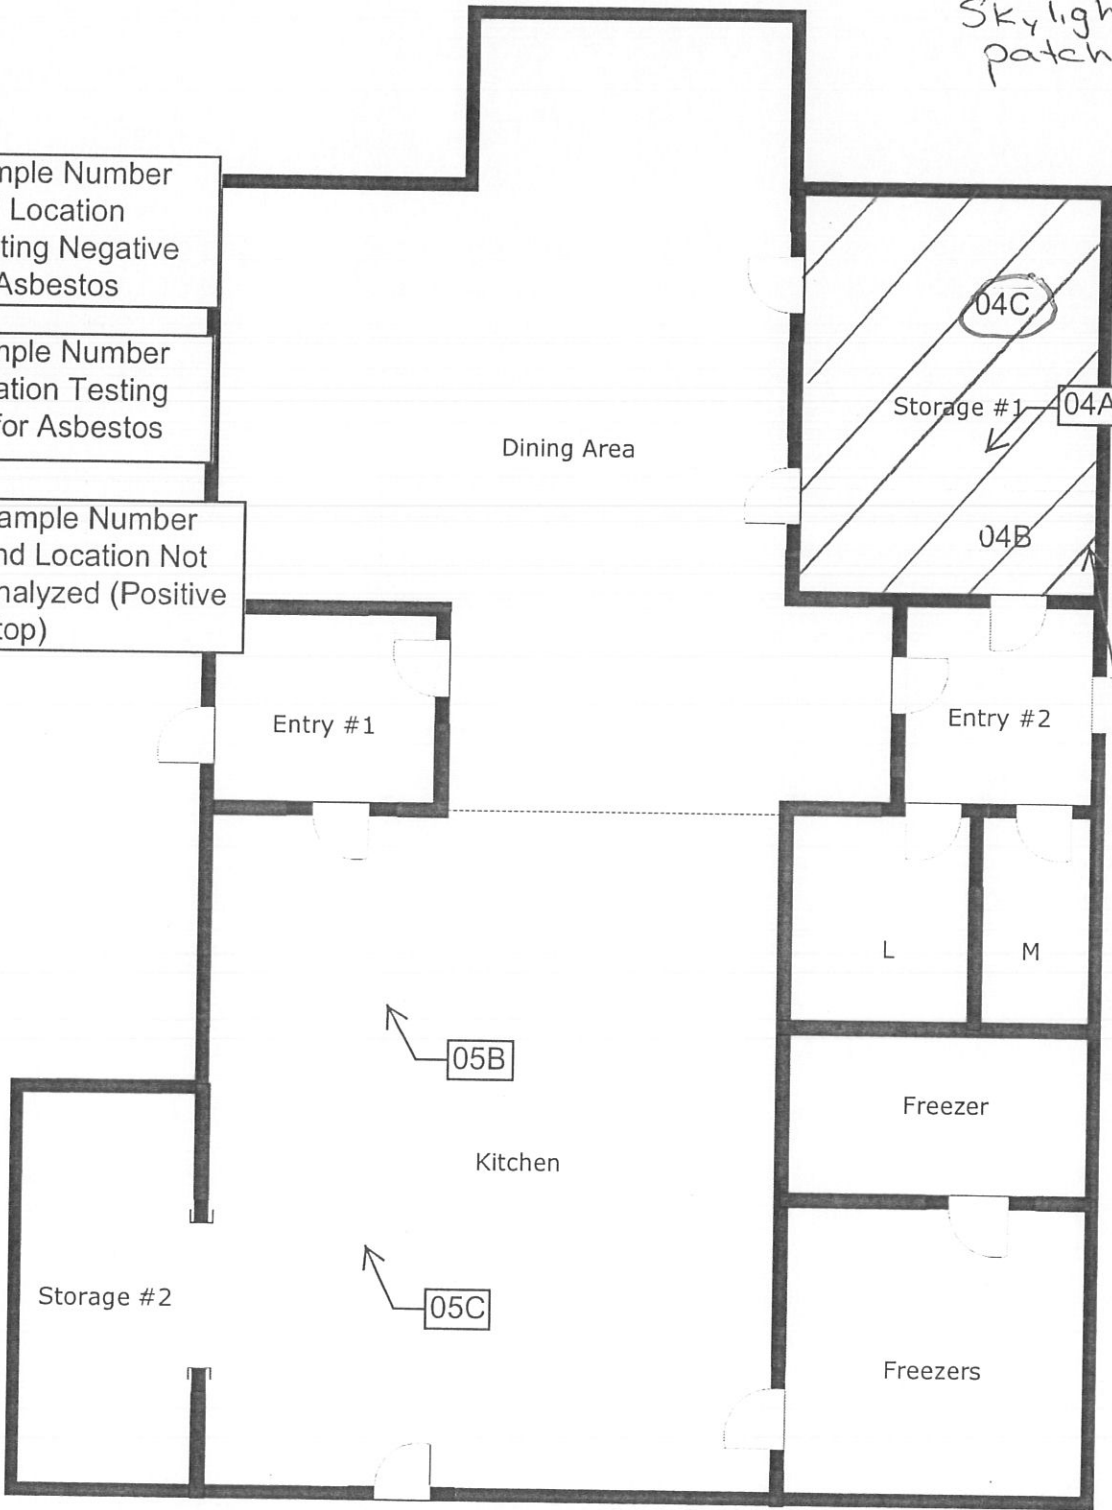
Figure 2

Thirteen (13) samples of suspect ACM were collected by Summit for laboratory analysis. Laboratory analysis identified black roof tar material as ACM.

Area with black roof tar around skylight and patching.

04B Sample Number and Location Testing Positive for Asbestos

The removal of asphaltic or petroleum-based asbestos-containing roofing materials, mastics, glues, cements, sealants, coatings and adhesives; provided they are not sanded, ground, abraded or cut with a mechanical roof cutter; is not subject to the MEDEP Chapter 425 Asbestos Management Regulations (April 3, 2011). It is recommended that these materials be removed by a roofing contractor whose employees have completed Occupational Safety and Health

Administration (OSHA) asbestos awareness training. The removed materials must be handled and disposed of as non-friable asbestos-containing waste.
