Project: **117 Dartmouth Roof Assessment**
Portland, ME

Date of visit: November 14, 2017

At your request, we visited the site to evaluate the existing condition of the roof framing at 117 Dartmouth. We understand the goal of our evaluation is to determine the existing condition of the roof structure and describe remedial action recommended/required. The following observations are based on conditions readily accessible to view at the time of our visit. See the images embedded within memo for reference purposes.

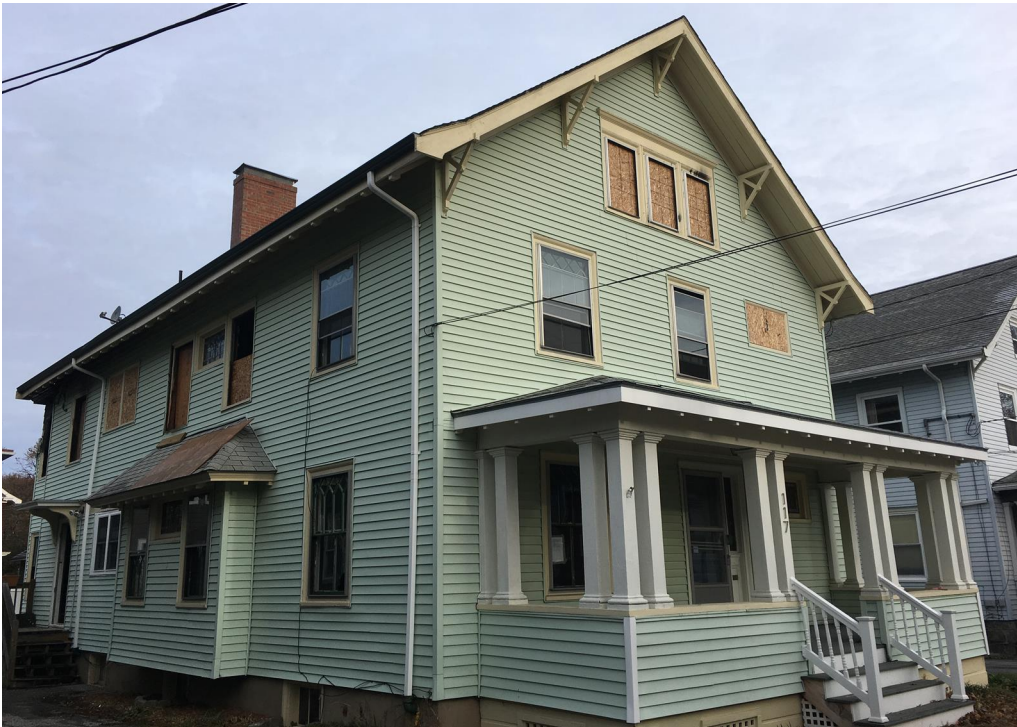
Photo A

The 2-story, gable roof building with a footprint of approximately twenty eight (28) feet by fifty (50) feet appears to be constructed of dimensional wood rafters, floor joists and interior/exterior bearing walls (Photo A). Rafters were observed spanning approximately fourteen (14) feet from a symmetrically located ridge to each eave. Elevated collar ties located at every other rafter were observed at approximately 8' above attic floor with no structural ridge present. Rafters were observed bearing on a double 2x4 dimensional lumber top plate at the exterior walls. Attic floor joists appeared to be fastened to the exterior wall studs just below the top plate. Attic floor joists were observed spliced at a continuous interior bearing wall which appeared to be offset from the ridge above. The interior bearing wall appeared to stack from floor to floor. At the first floor, a continuous floor beam was observed carrying the bearing walls above. The first floor beam was found to be supported by steel pipe columns spaced at seven (7) to eight (8) feet on centers. It appears that the exterior bearing walls are supported by a cast-in-place concrete foundation wall with the interior steel posts bearing on unknown foundation elements.

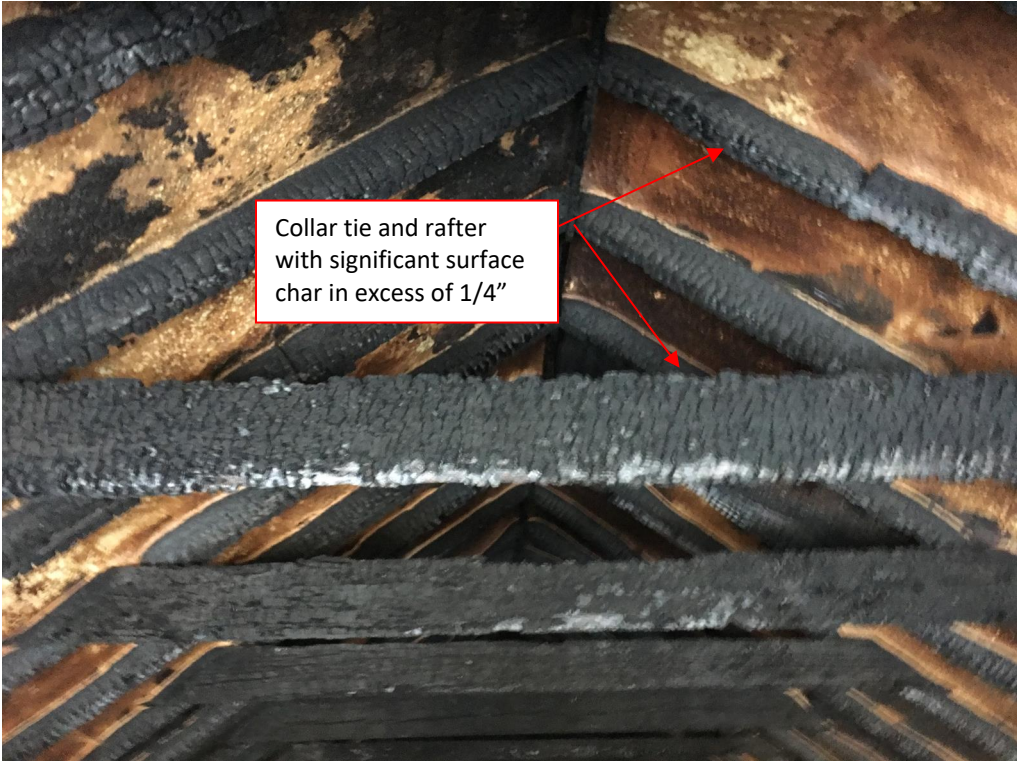
Photo B

Many of the rafters and collar ties were found with significant fire damage with approximately one quarter of an inch (1/4") or greater of surface char depth (Photo B). The northwest gable end wall framing was also found with significant fire damage and char depths, however, no significant fire damage was observed at the southeast gable end wall or at either eave wall (Photo C). The attic floor sheathing appeared to be slightly charred along the top surface but the underside of the board sheathing and the attic joists below showed no signs of fire damage.

In summary, the roof framing and northwest gable end wall framing were found with significant fire damage and we believe them to be structurally compromised. As such, we recommend the roof framing (roof sheathing, rafters and collar ties) and northwest gable end wall framing be demolished and rebuilt in a way that does not increase the load being delivered to existing structure below at both interior and exterior of building.
