September 25, 2015 (Updated report)

Re: Field investigation of existing framing at 118 Brentwood Street, Portland, Maine

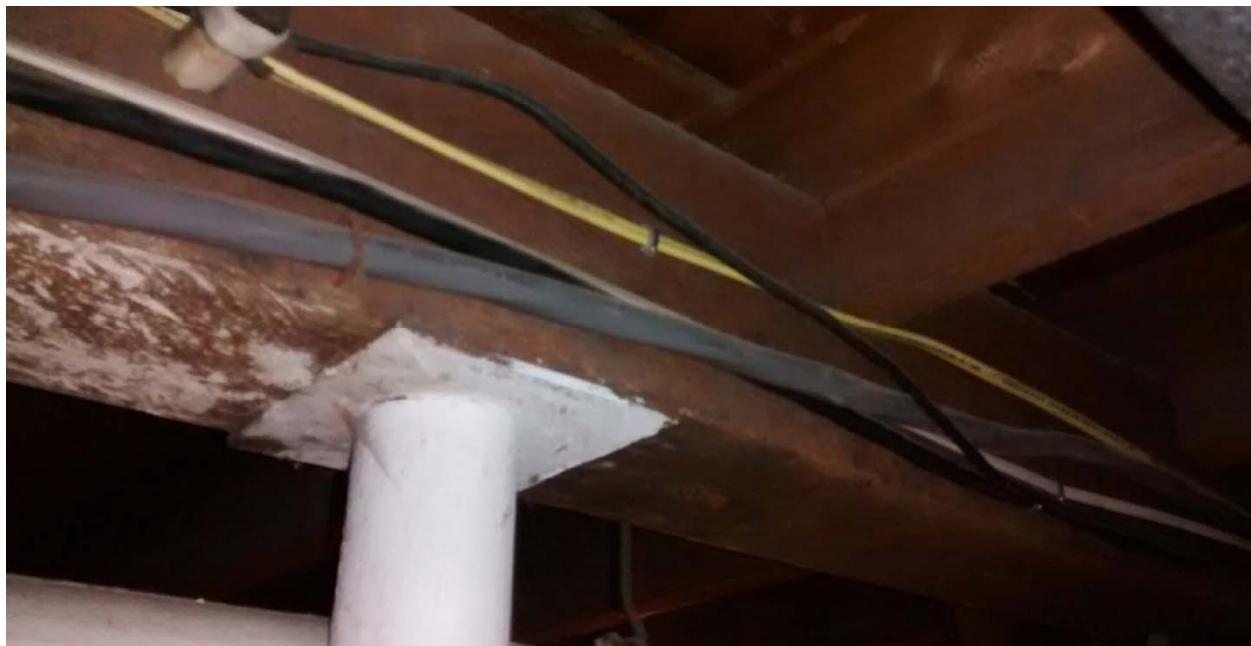
Photo #1:

The subject residence is a traditional colonial style home with a full finished attic (approximately 12/12 pitch roof) and one larger A-dormer on the front side of the building. The main size of the home is approximately 24'-0" x 25'-0" w/ a 12'-2" x 24'-0" single story mono pitch roof at the rear of the building. The first floor consist of the foyer, living room, stairwell, and kitchen. The second floor consist of (3) bedrooms, bathroom, and stairwell. The third floor (attic space) consist of (1) large bedroom, stairwell, and minimal storage space behind the knee wall on the stairwell side. At the time of my inspection only the first floor framing (Refer to photo #1) and the floor framing in the storage area behind the knee wall was visible.

The first floor framing consisted of 2x8 rough sawn floor joist @ 16"o.c. with a 5"x7" rough sawn girder beam down the center of the basement. This has a maximum span of 7'-4" from the edge of the fireplace to a lally column support and then 5'-5" from lally to lally. Per my request the client has opened up the gypsum ceiling so the direction of the framing may be confirmed. The framing appears to run the width of the building (24' span direction, Refer to Photo #2) with the wall down the center of the building as a load bearing support. This coincides with the girder location in the basement.

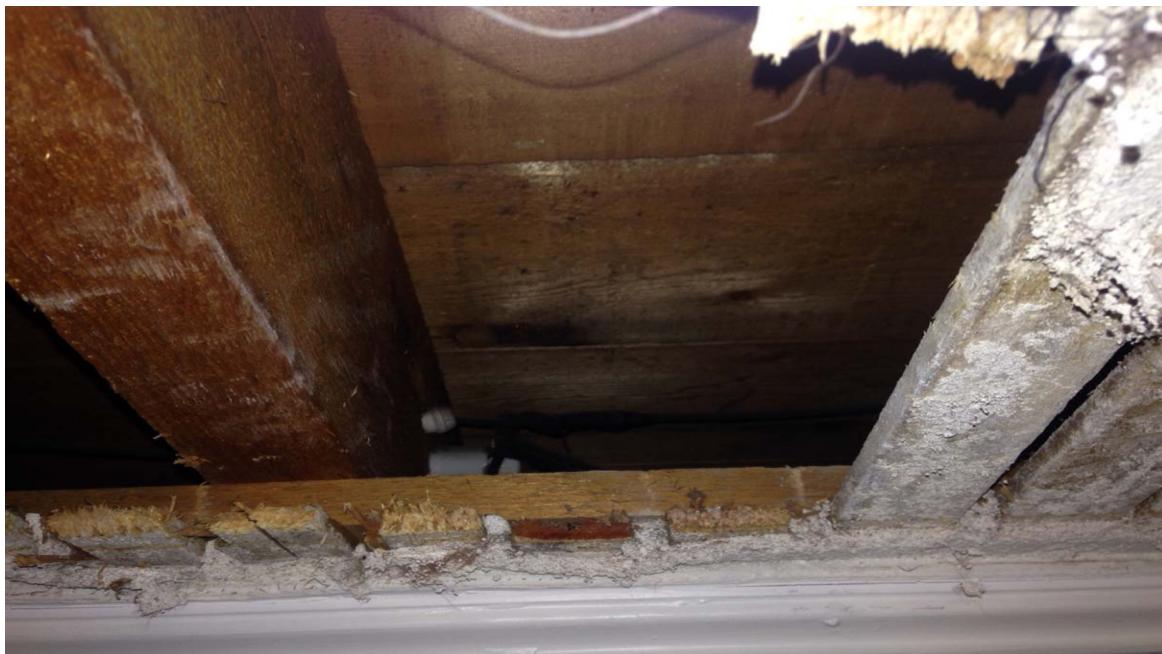
Photo #2:

It is fair to assume the 2nd floor ceiling/ 3rd floor floor framing also runs in this direction for there is also a wall that runs down the middle of the house at that level. The roof framing runs in the opposite direction.

The direction of the joist at each level indicates that the center wall is load bearing and supports the floor loads from above.

There is a bump out on the living room gable end side that increases the tributary length of the joist to 25'-6". I would propose a 3-1/2" x 11-1/4" LVL header be installed directly below the top plate of the existing wall at the first floor level for the proposed 11'-0" span. Each End of the header shall bear on a minimum of (2) 2x4's that carry the load to the basement floor. These 2x4 columns may be stopped at the first floor level but shall be continued from the bottom of the floor sheathing to the basement floor level.

I would propose either a (3) 2x10 SPF #2 Header or a 3-1/2" x 9-1/4" LVL header be installed directly below the top plate of the existing wall at the first floor level for the proposed 6'-0" span. Each End of the header shall bear on a minimum of (2) 2x4's that carry the load to the basement floor. These 2x4 columns may be stopped at the first floor level but shall be continued from the bottom of the floor sheathing to the basement floor level. The contractor is to confirm that this location falls over a foundation wall.
