FIELD REPORT: Stairs A, E, and G

Project Name.: Motherhouse Senior Housing 605 Stevens Ave. Portland, ME

Date of Inspection August 23, 2018 Page 1 of 9 Report by: David Mele, Architect, Archetype Architects

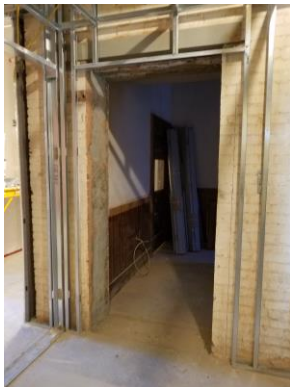
Figure 1

Figure 1: Stair A 1st Floor Discharge Level to Main Lobby – Corridor Side to receive new 90-min. door & frame

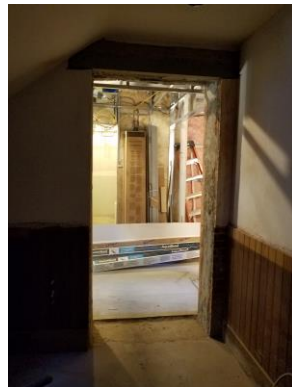
Figure 2

Figure 2: Stair A 1st Floor Discharge Level – Stairwell side

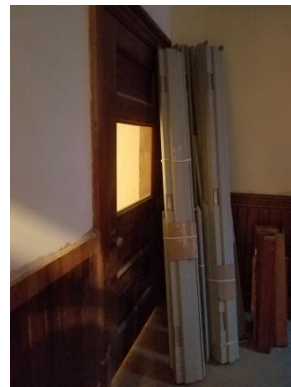
Figure 3

Figure 3: Existing Door to be sealed shut and covered w/2 hr. wall

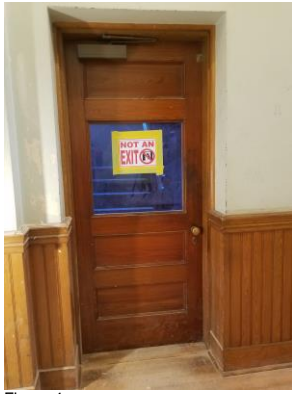
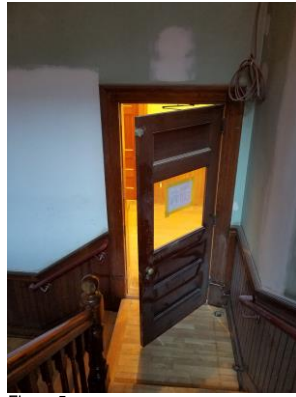
Figure 4: Stair A Level 2 – Corridor Side.

Figure 5: Stair A Level 2 – Stairwell Side.

Stair A Level 2 will receive a new 90-min rated wood door with new smoke seals in the existing frame and also receive a new door closer and sweep at the threshold. The existing wood frame is in a solid masonry opening. The wood frame will receive a clear coat of intumescent paint applied with the required number of coats to achieve a 90-minute rating.

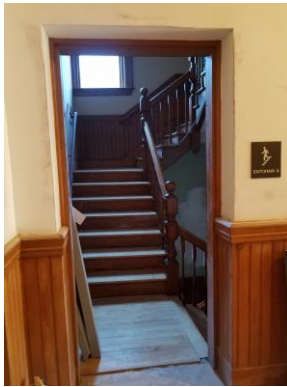
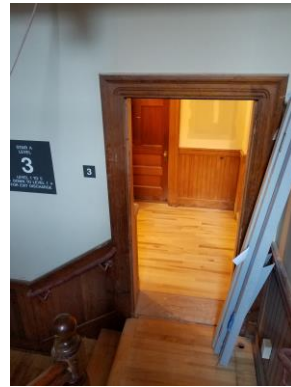
Figure 6: Stair A Level 3 - Corridor Side.

Figure 7: Stair A Level 3 – Stairwell Side.

Stair A Level 3 will receive a new 90-min rated wood door with new smoke seals in the existing frame and also receive a new door closer and sweep at the threshold. The existing wood frame is in a solid masonry opening. The wood frame will receive a clear coat of intumescent paint applied with the required number of coats to achieve a 90-minute rating.

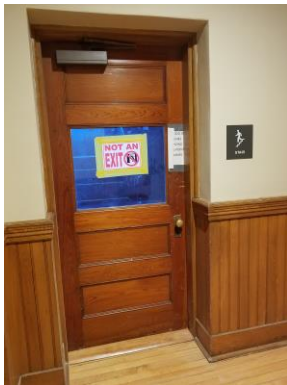
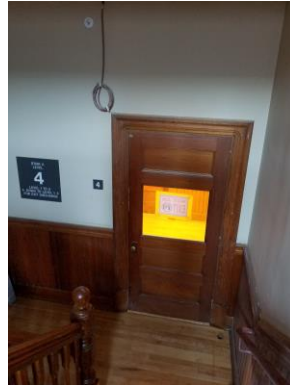
Figure 8: Stair A Level 4 – Corridor Side.

Figure 9: Stair A Level 4 – Stairwell Side.

Stair A Level 4 will receive a new 90-min rated wood door with new smoke seals in the existing frame and also receive a new door closer and sweep at the threshold. The existing wood frame is in a solid masonry opening. The wood frame will receive a clear coat of intumescent paint applied with the required number of coats to achieve a 90-minute rating.

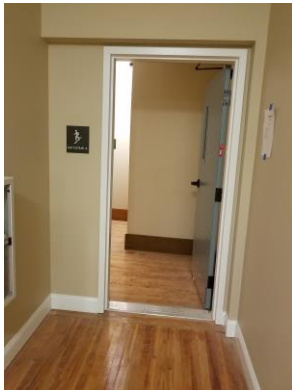
Figure 10

Figure 10: Stair A Level 5 – Corridor side of Vestibule enclosure.

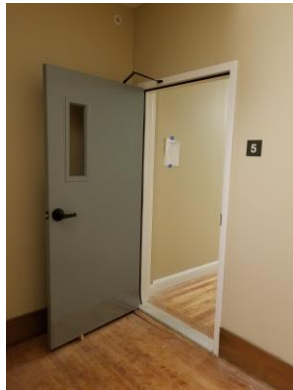
Figure 11

Figure 11: Stair A Level 5 – Vestibule enclosure stairwell side with 90-minute doors in 2-hour rated walls per approved plans.

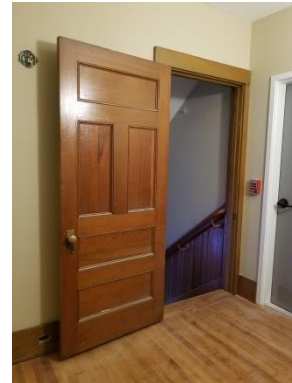
Figure 12

Figure 12: Stair A Level 5 – Existing Stairwell door inside rated vestibule to remain and permanently held open.

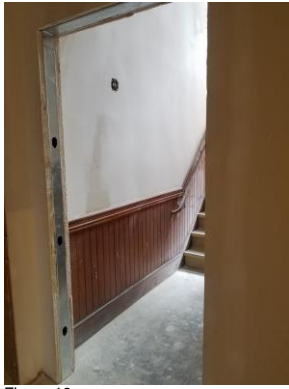
Figure 13

Figure 13: Stair E Level 1 view from north corridor. New 2-hour rated vestibule to receive 90-min. rated door.

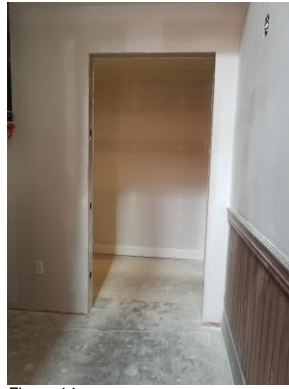
Figure 14

Figure 14: Stair E Level 1 View of new 2-hour vestibule from stairwell side.

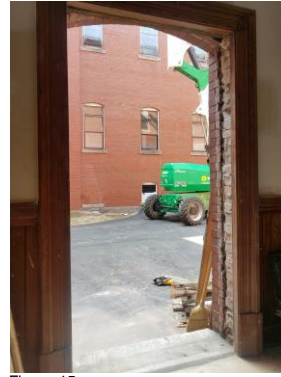
Figure 15

Figure 15: Stair E Mid-Level – between Level 1 & 2 - Discharge to paved north courtyard. Opening to receive new HM door with weatherstripping and exit hardware.

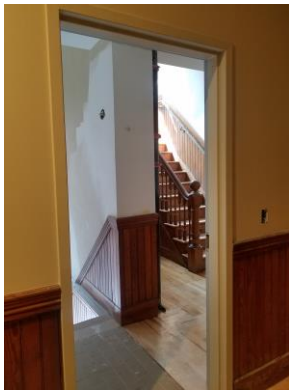
Figure 16

Figure 16: Stair E Level 2 Vestibule Corridor Side. New opening in new 2-hour rated vestibule to receive new HM 90-min rated door & frame with smoke seals, threshold & sweep, new closer and hardware.

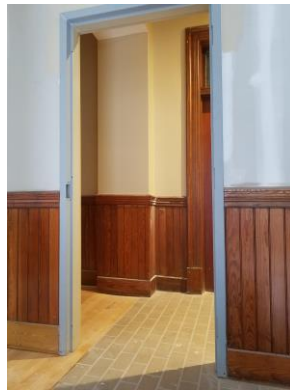
Figure 17

Figure 17: Stair E Level 2 Vestibule Stairwell Side.

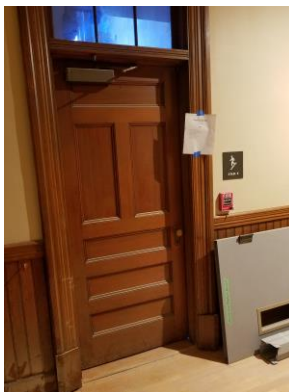
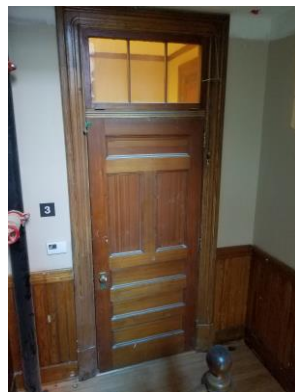
Figure 18: Stair E Level 3 – Corridor Side.

Figure 19: Stair E Level 3 – Stairwell Side.

This opening will remain as is with the following conditions:

1. A new 90-min rated wood door with new smoke seals will replace the existing door and receive new hardware, a new door closer and sweep at the threshold.

2. The existing door frame will receive a clear coat of intumescent paint applied with the required number of coats to achieve a 90-minute rating.
3. The transom glazing will be moved to the corridor side. Behind the glazing a sandwich of 5/8" gyp, mineral wool, and another layer of 5/8" gyp will fill the transom opening.

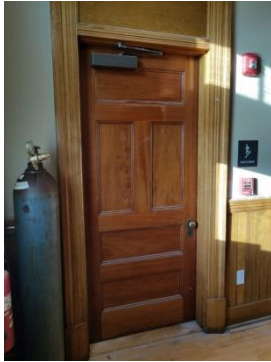
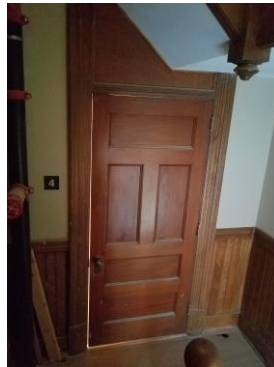
Figure 20: Stair E Level 4 – Corridor Side.

Figure 21: Stair E Level 4 – Stairwell Side.

This opening will remain as is with the following conditions:

1. A new 90-min rated wood door with new smoke seals will replace the existing door and receive new hardware, a new door closer and sweep at the threshold.
2. The existing door frame will receive a clear coat of intumescent paint applied with the required number of coats to achieve a 90-minute rating.
3. The existing transom panels will be removed and a gyp and mineral wool sandwich will be installed. The original luan plywood panels will then be reinstalled.

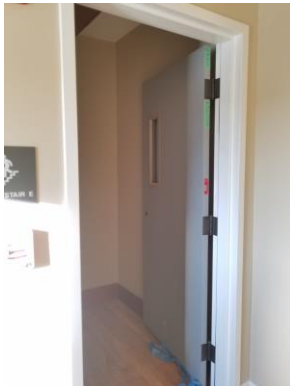
Figure 22

Figure 22: Stair E Level 5 – Corridor Side. At Level 5 a new 2-hour rated enclosure with new 90-minute door has been installed.

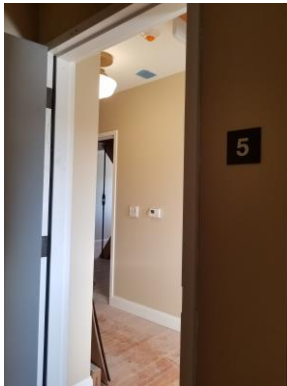
Figure 23

Figure 23: Stair E Level 5 – Stairwell Side.

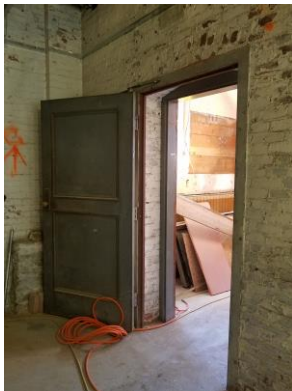
Figure 24

Figure 24: Stair G 1st Floor - Corridor Side. This existing 90-min rated door and frame will be cleaned and remain. It will receive a new closer, new hardware, new smoke seals and door sweep.

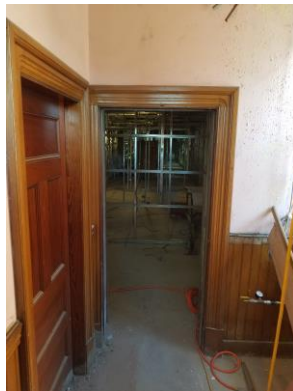
Figure 25

Figure 25: Stair G 1st Floor – Stairwell Side. The door on the left will be visible inside the stairwell, be sealed shut, have a “No Exit” sign and be protected by a 2-hour wall on the other side of the existing wall.

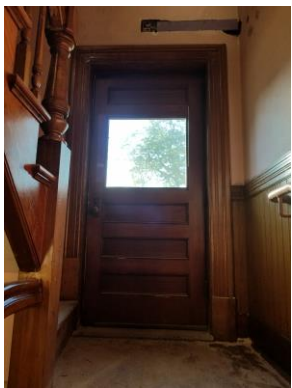
Figure 26

Figure 26: Stair G – Discharge Level to Exterior between Levels 1 & 2 Stairwell Side. This opening will receive a new door to replicate the original door shown here, new closer, hardware, weatherstripping, threshold and door sweep. The new door will swing towards the exterior in the direction of egress.

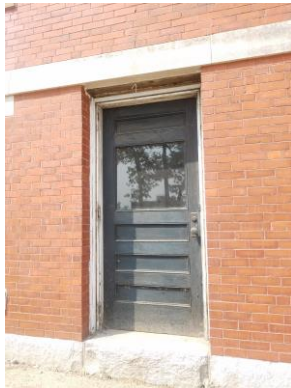
Figure 27

Figure 27: Stair G – Discharge to Exterior, Existing Door. See above. In addition to that, the grade will be raised and join a walkway with a handrail.

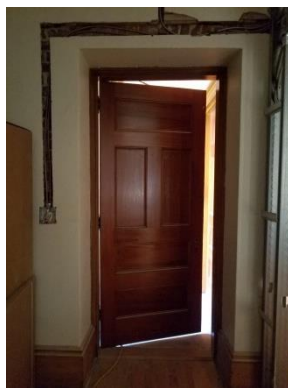
Figure 28

Figure 28: Stair G Level 2 – Corridor Side. A new 45-min. rated wood door will replace the existing door and receive new hardware, new closer, smoke seals, and a new threshold and door sweep.

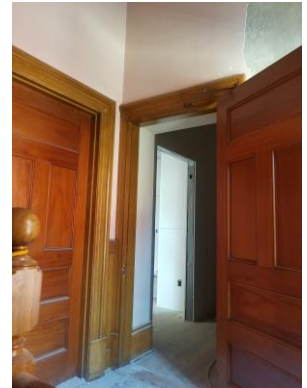
Figure 29

Figure 29: Stair G Level 2 – Stairwell Side. The door on the left will be visible inside the stairwell, be sealed shut, have a “No Exit” sign and be protected by a wall with 2 layers of 5/8” gyp on the other side of the existing wall where there’s an apartment unit.

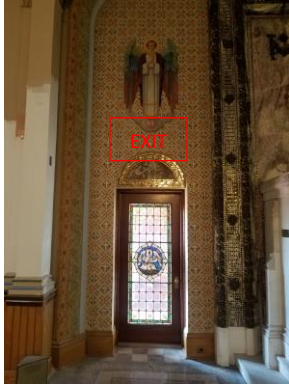
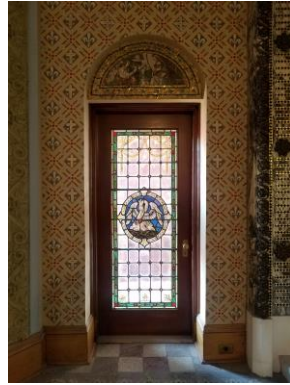
Figures 31 & 32: Stair G Level 3 - Chapel Side

This door will remain in place with the following additional components: new protective metal rails aligned with the stained glass pattern, new hardware, including an exit device, smoke seals, door sweep and threshold. A new lighted exit sign will be installed above the archway.

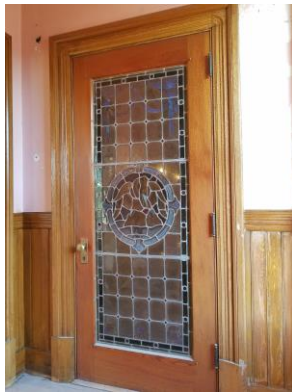
Figure 33

Figure 33: Stair G Level 3 - Stairwell Side. On the stairwell side a sheet of 3/4” hardwood plywood will be fastened to cover the entire area of stained glass.

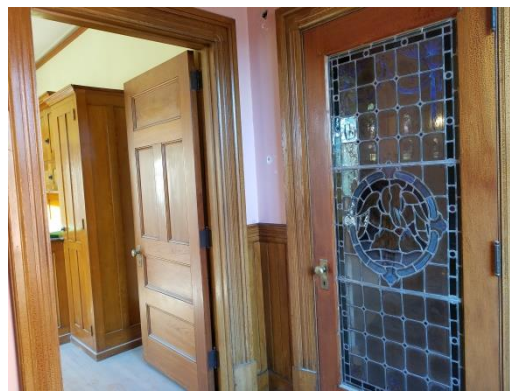
Figure 34

Figure 34: Stair G Level 3 – Stairwell Side with adjacent door to Sacristy. This door will be fixed in place and have a “No Exit” sign. A new 1-hour rated wall will be built on the other side of the existing wall.
