1 EXISTING CONDITION - NORTH ELEVATION
SCALE: 1/4" = 1'-0"

PERMIT SET

**UNIVERSITY OF
NEW ENGLAND**
PORTLAND, MAINE
**ALUMNI HALL
RENOVATION**
**RESTORATION
ELEVATION**

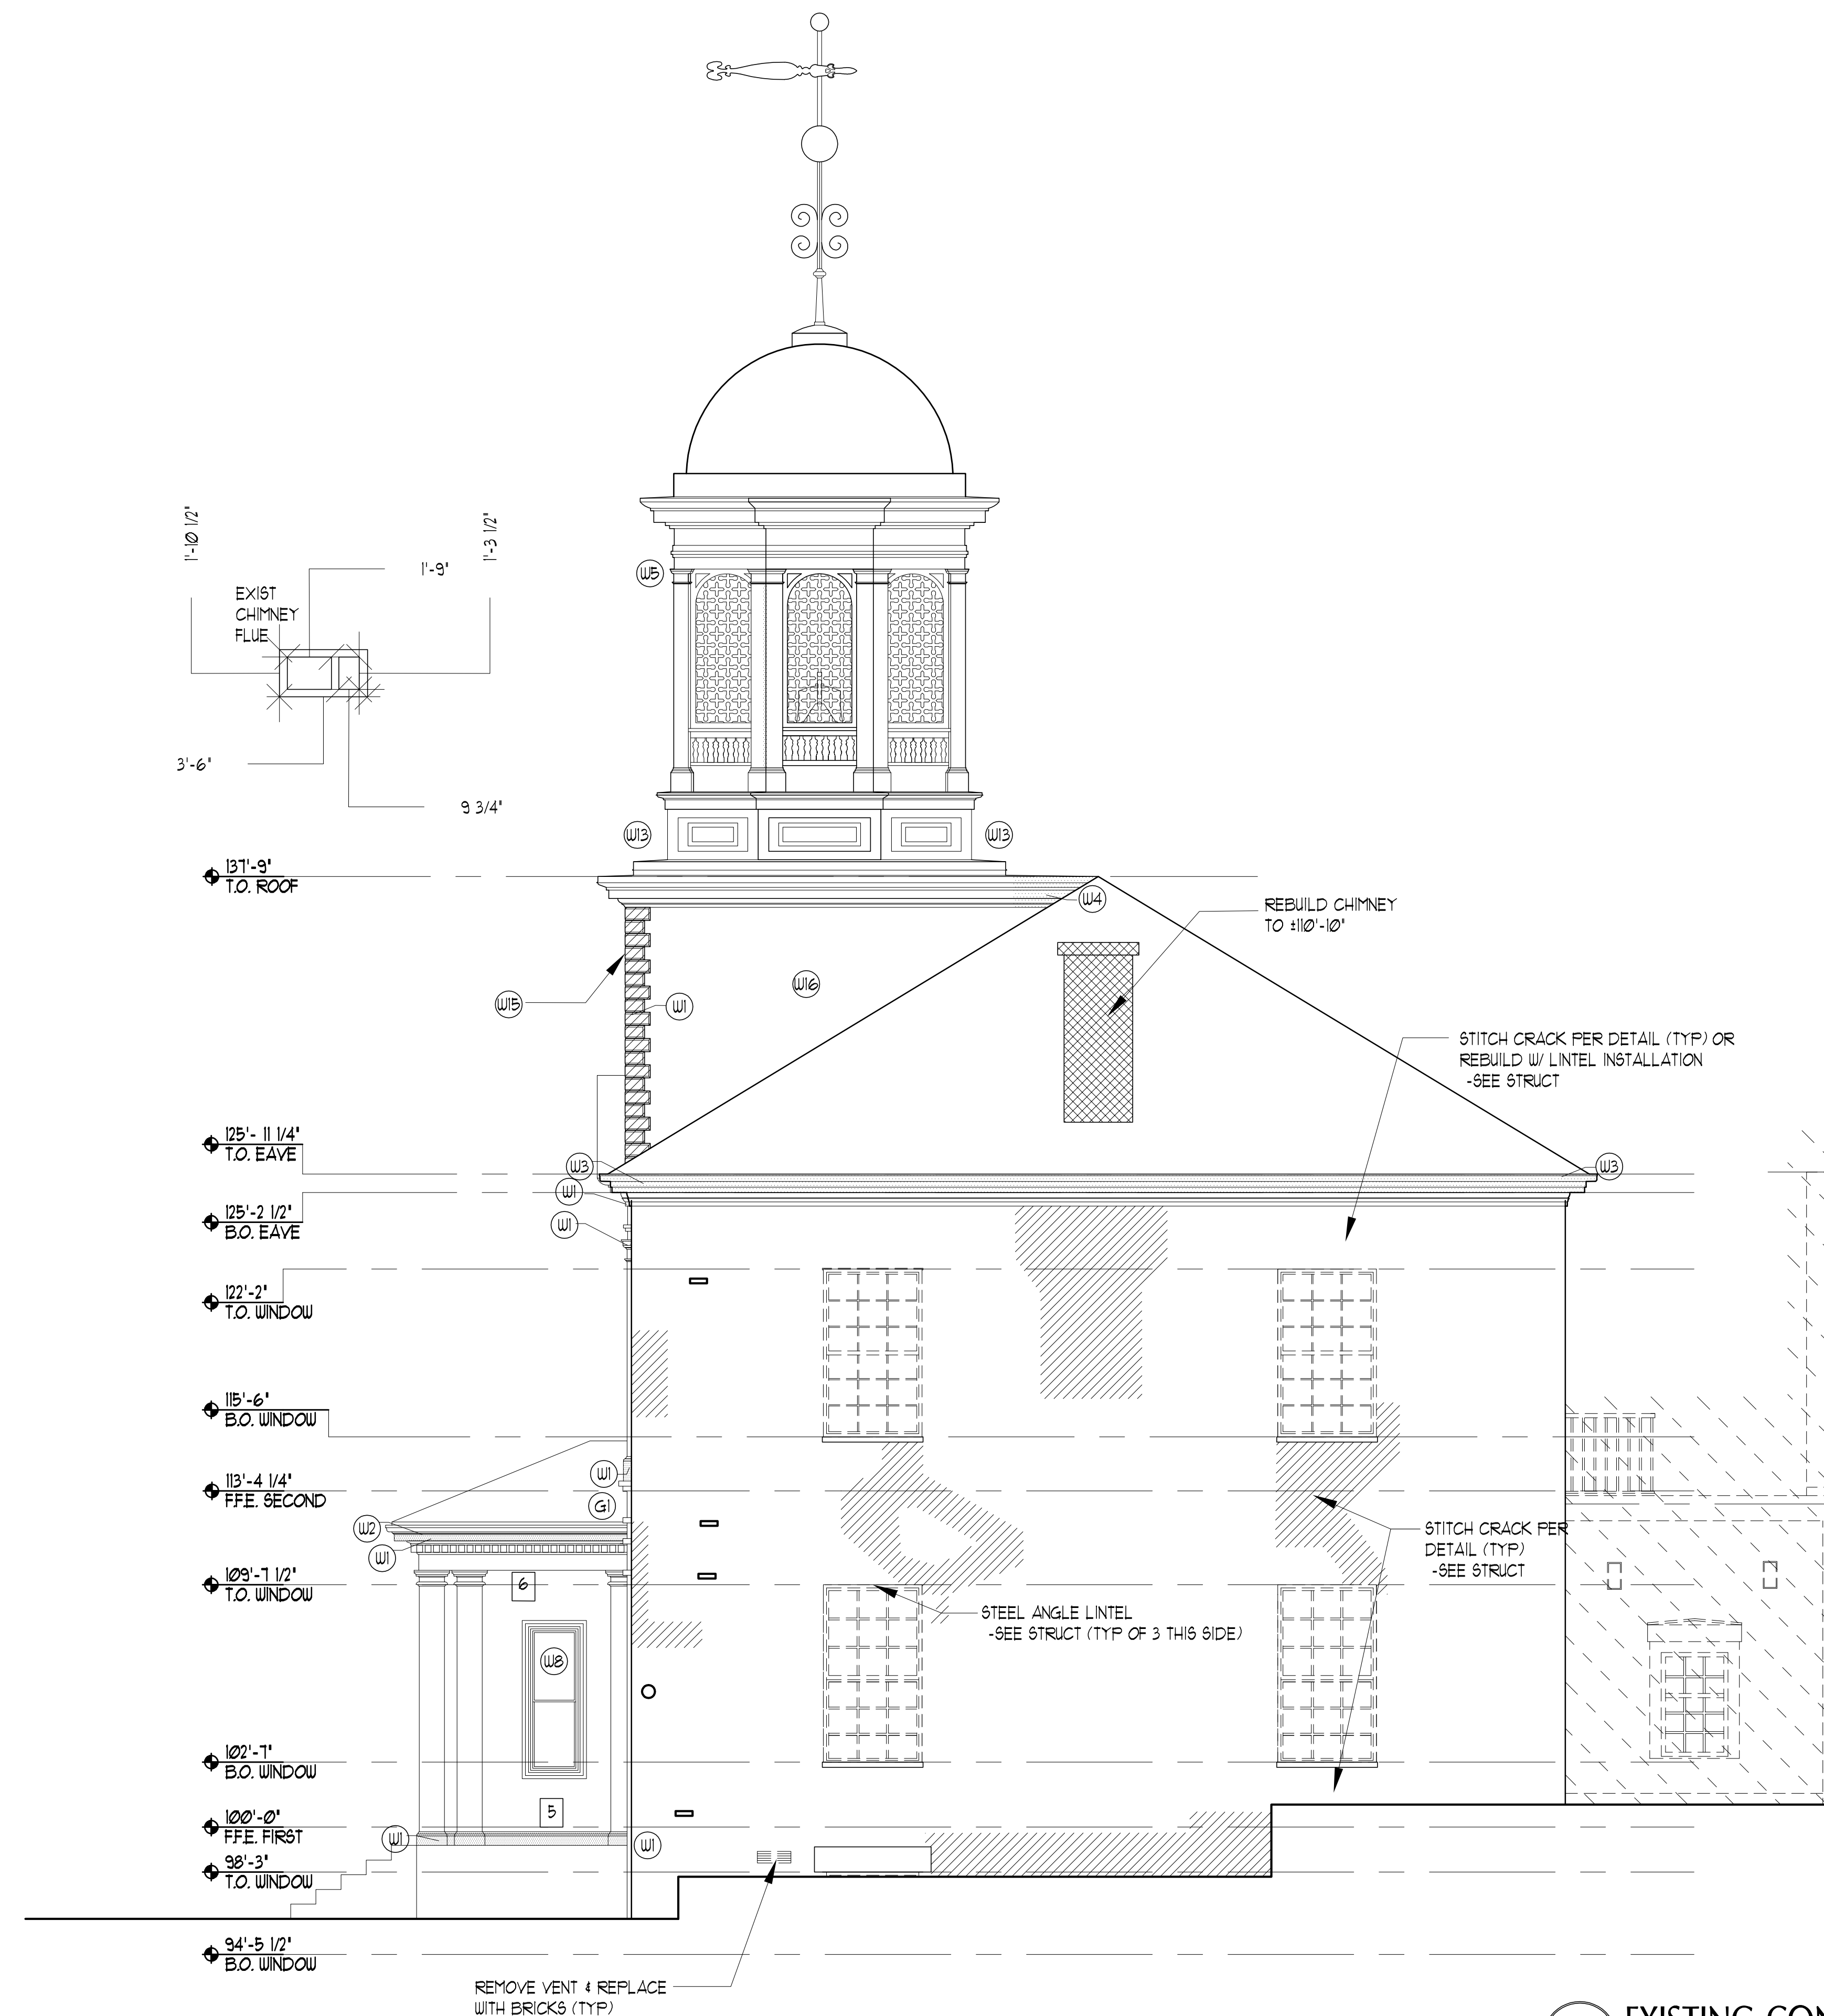
- RESTORATION KEY
- /// MORTAR SOFT OR MISSING
ACTION: CUT BACK 3/4\"/>

- WOOD TREATMENT NOTES
- (U1) REMOVE MISSING OR NON-REPAIRABLE WOOD TRIM. REPLACE WITH NEW TRIM TO MATCH EXISTING PROFILE.
 - (U2) REMOVE EXISTING WOOD GUTTER AND REPLACE WITH NEW METAL GUTTER SYSTEM. MATCH EXISTING PROFILE.

- (U3) REMOVE EXISTING METAL GUTTER BACKER TRIM AND SOFFIT AS SHOWN IN DETAIL 2/A 8. REPLACE WITH NEW METAL GUTTER AND WOOD TRIM TO MATCH EXISTING PROFILE.

- (U4) EPOXY INJECTION REPAIR.
 - (U5) EPOXY SECTION REPAIR.
 - (U6) NEW MAHOGANY THRESHOLD TO MATCH EXISTING PRETREAT ALL SIDES. PRIME, BACK PRIME, END PRIME AND PAINT.

- (U7) REMOVE EXISTING DOOR AND HARDWARE. STEAM STRIP PAINT. PREP FOR NEW PAINT AND HARDWARE. CLEAN AND REINSTALL VERTICAL DEADBOLTS. DISABLE DEADBOLTS TO BECOME INOPERABLE.

- (U8) REMOVE EXISTING WINDOW SASH. STEAM STRIP REFINISH AND REINSTALL AS PER SPEC SECTION XXXXX.
 - (U9) REMOVE EXISTING LIGHT FIXTURE. PREP FOR NEW FIXTURE. INSTALL NEW WOOD KEYSTONE TO MATCH. PRETREAT ALL SIDES OF NEW KEYSTONE, INCLUDING GROMMET HOLE FOR NEW FIXTURE.

- (U10) REBUILD 2 CLOVERS
EACH PANEL = 31 FULL CLOVERS
14 HALF CLOVERS @ PERIMETER
REMOVE EA. PANEL 1 OF 3
HAND SCRAPE - LIGHT SANDBLAST
SECURE EA. CLOVER @ CENTER W/ 66 TRIM SCREW

- (U11) BACK PANEL - OPERABLE - NEEDS 2 NEW 66 HINGES
 - (U12) ADD HASP TO ROOF HATCH - GOOD CONDITION
 - (U13) RESTORE PANELS
 - (U14) REMOVE ROTTED WD FOR REPLACEMENT

- (U15) REMOVE AND REPLACE ALL QUONS WITH WESTERN RED CEDAR (TYP ALL SIDES)
 - (U16) REMOVE SHIPLAP SIDING AT BELFRY BASE SIDES. SALVAGE FOR REINSTALLATION. INSPECT CONDITION RESTORE AND REINSTALL AFTER ROOF FLASHING HAS BEEN INSTALLED.

- (G1) REMOVE ASPHALT SHINGLE ROOFING AND LEAD STEP FLASHING AT ENTRY VESTIBULE ROOF. INSTALL NEW LEAD STEP FLASHING AND REROOF.
 - (G2) REMOVE EXISTING SPOT LIGHTS AND MOUNTING BRACKETS AT BELFRY AS REQUIRED. INSTALL NEW SPOTLIGHTS AS PRESCRIBED IN ELECTRICAL. REPAIR & PATCH ROOFING TO MAINTAIN WATER TIGHTNESS.

- (G3) RESTORE BOOT SCRAPE - SAND AND PAINT.
