Field Report

The Park Danforth **Project No:** 13-059-00
Portland ME **Field Report No:** 12

To: Mark Donovan **Time of Visit:** 8:00 AM
 PC Construction **Date of Visit:** 5/10/2016
 131 Presumpscot Street **Weather:** Clear, Sunny, 55F
 Portland ME

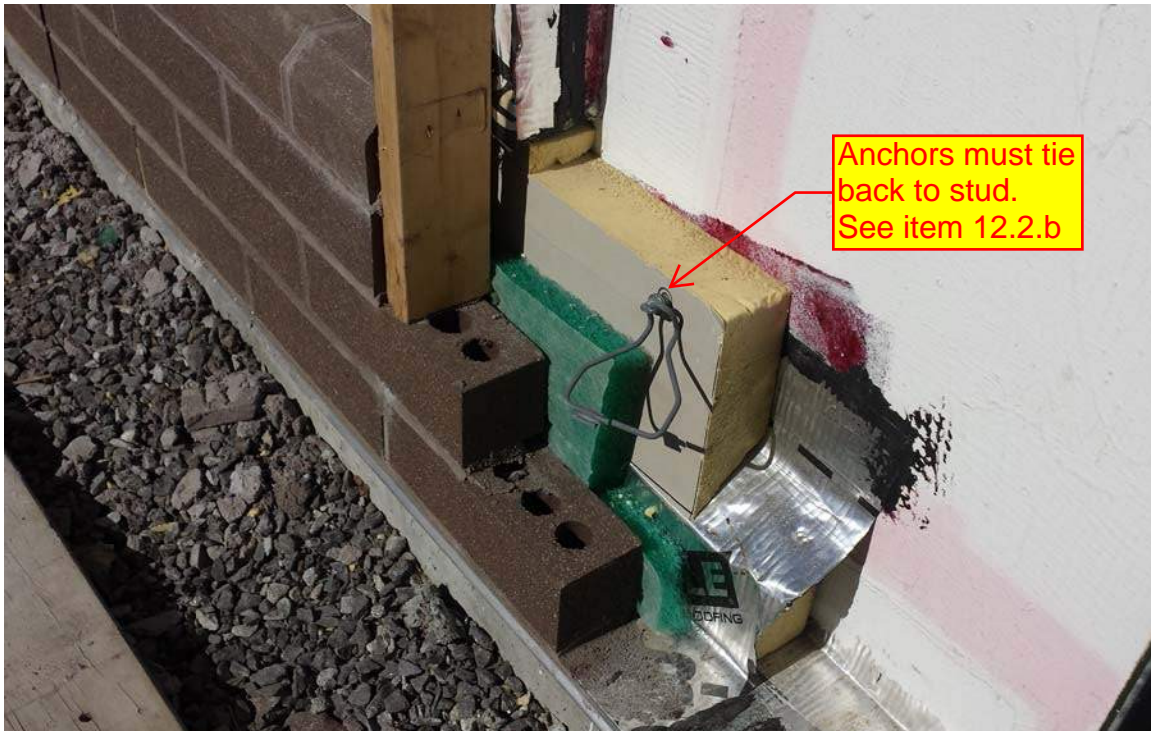
A

Anchors must tie back to stud.
See item 12.2.b

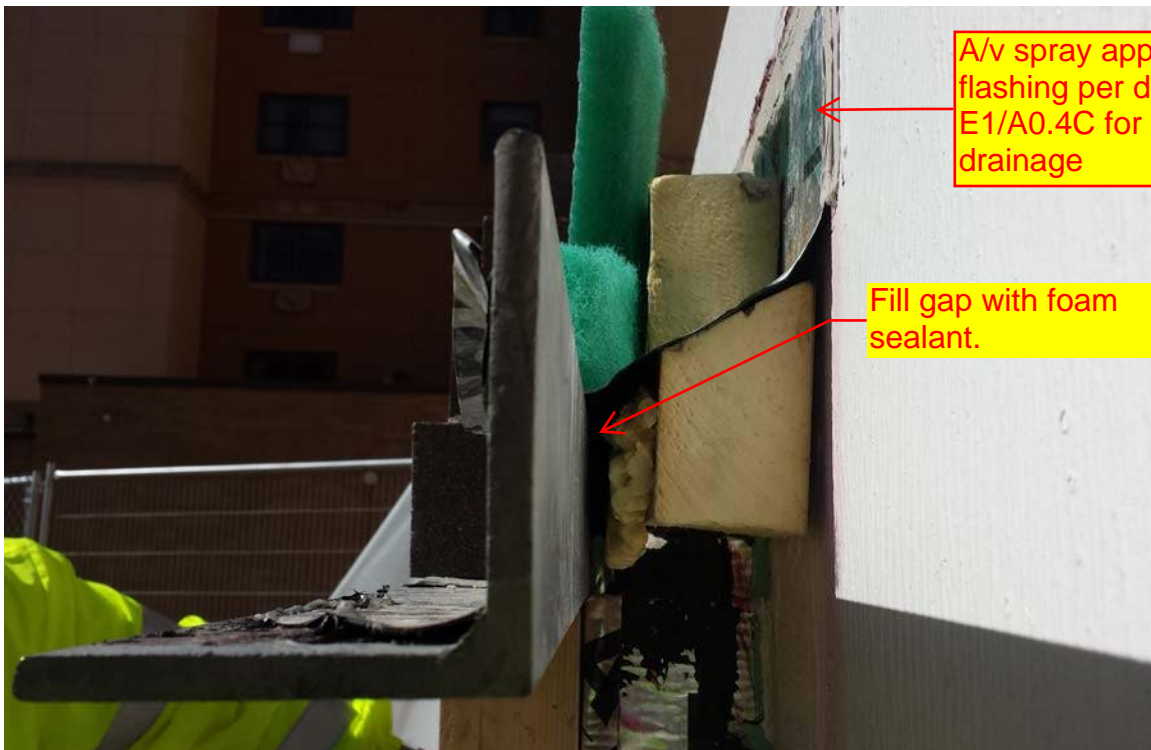
B

A/v spray applied over flashing per detail E1/A0.4C for positive drainage

Fill gap with foam sealant.

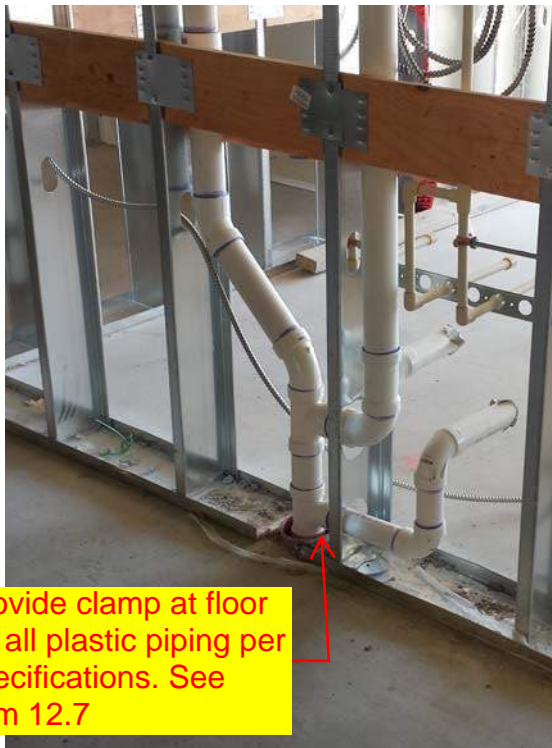
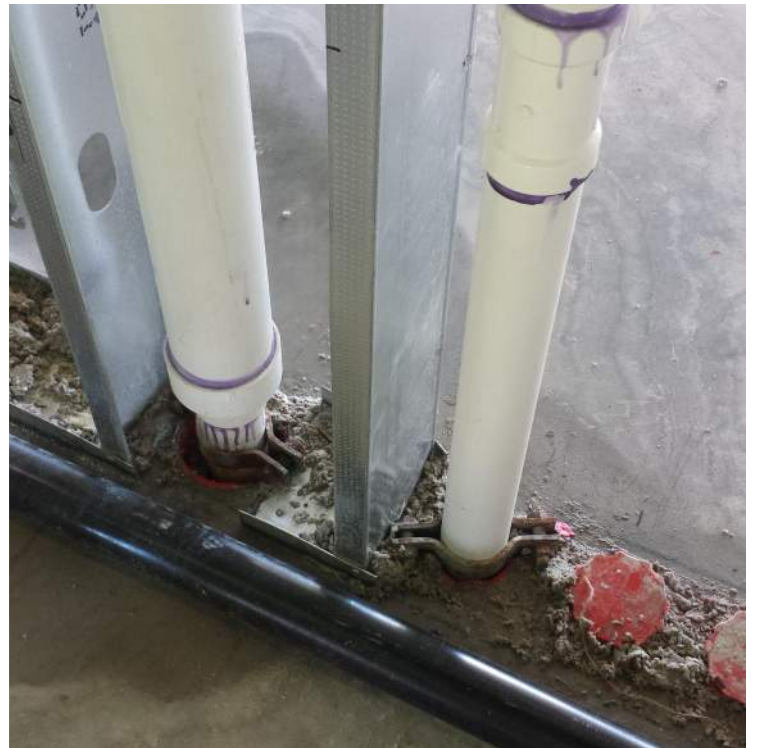
12.7	Support is required at the base of all floor penetrations and ten vertical feet for plastic pipe, all sizes. Verify installation at all plastic pipes. Ref: Spec 230529 Part 3.7 F and G and reference MSS SP-694996 Pipe Hangers and Supports-Selection and Application	CM follow up
	See Photo B P13 of 18

Provide clamp at floor for all plastic piping per specifications. See item 12.7

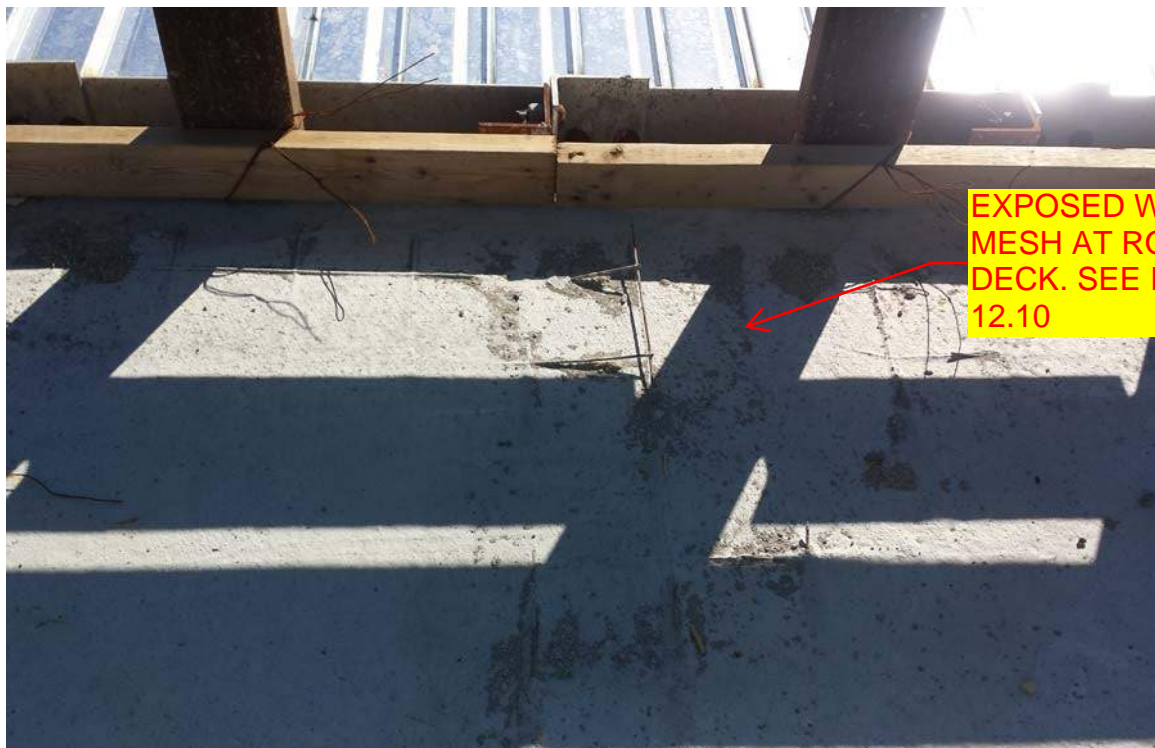
12.10	Wire mesh in the concrete at the 5th floor garden roof deck is exposed in some areas. See Photo A P17 of 18	Correct Work
12.2	<u>MOCK UP WALL</u>	Correct Work
	<ul style="list-style-type: none"> a. Flashings at lintel shall extend the full length of the lintel per 04 20 00-3.14. See Photo B P3 of 19 b. Brick ties shall be secured to stud framing per 04 20 00-3.12E. See photo A P4 of 18 c. Control joints at masonry openings shall be constructed in accordance with the Brick Industry Associations TN 18A, Figure 6 (see attachment 1 for reference)

EXPOSED WIRE MESH AT ROOF DECK. SEE ITEM 12.10

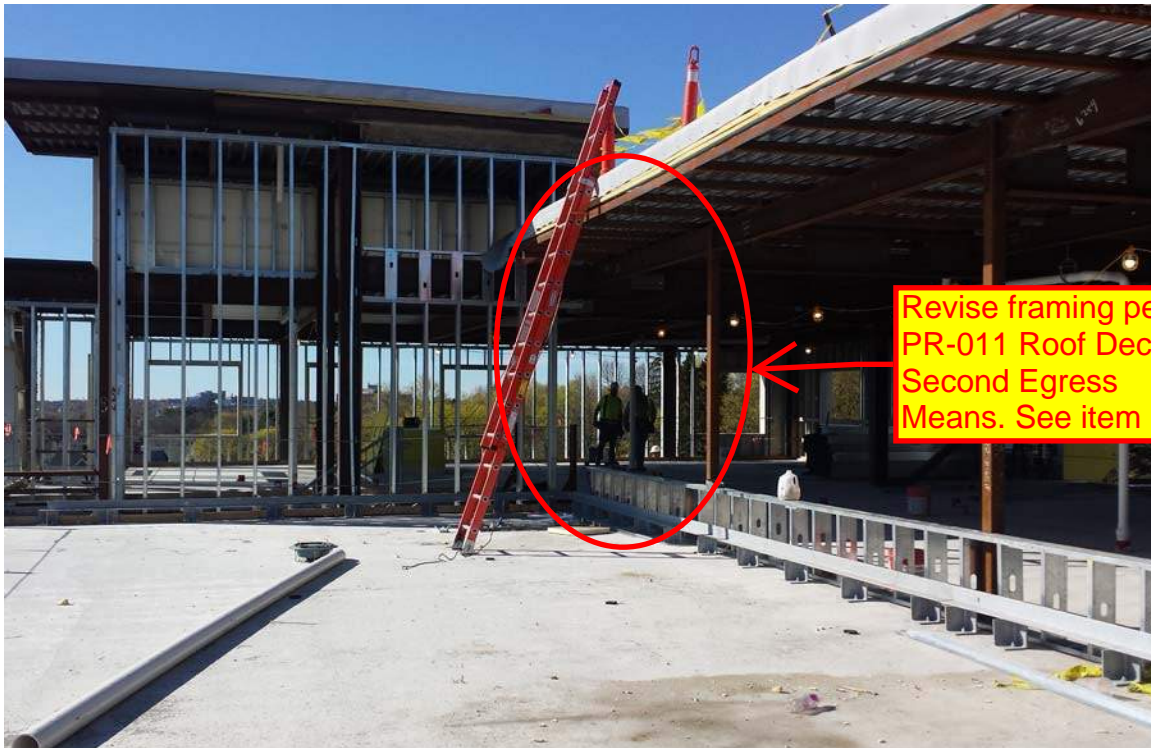
12.6	Correct Roof deck area at grid line F.4 between grid lines 8.5 and 9 to match PR 011 Roof Deck Second Egress Means . See Photo B P17 of 18.	Correct Work

Revise framing per PR-011 Roof Deck Second Egress Means. See item 12.6

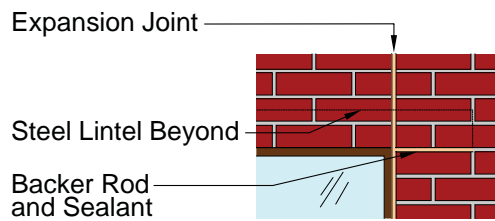
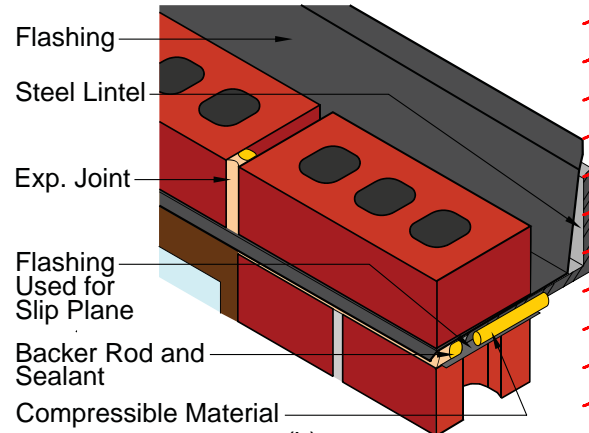
Figure 6**Expansion Joint at Loose Lintel**

If a vertical expansion joint runs alongside an opening spanned by a loose lintel as shown in **Figure 6a**, the loose steel lintel must be allowed to expand independently of the masonry. A slip plane should be formed by placing flashing above and below the angle. Mortar placed in front of the lintel is subject to cracking; thus, a backer rod and sealant should be used, as shown in **Figure 6b**. Because steel expands more than masonry, a $\frac{1}{8}$ to $\frac{1}{4}$ in. (3.2 to 6.4 mm) space should be left at each end of the lintel. These measures form a pocket that allows movement of the steel angle within the brickwork. Locating the expansion joint adjacent to the window will influence the dead weight of the masonry bearing on the lintel. Instead of the usual triangular loading, the full weight of the masonry above the angle should be assumed to bear on the lintel. See *Technical Note 31B* for more information about steel lintel design. If a vertical expansion joint cannot be built in this manner, do not place it alongside the opening.

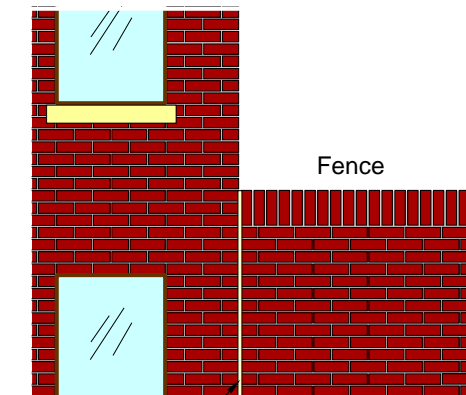
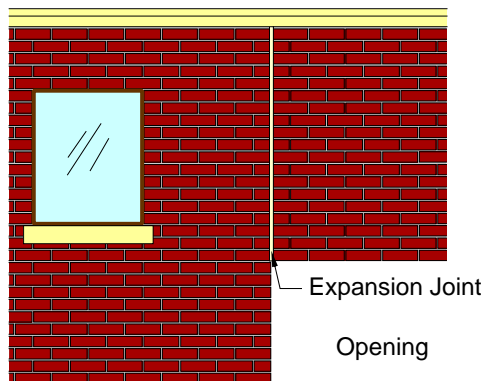
Figure 7**Expansion Joints at Junctions**

Junctions. Expansion joints should be located at junctions of walls with different environmental exposures or support conditions. Separate portions of brickwork exposed to different climatic conditions should be separated with expansion joints since each area will move differently. An exterior wall containing brickwork that extends through glazing into a building’s interior should have an expansion joint separating the exterior brickwork from the interior brickwork. You may need to use expansion joints to separate adjacent walls of different heights to avoid cracking caused by differential movement, particularly when the height difference is very large. Examples are shown in **Figure 7**.
