LAVALLEE BRENSINGER ARCHITECTS

Field Report

The Park Danforth

Portland ME Field Report No: 14

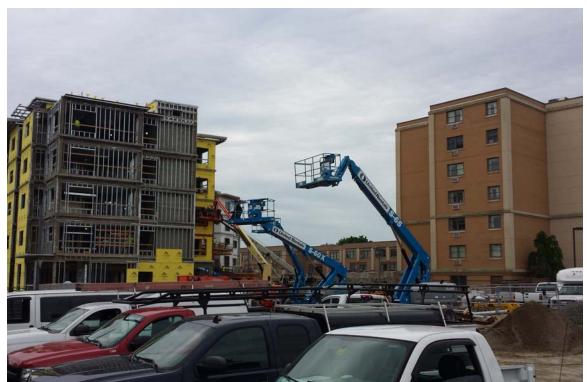
Tower west wing looking southeast

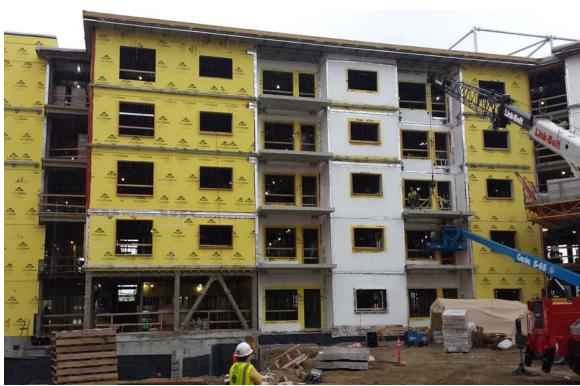
Tower west wing construction courtyard side

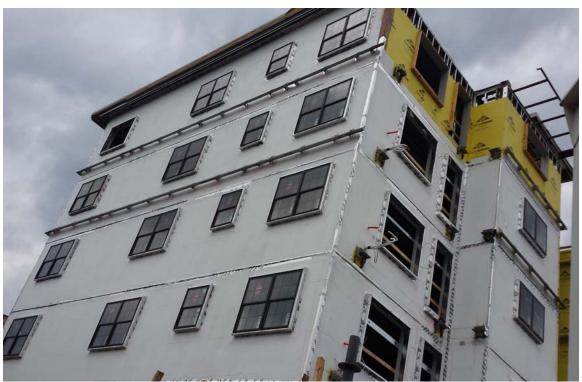
Tower east wing construction

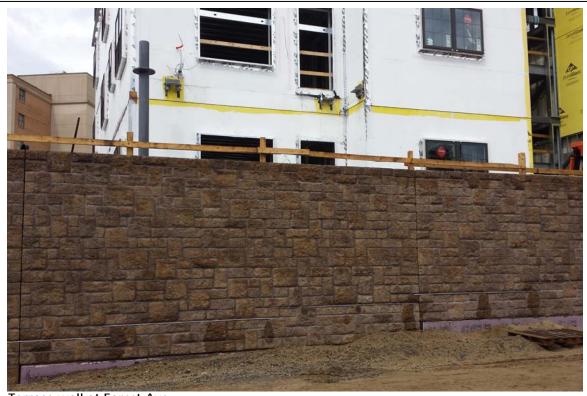
Terrace wall at Forest Ave.

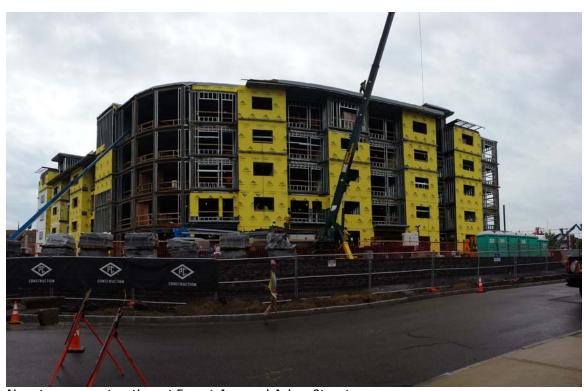
New tower construction at Forest Ave and Arbor Street

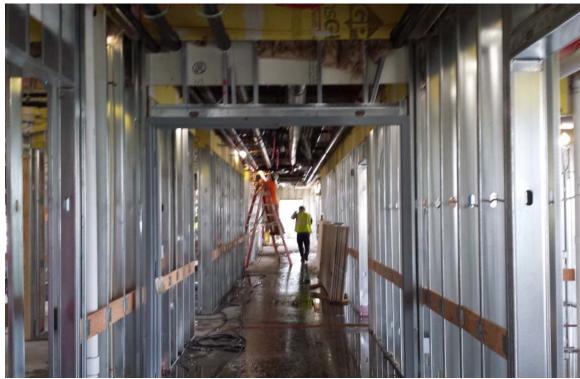
New tower construction, level 1, west wing

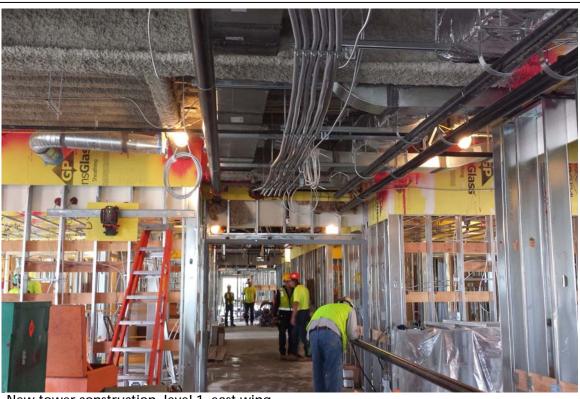
New tower construction, level 1, east wing

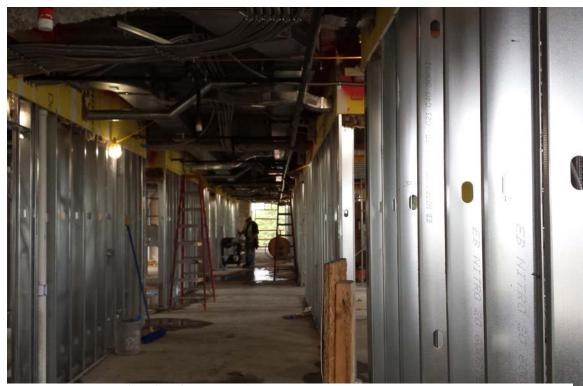
New tower construction, level 3, west wing

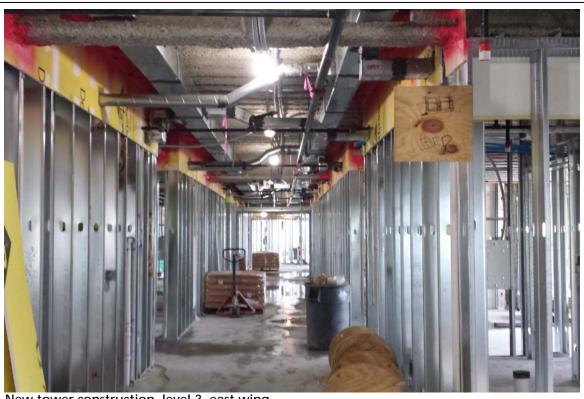
New tower construction, level 3, east wing

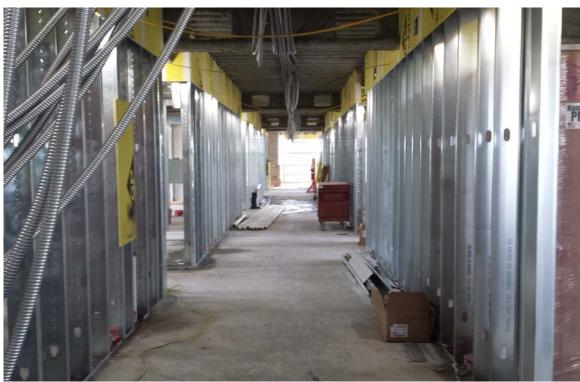
New tower construction, level 4, west wing

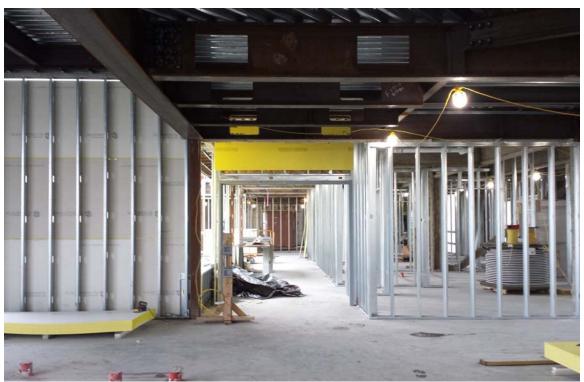
New tower construction, level 5, east wing
