Field Report

The Park Danforth **Project No:** 13-059-00
Portland ME **Field Report No:** 15

To: Mark Donovan **Time of Visit:** 8:00 AM
 PC Construction **Date of Visit:** 6/21/2016
 131 Presumpscot Street **Weather:** Sunny, Warm (75 deg)
 Portland ME

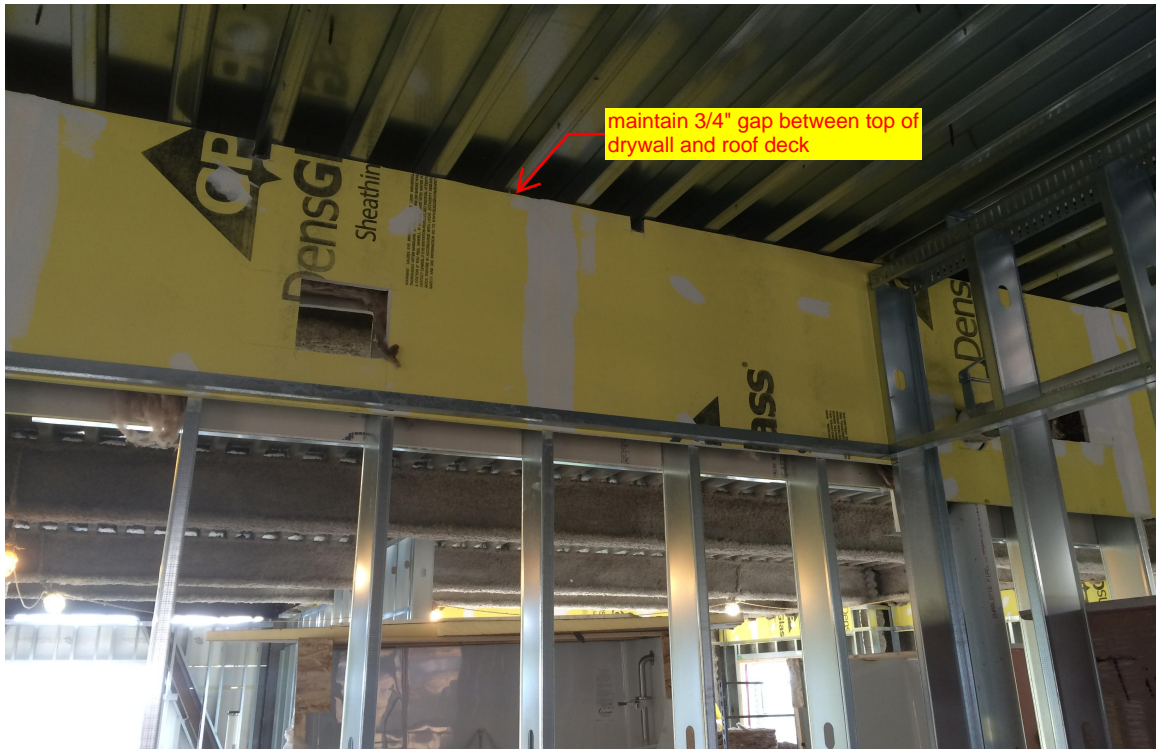
A

Maintain a 3/4" gap between drywall and the underside of structure/deck at all locations, typ. (Reference Photos P5 of 9)

Top of wall detail - Level 5

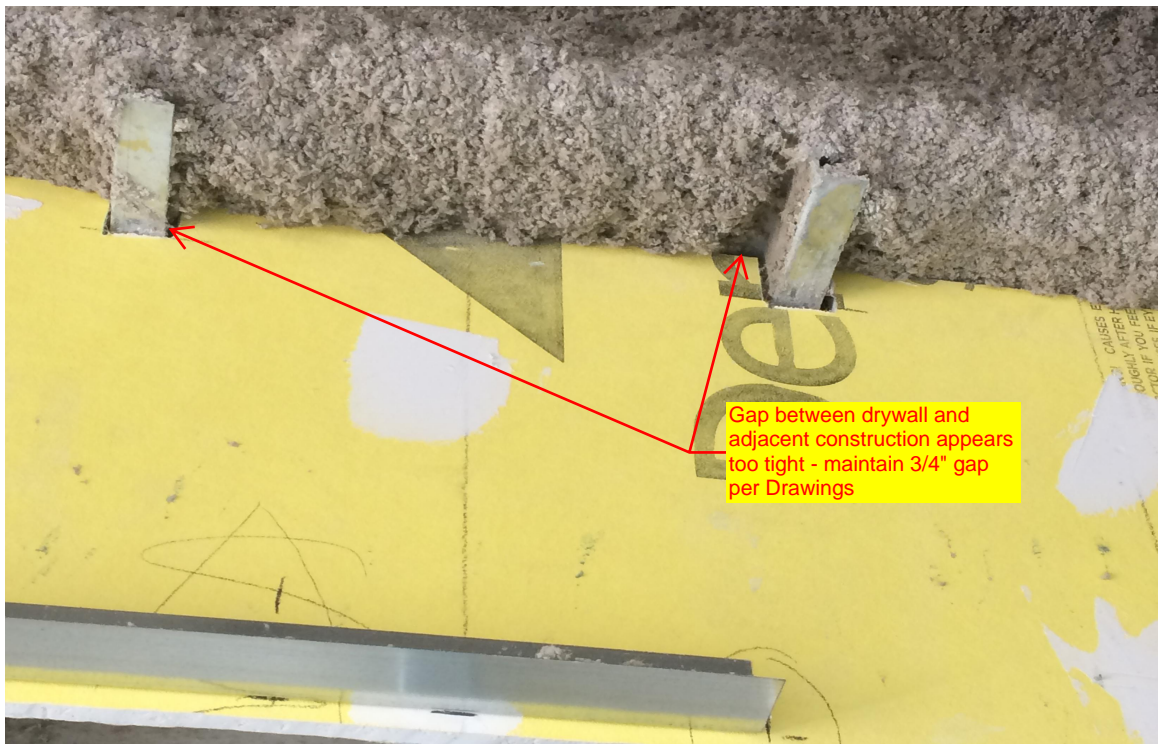
B

Top of wall detail - Level 5

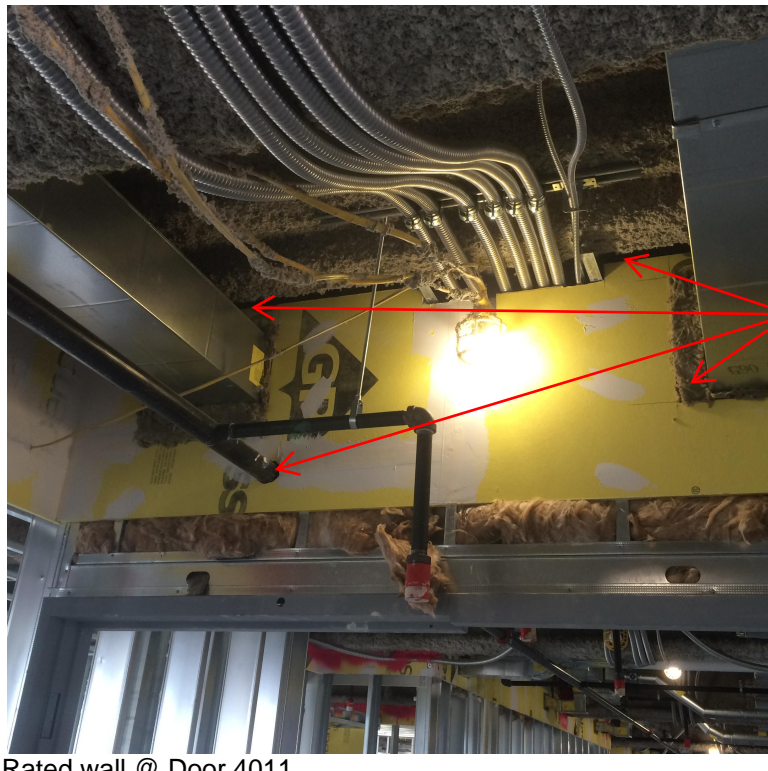
A

Item	Description	Status:
15.4	<u>Firestopping</u> There are a number of areas throughout the building where top of wall firestopping and/or partition penetrations have not been firestopped and subsequent work has been installed that will make firestopping difficult. All tops of rated wall and penetrations thru rated walls must be completely firestopped per their respective UL designs prior to start of ceiling construction. Reference Page P6 of 9 for examples. The horizontal rated drywall that was installed above door entrance 1111 needs to have it's joints and penetrations completely firestopped (no gaps). See Photos on page P9 of 9.	Correct Work

firestopping required at
top of wall and all
penetrations

Rated wall @ Door 4011

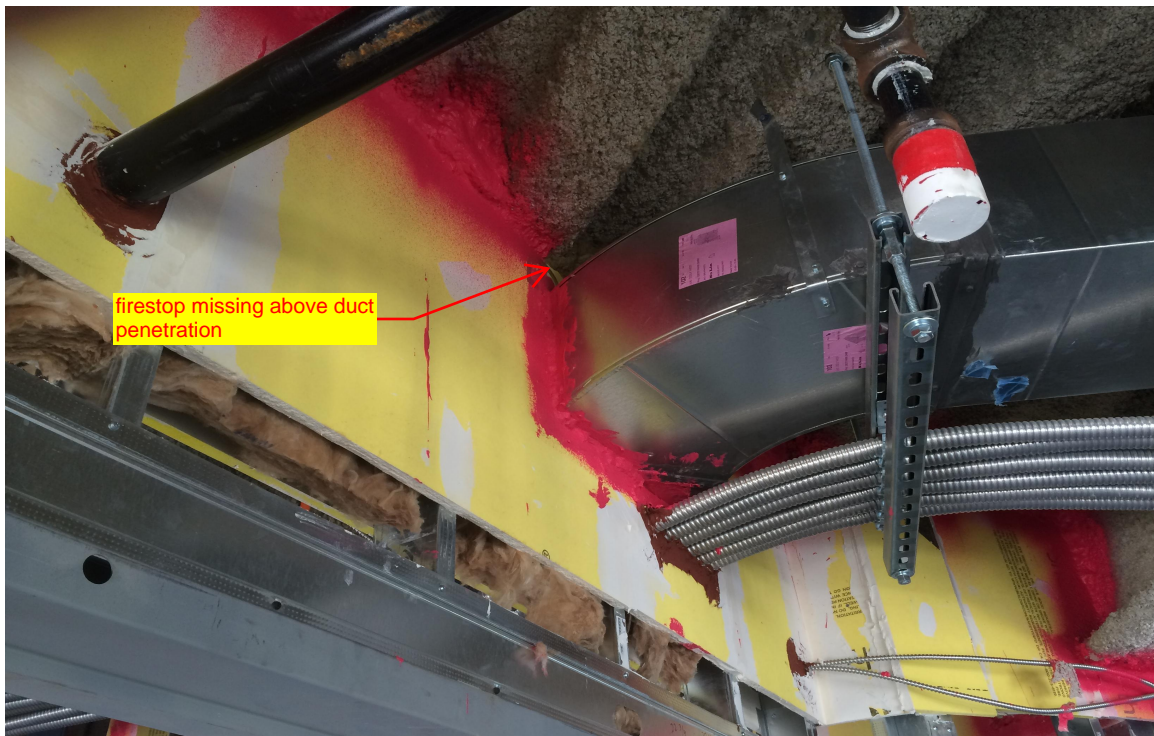
B

firestop missing above duct
penetration

Rated wall @ Door 1010

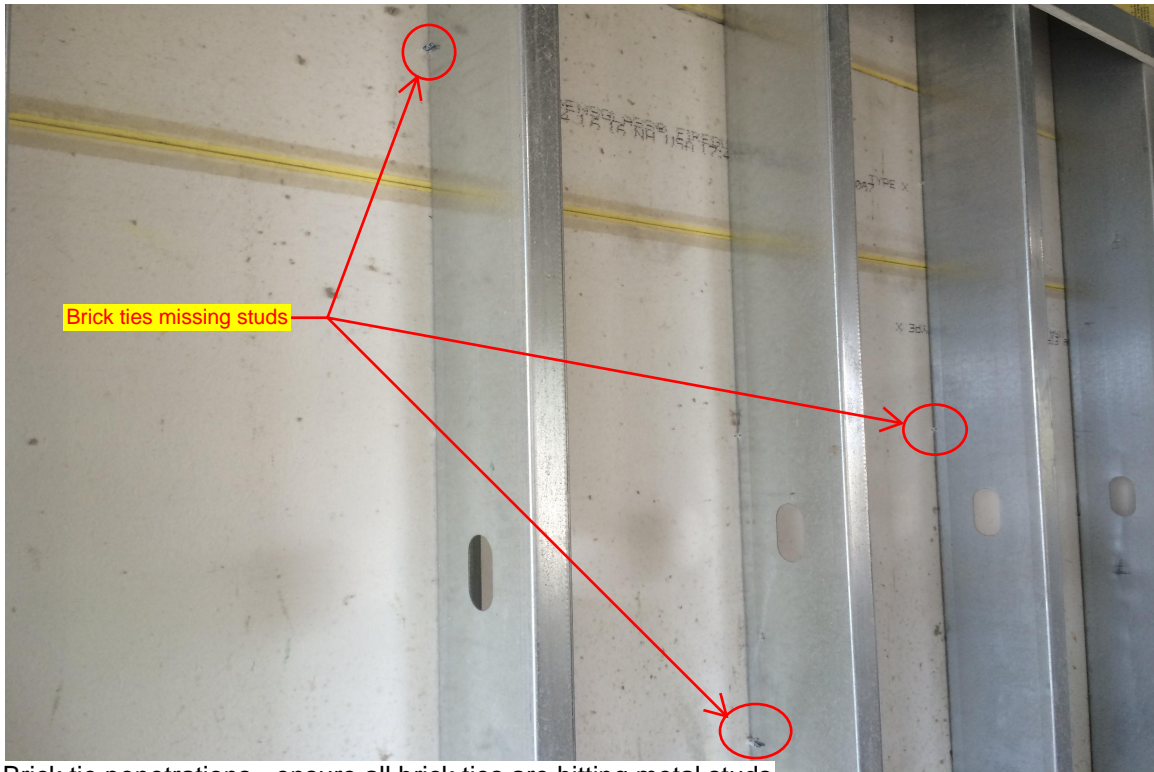
A

Masonry wall anchors must tie back to a metal stud. In locations where a wall anchor misses the stud, remove the tie and repair the weather barrier per 04 20 00-3.12.E.1. Reference Photos on P7 of 9

Brick tie penetrations - ensure all brick ties are hitting metal studs

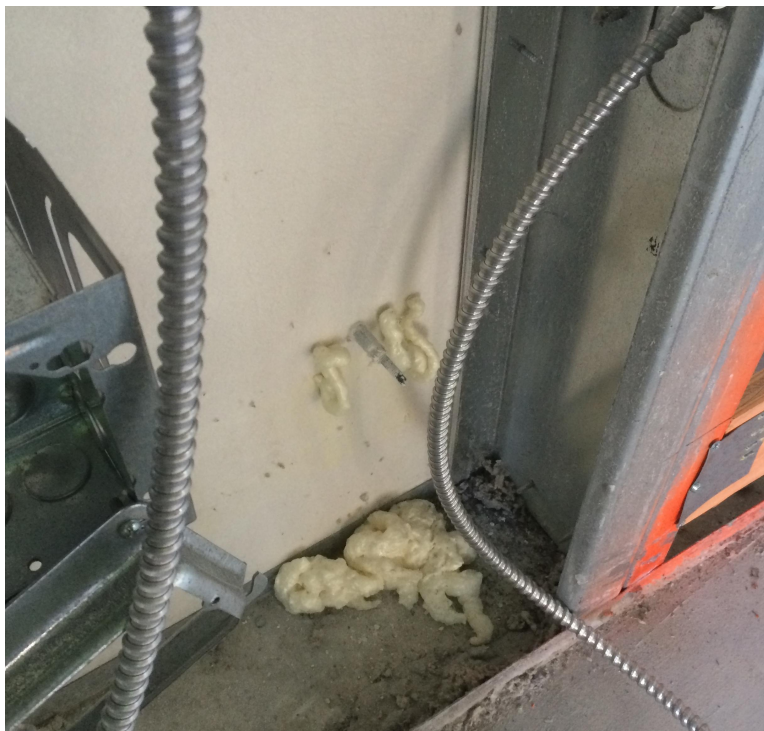
B

Brick tie penetrations @ Unit 1309 - Remove all brick ties that miss the stud and repair the A/V barrier per the Project Specifications

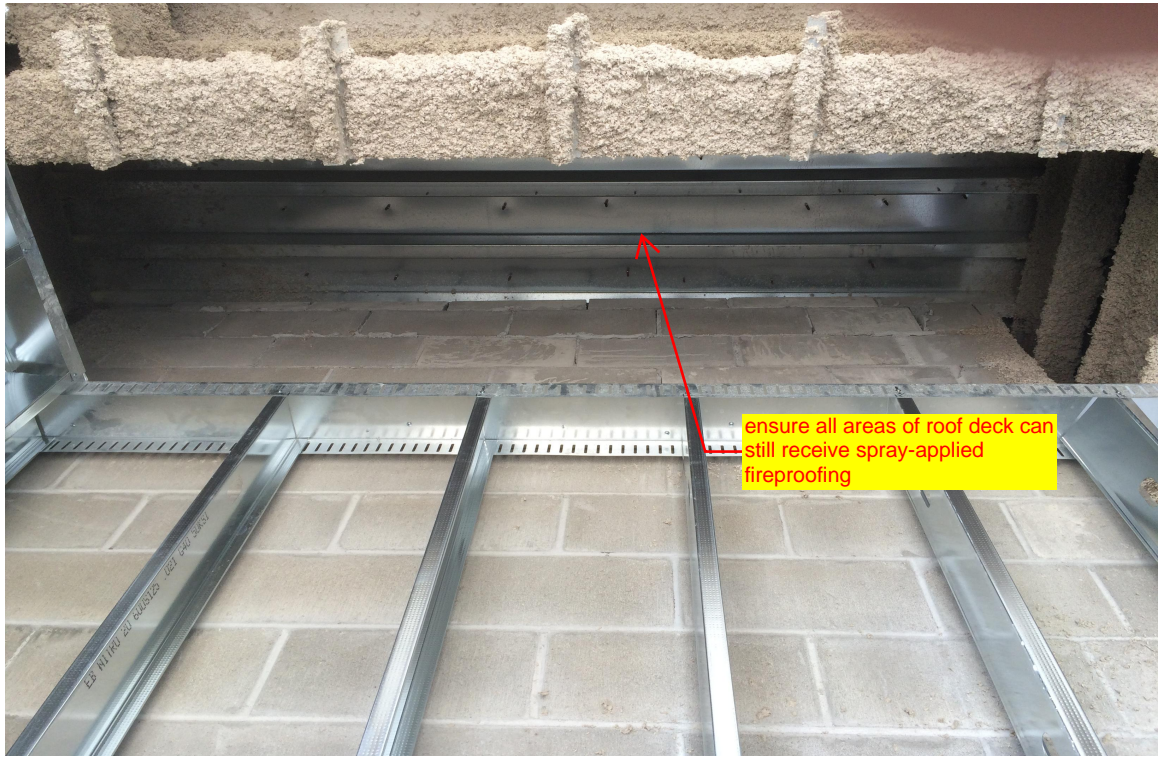
15.5	<u>Spray Fireproofing</u> Touch up areas of spray fireproofing where it has been removed by installation of subsequent work prior to closing up the ceilings. Reference Photo B page P8 of 9. All areas of roof deck and structure around the elevator shaft B shall be fully spray-fireproofed. Reference Photo A page P8 of 9.	Correct Work

Elevator B top of shaft

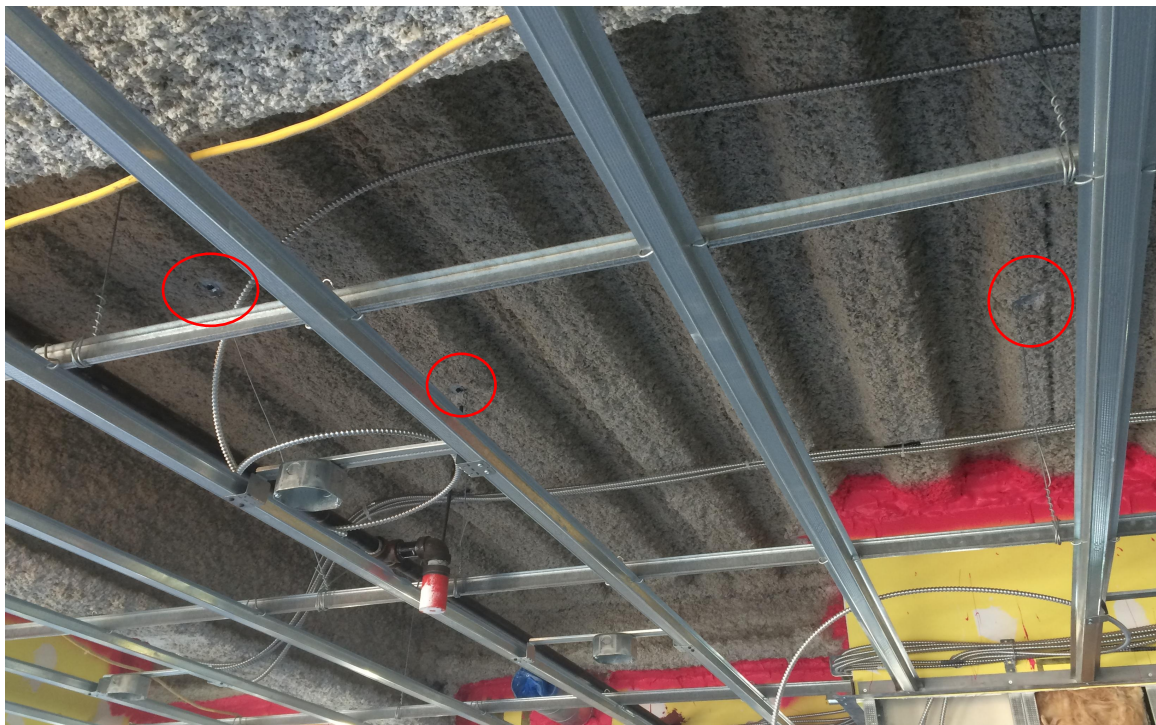
B

Touch up areas of spray fireproofing that have been removed for installation of new work prior to closing up the ceilings

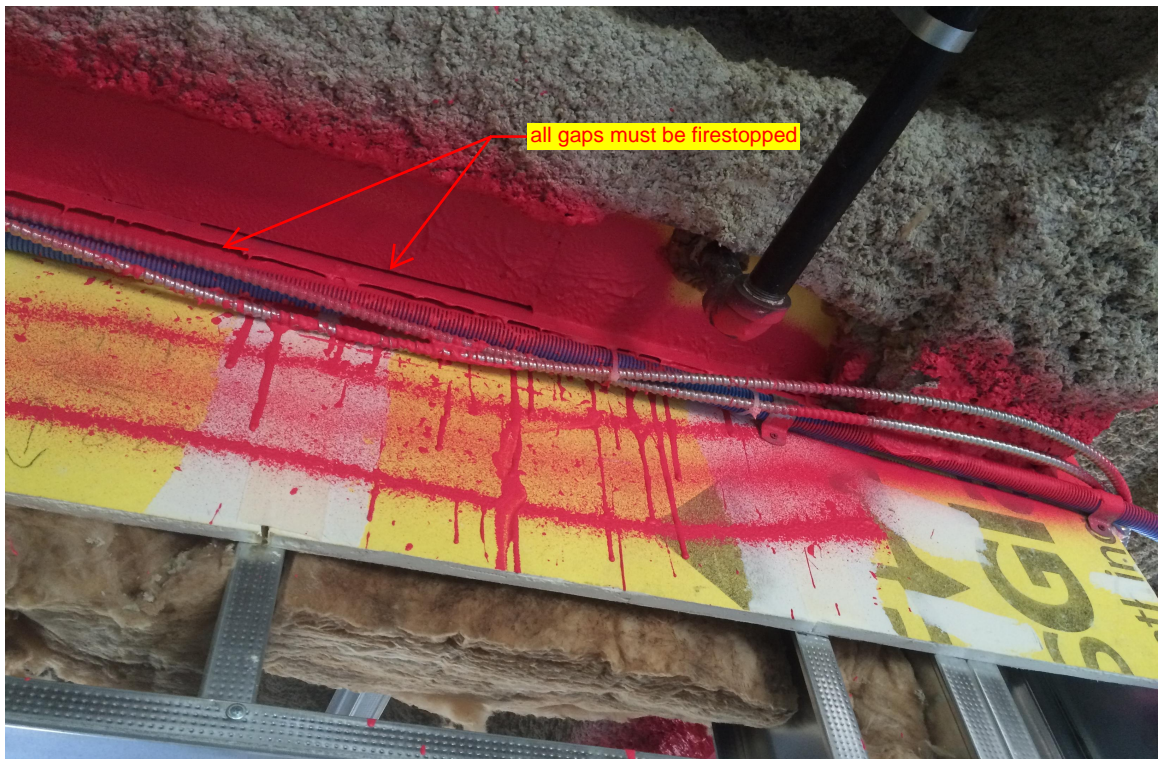
A

Top of wall detail above door 1111

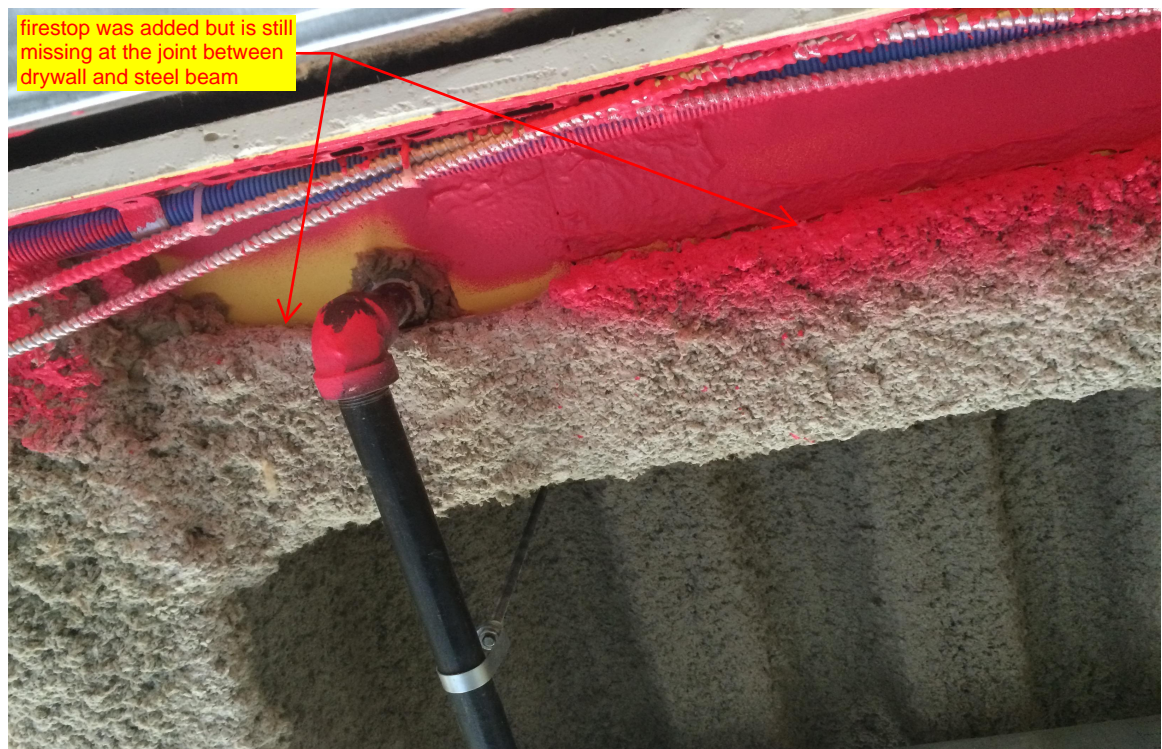
B

Top of wall detail above door 1111
