Field Report

The Park Danforth **Project No:** 13-059-00
Portland ME **Field Report No:** 16

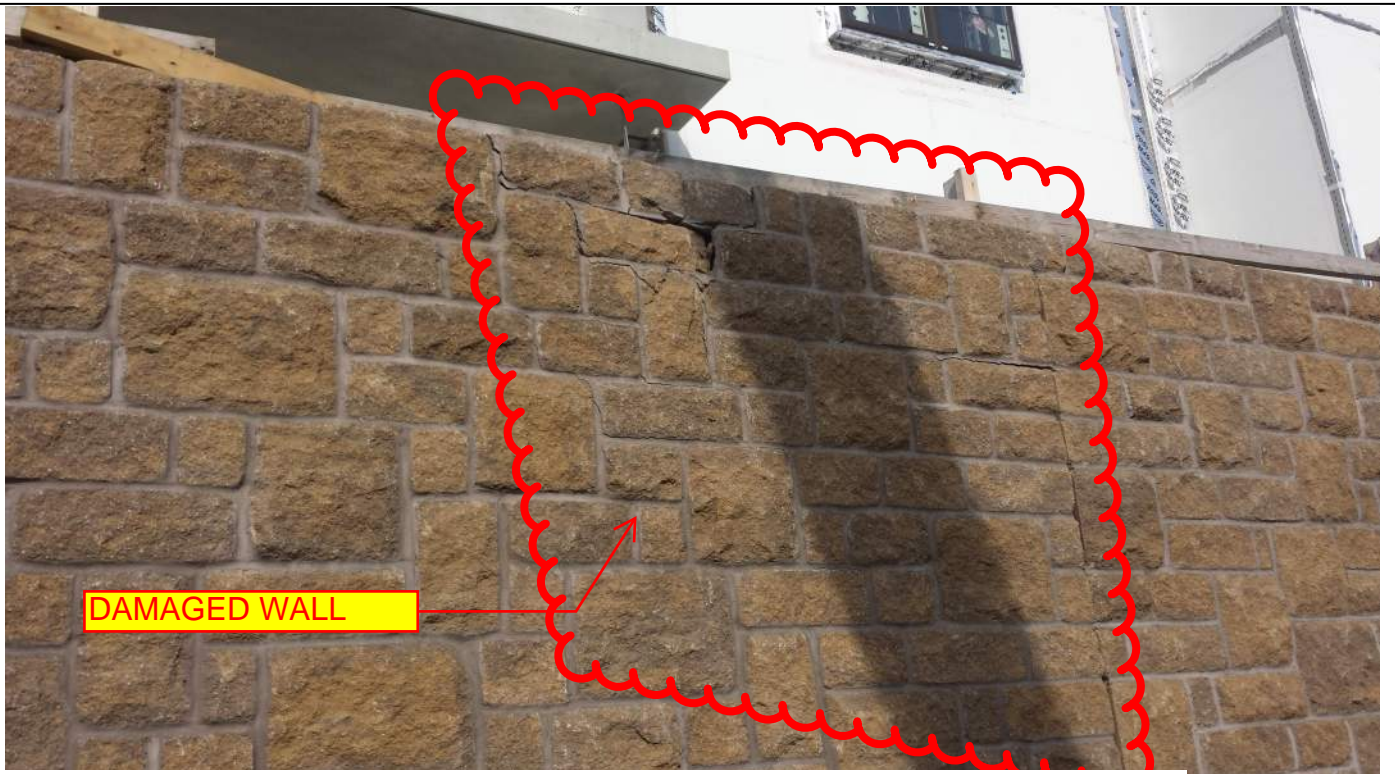
16.2	<p><u>FOREST AVE MASONRY TERRACE WALL</u></p> <p>The stone masonry work on the terrace wall outside of unit 1113 (roughly between grid lines 10.5 and 11) has been damaged. Reference photo B on P3 of 17</p>	<div style="border: 1px solid black; padding: 5px; width: fit-content; margin: auto;">Correct Work</div>

FOREST AVE. TERRACE WALL

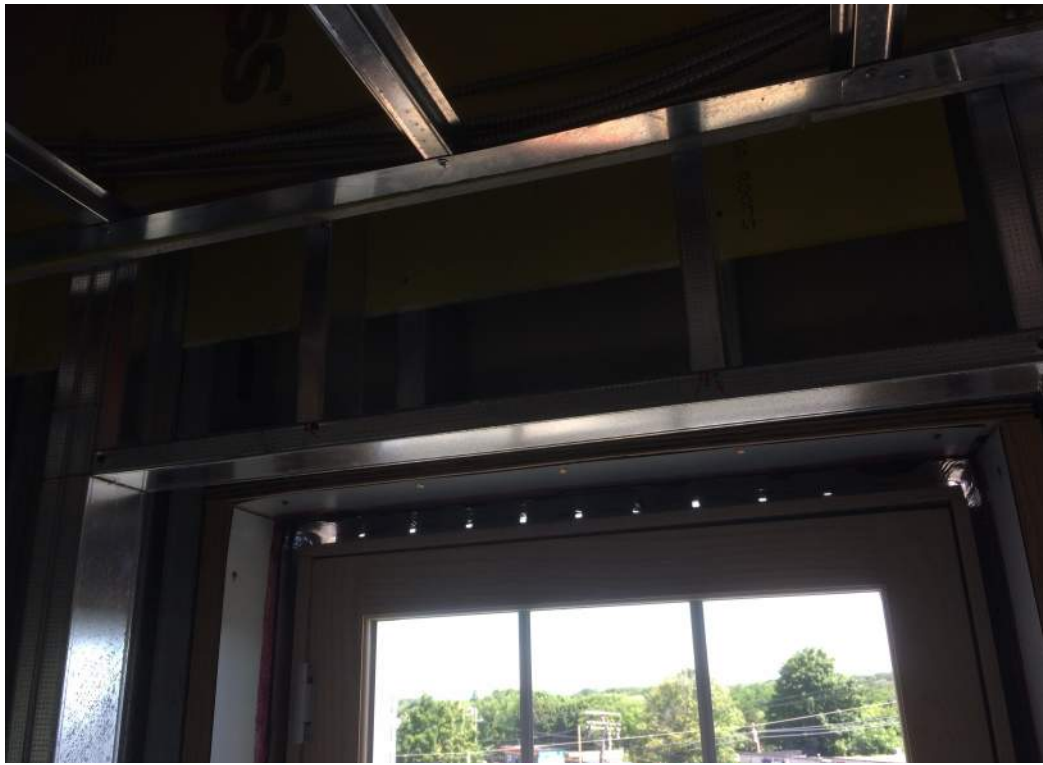
16.4	There are a number of locations throughout the building where 3/4" plywood is being used as head blocking at exterior doors and windows, and the head nailing flange does not properly engage the wood blocking. In these cases, remove the plywood blocking, provide the specified 2X frt wood blocking and re-detail the flashings as per the Drawings. Reference Photo A P16 of 17	Correct Work

EXTERIOR DOOR INSTALLATION, SEE NOTE 16.4

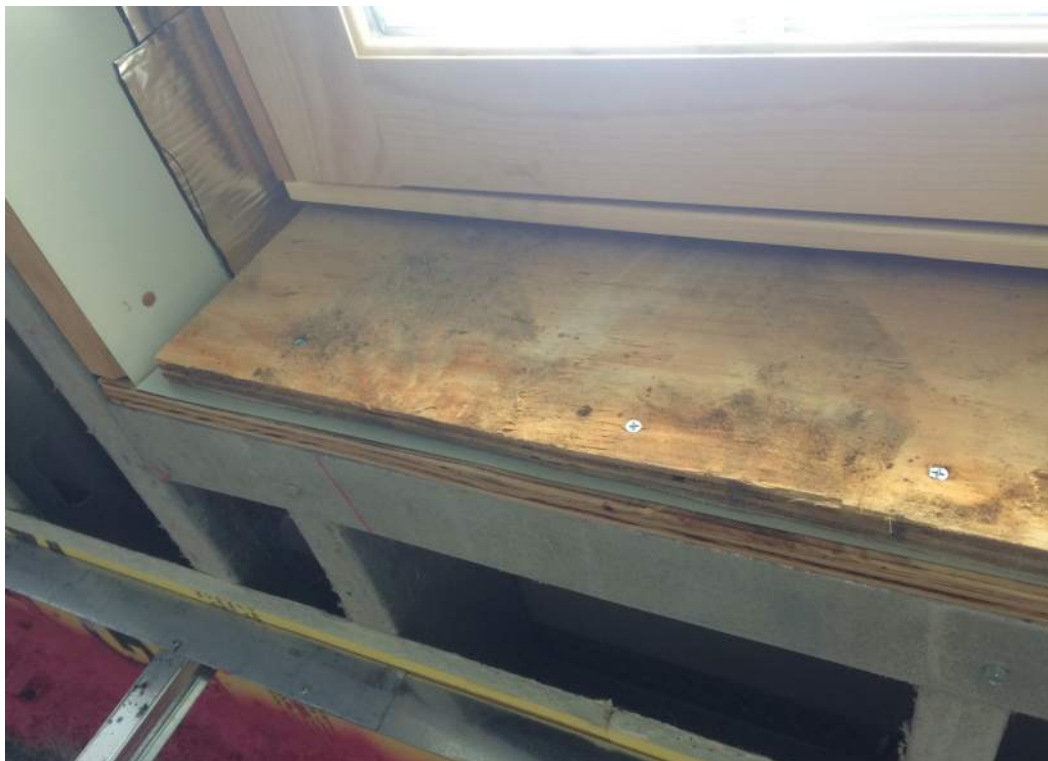
B

16.5	All exterior window and door flashings shall be installed in relationship to the wood blocking as per the Drawings. Remove double layers of plywood blocking and replace with 2x frt solid wood blocking and redetail the flashings. Reference Photo	Correct Work

EXTERIOR WINDOW INSTALLATION, SEE NOTE 16.5

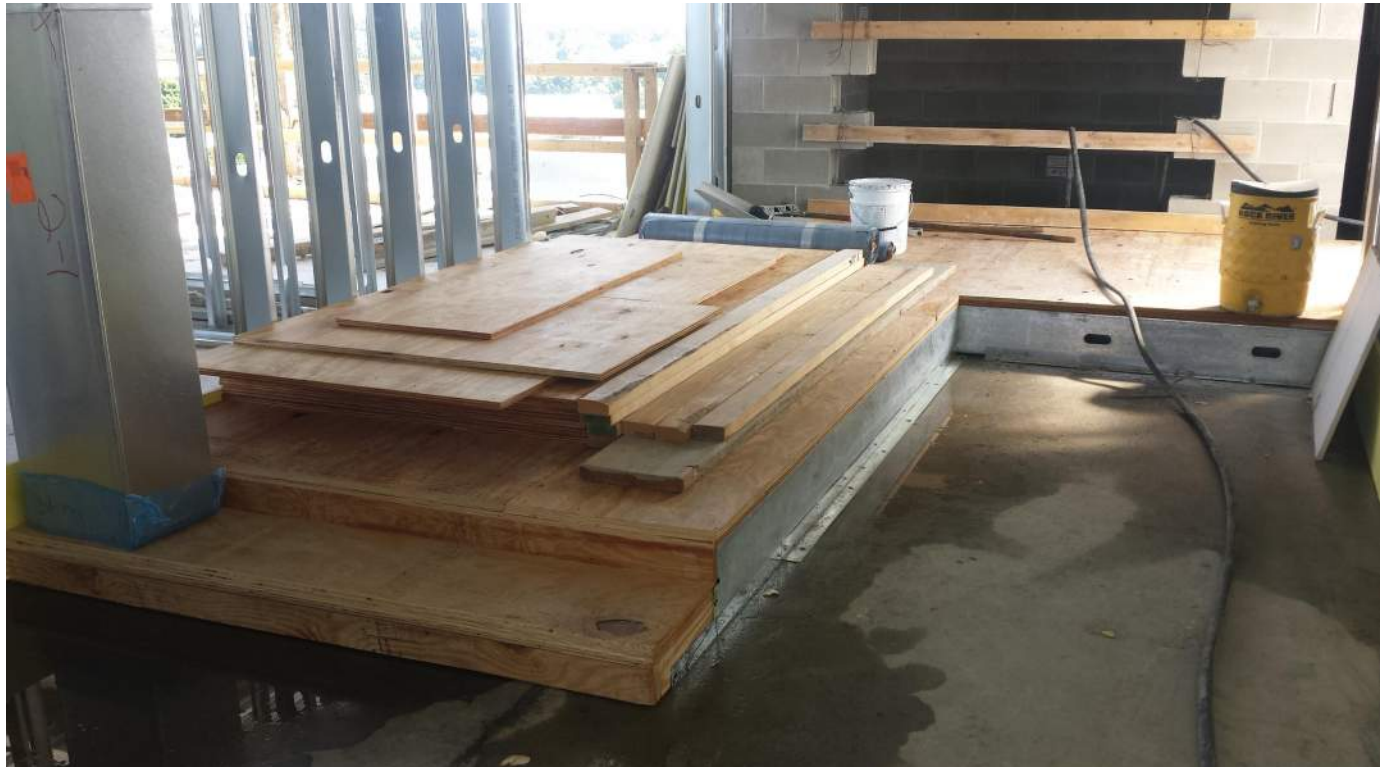
16.6	Observed standing water on Level 5 near exterior openings. Protect all in-place work from water infiltration. See photos A and B on P17 of 17	Observation

LEVEL 5 ELEVATOR LOBBY 5003

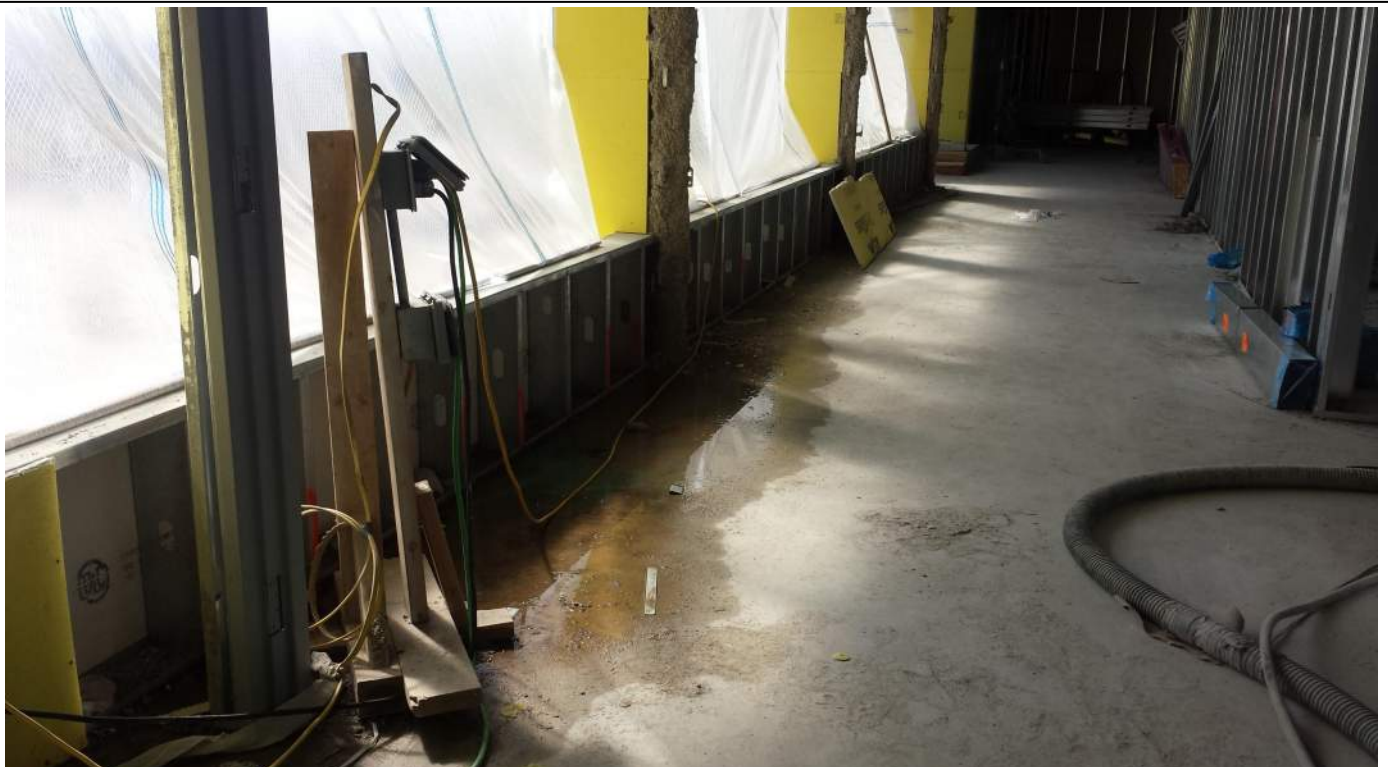
B

LEVEL 5 CORRIDOR 5011
