Field Report

The Park Danforth **Project No:** 13-059-00
Portland ME **Field Report No:** 17

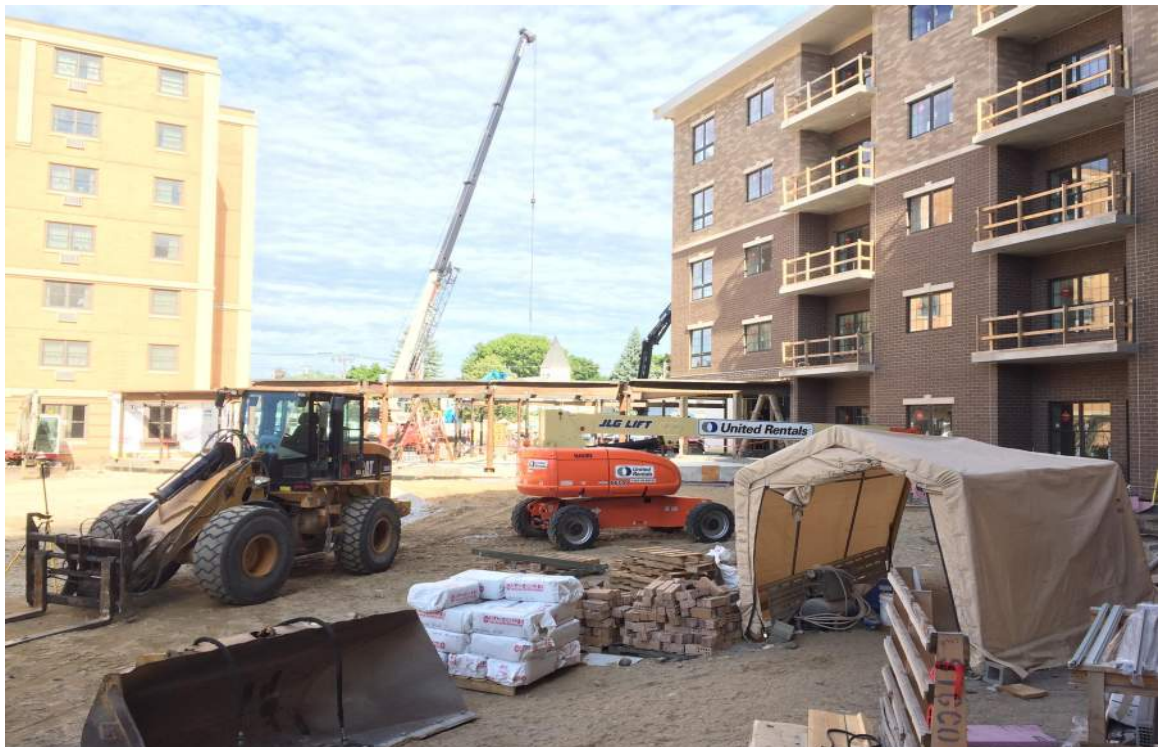
A

Courtyard looking toward connector

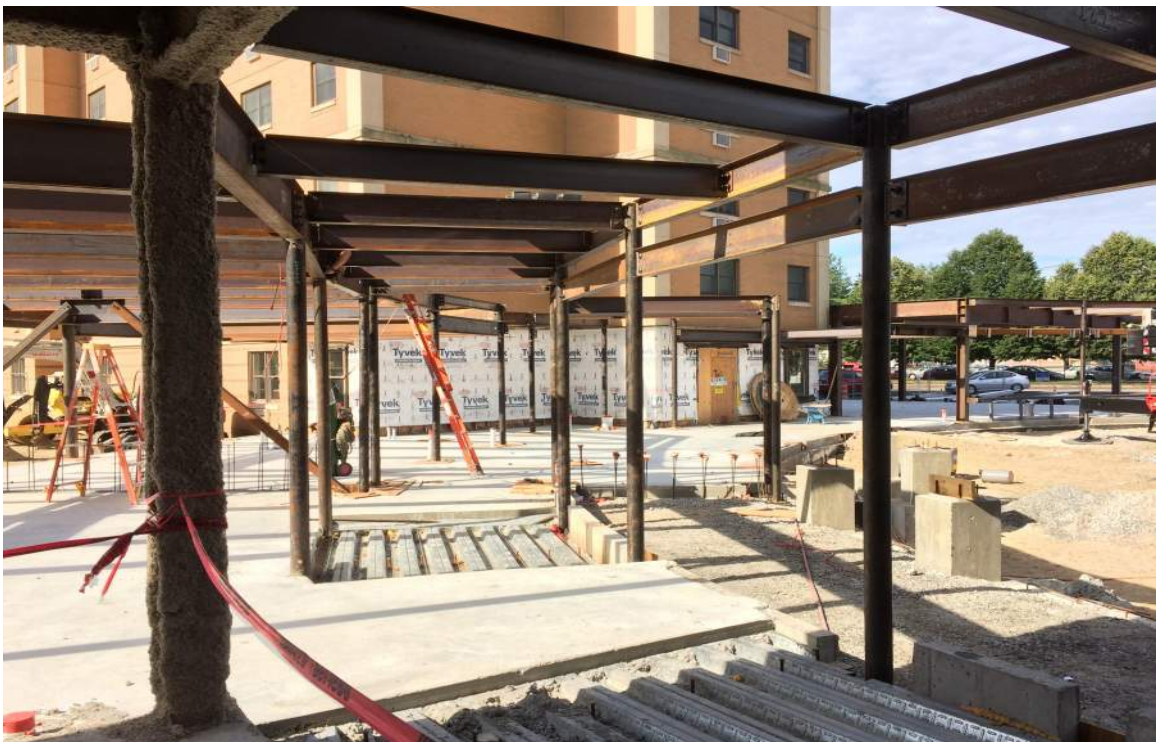
B

Connector framing from Board Room

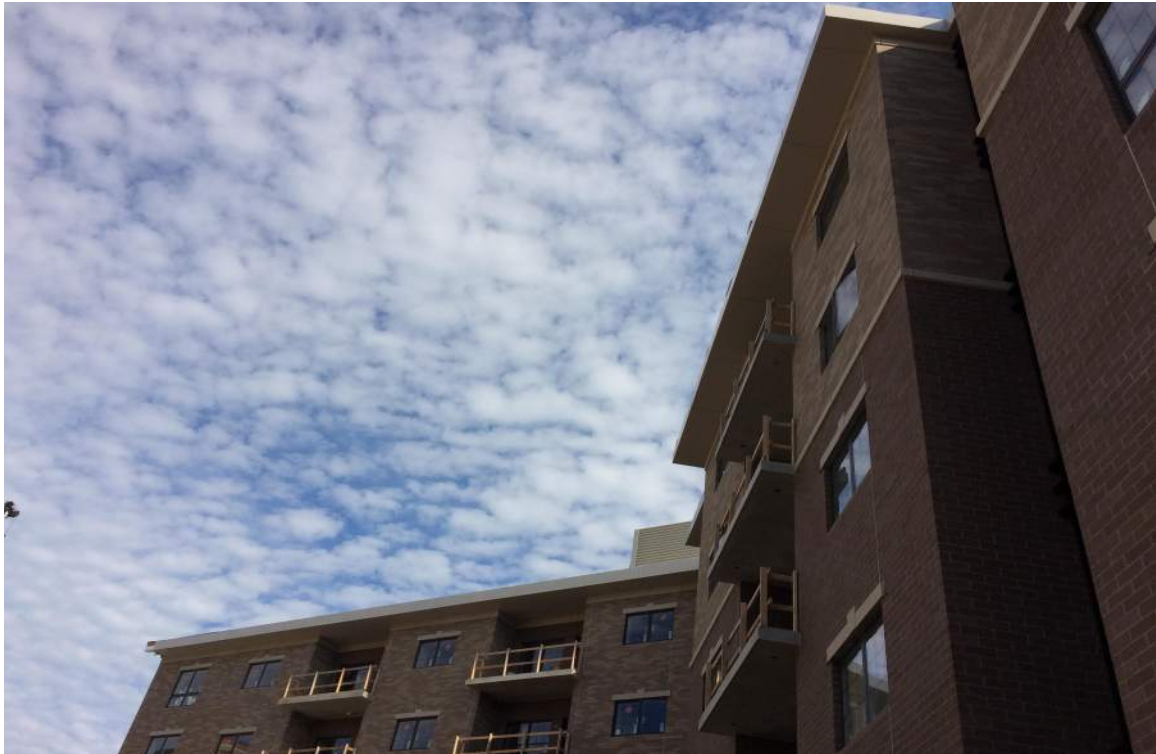
A

Aluminum roof soffit panels

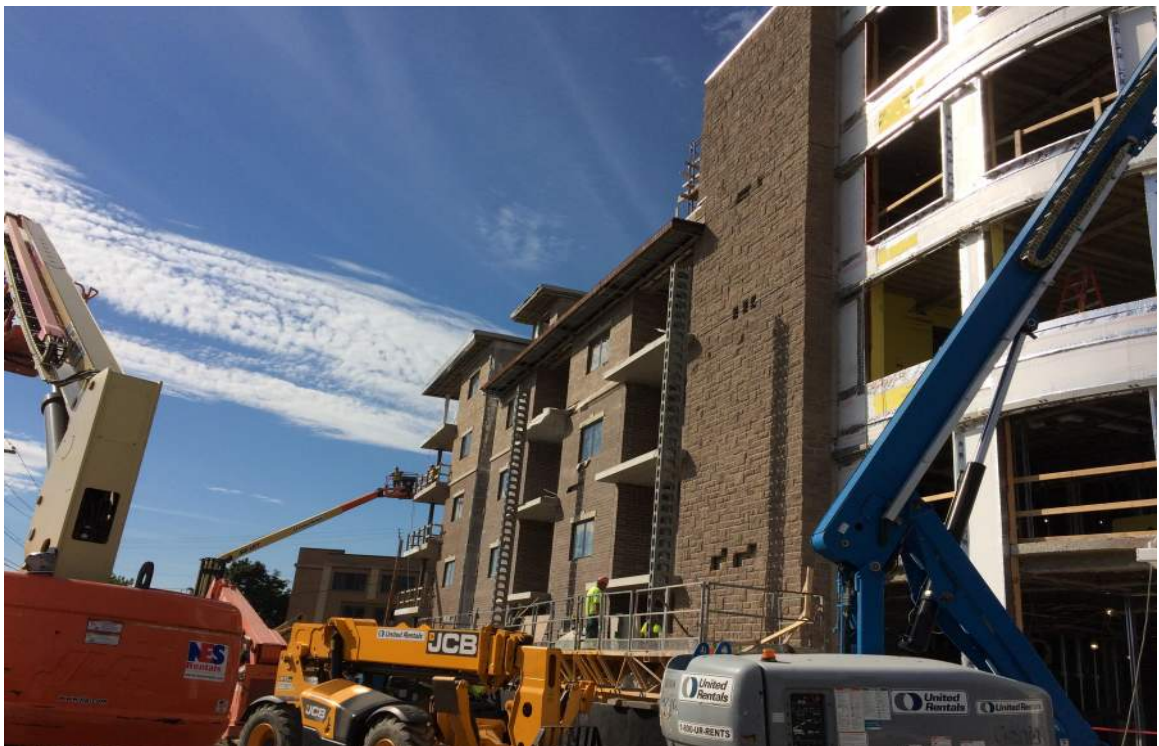
B

Forest Ave elevation

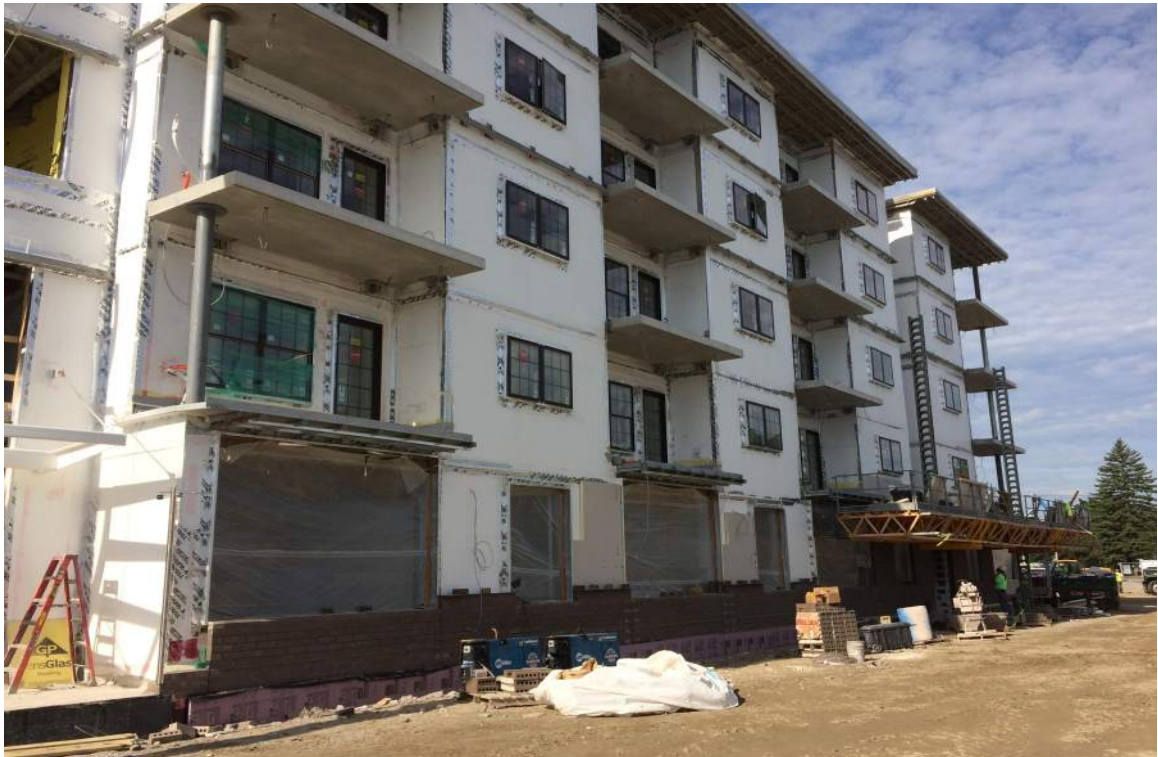
A

Arbor Street Elevation

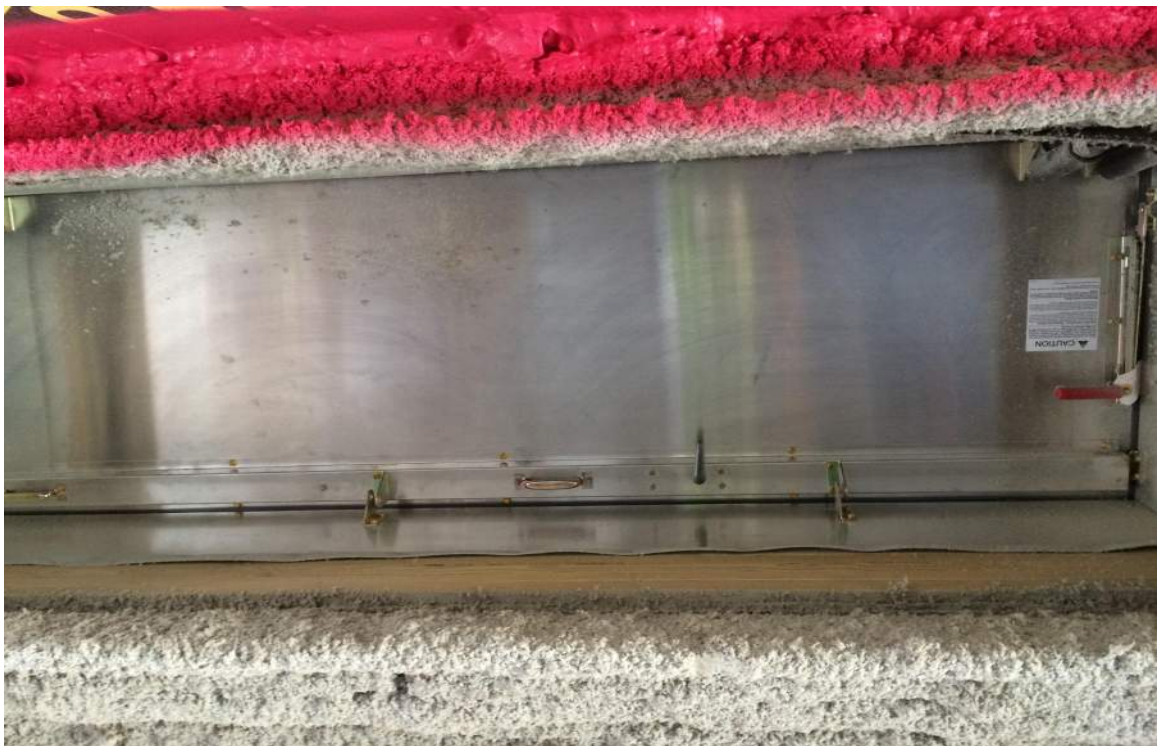
B

17.2	Level 5 Roof Hatch Confirm hatch is installed in the proper configuration that will allow access to the hatch handles from the alternating tread device. See Photo 9B.	CM follow up
-------------	--	--------------

Roof Hatch - East wing - See Item #17.2

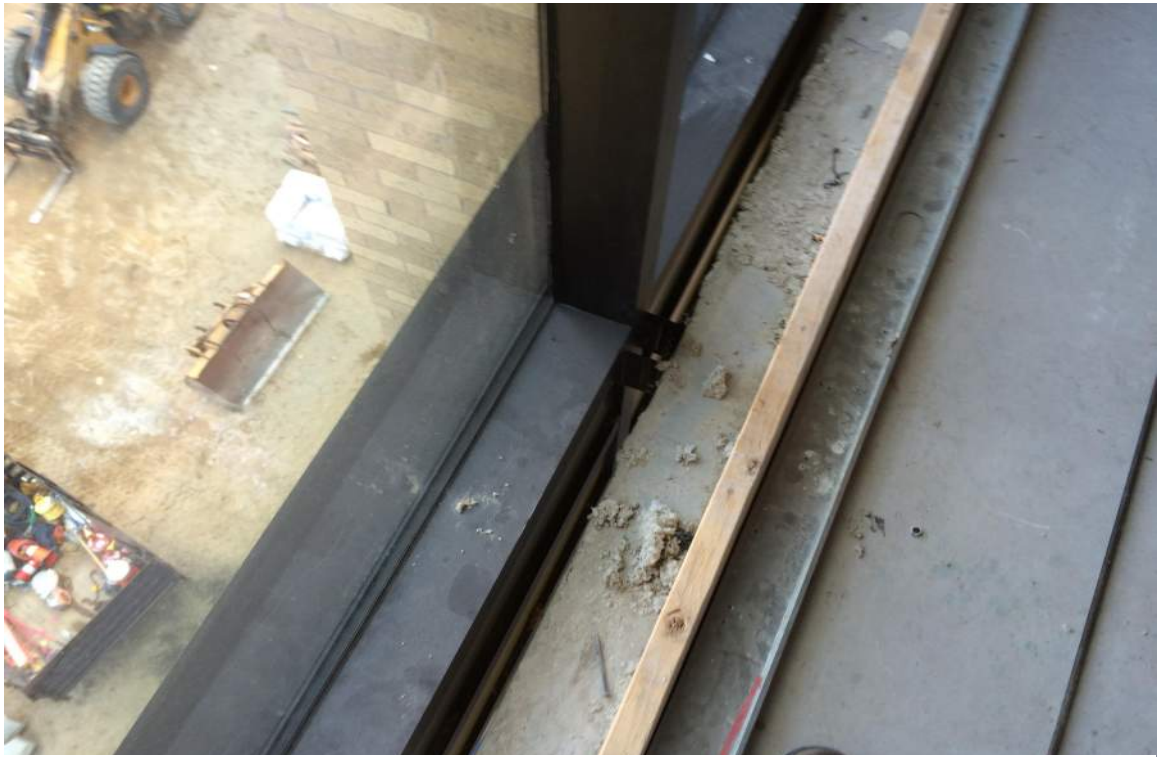
A

17.3	Curtainwall Joint at Floor Perimeter firestopping detail at curtainwall and floor joint still needs to be installed. Reference Photo 10A.	Observation
-------------	---	-------------

Typical Joint between curtainwall and floor; See Item #17.3
