Field Report

The Park Danforth **Project No:** 13-059-00
Portland ME **Field Report No:** 18

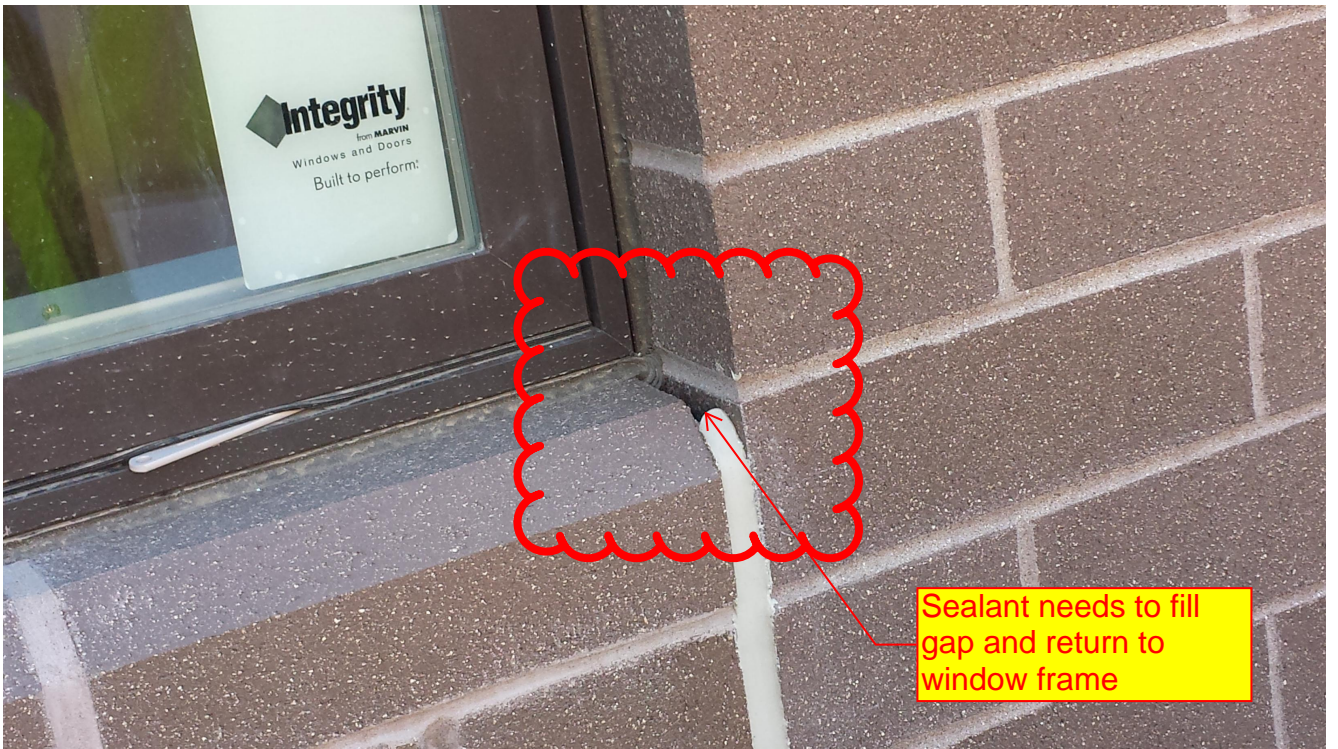
Item	Description	Status:
18.02	Verify installed finish flooring remains properly protected. See image B P18 of 19	CM follow up
18.03	Sealant should return to window frame and not leave a gap. See image A P 17 of 19	Correct Work
18.04	Deficiencies in mortar are visible. Correct work per specification section 04 20 00-3.01. See image B P17 of 19	Correct Work
18.05	Repair and/or replace any damaged casework. See image a P 18 of 19	Correct Work
18.06	Precast concrete balcony patch does not match samples previously submitted. See image A P19 of 19	Correct Work
18.07	At locations where the exterior brick intersects a precast balcony, add another brick course and seal gap to balcony. See image A P19 of 19	Correct Work

Reference item 18.03

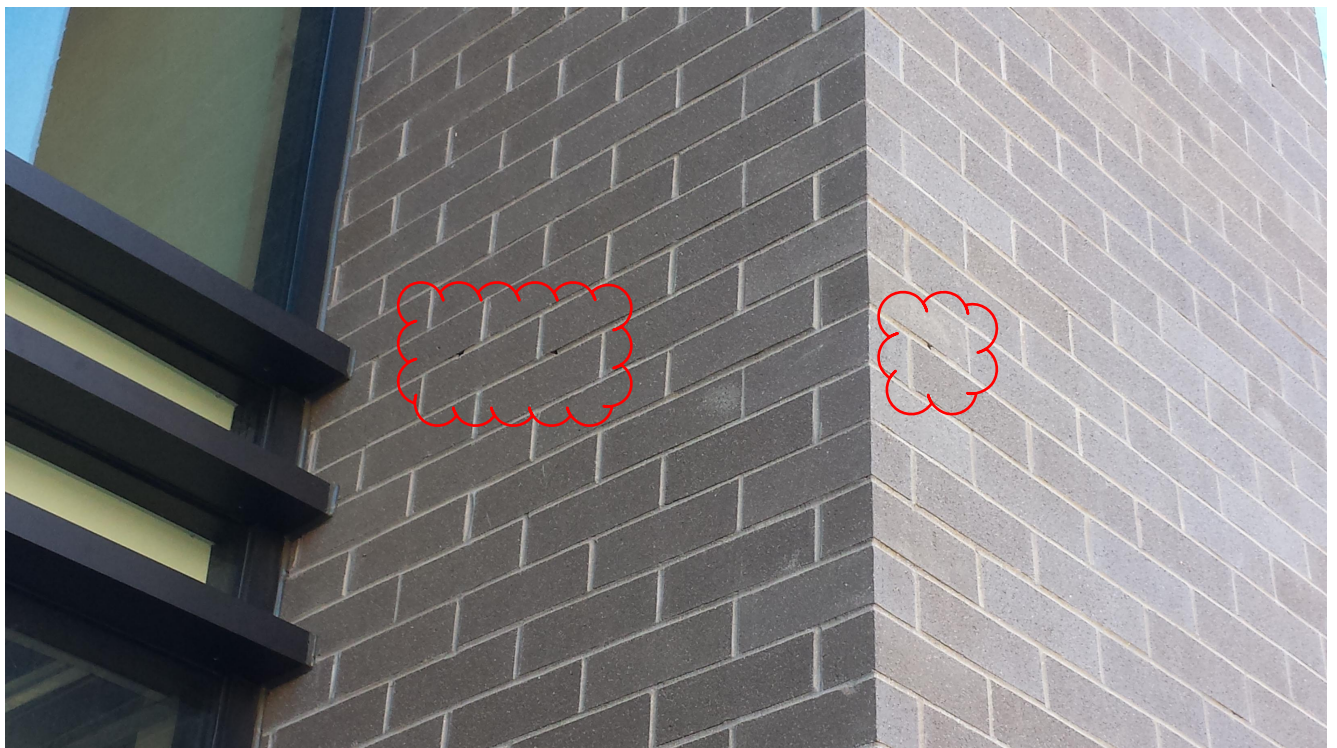
B

Reference item 18.04

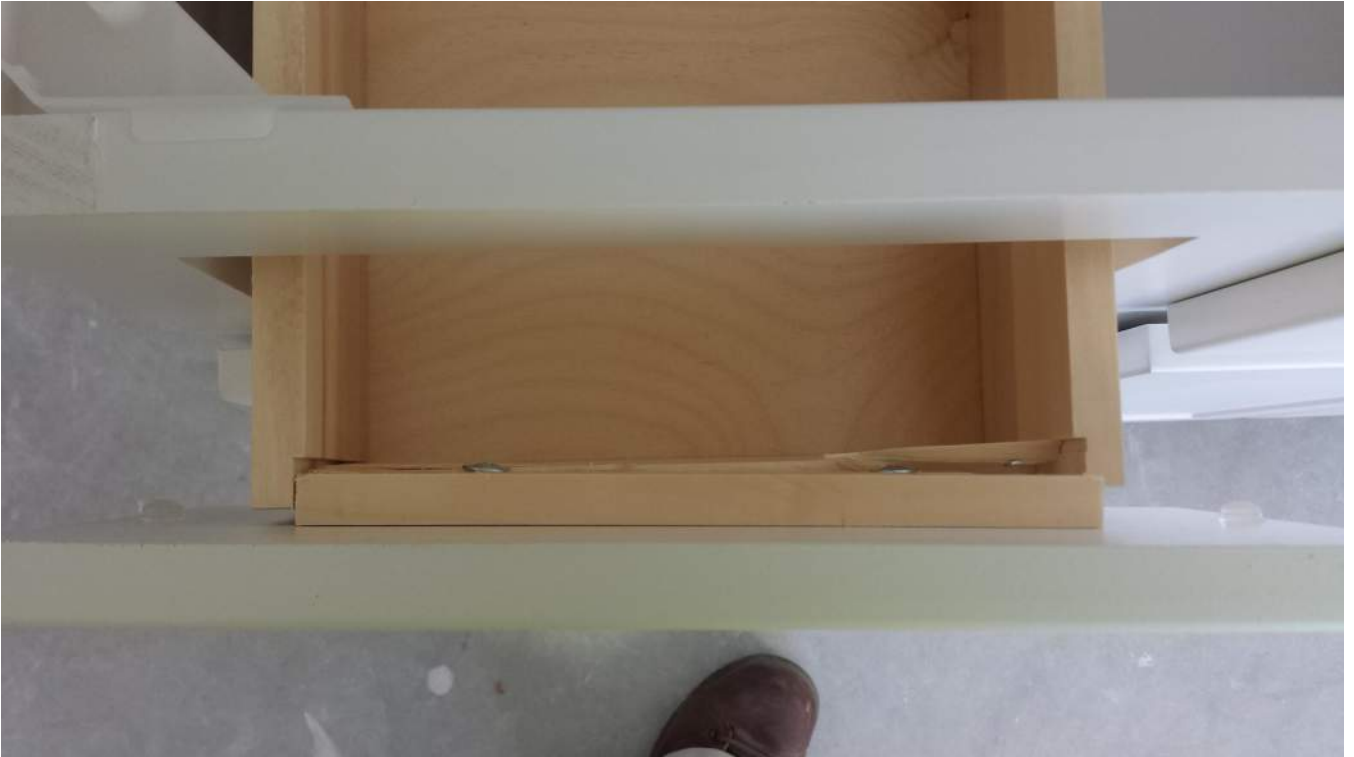
A

Reference item 18.05

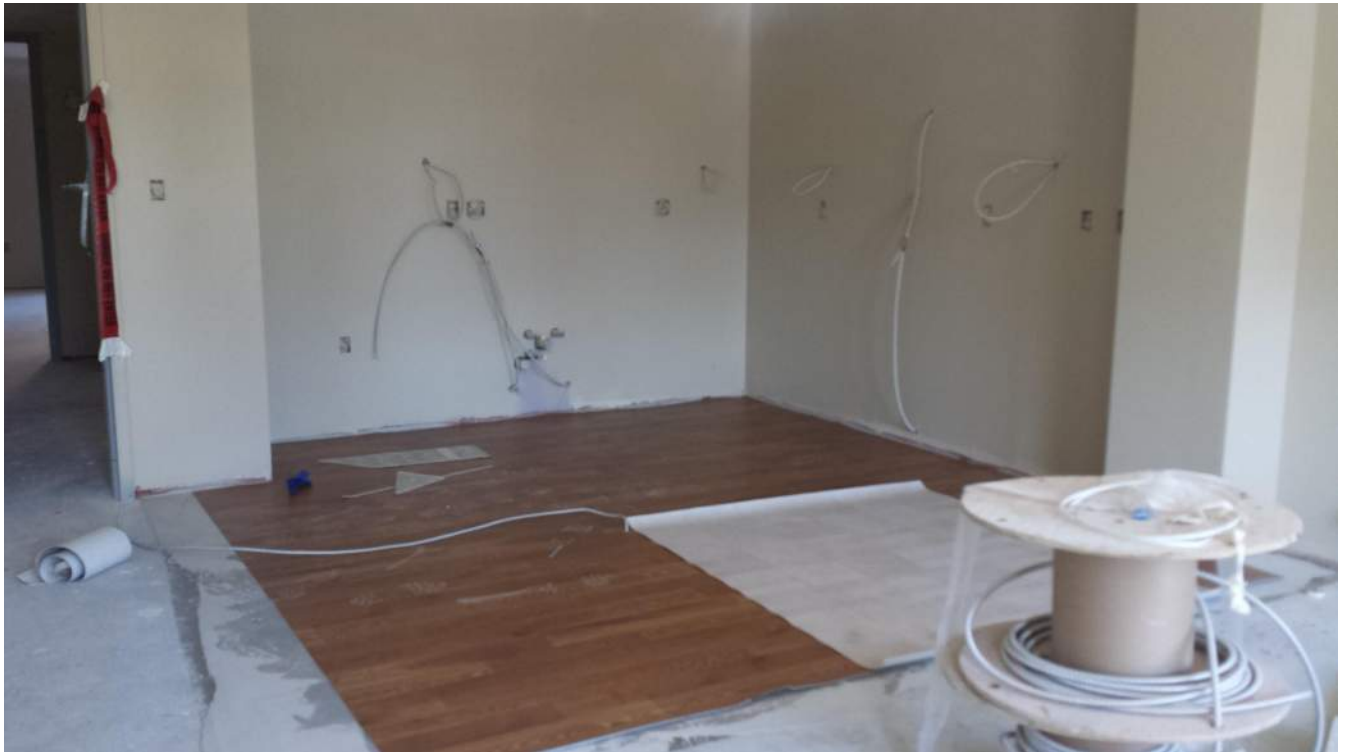
B

Reference item 18.02
