# Field Report

**The Park Danforth** **Project No:** 13-059-00  
**Portland ME** **Field Report No:** 19

**To:** Mark Donovan **Time of Visit:** 12:30 PM  
 PC Construction **Date of Visit:** 10/4/2016  
 131 Presumpscot Street **Weather:** Sunny, Mild  
 Portland ME

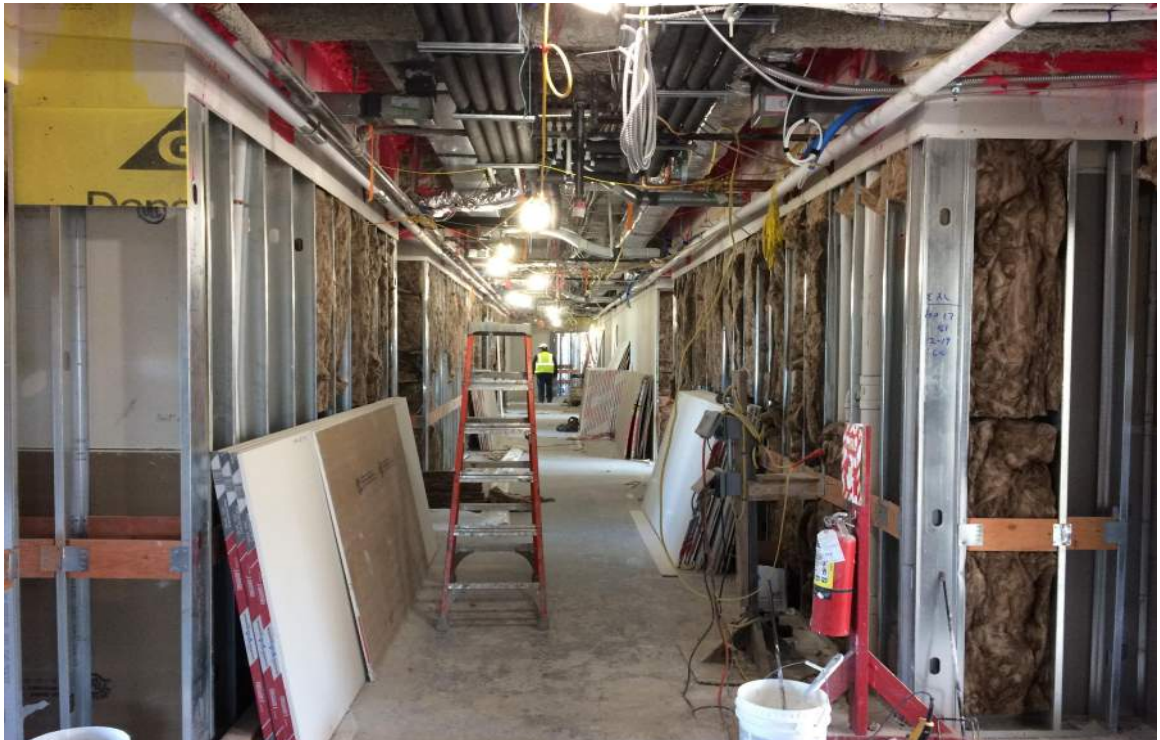
**A**

Level 5 corridor looking East

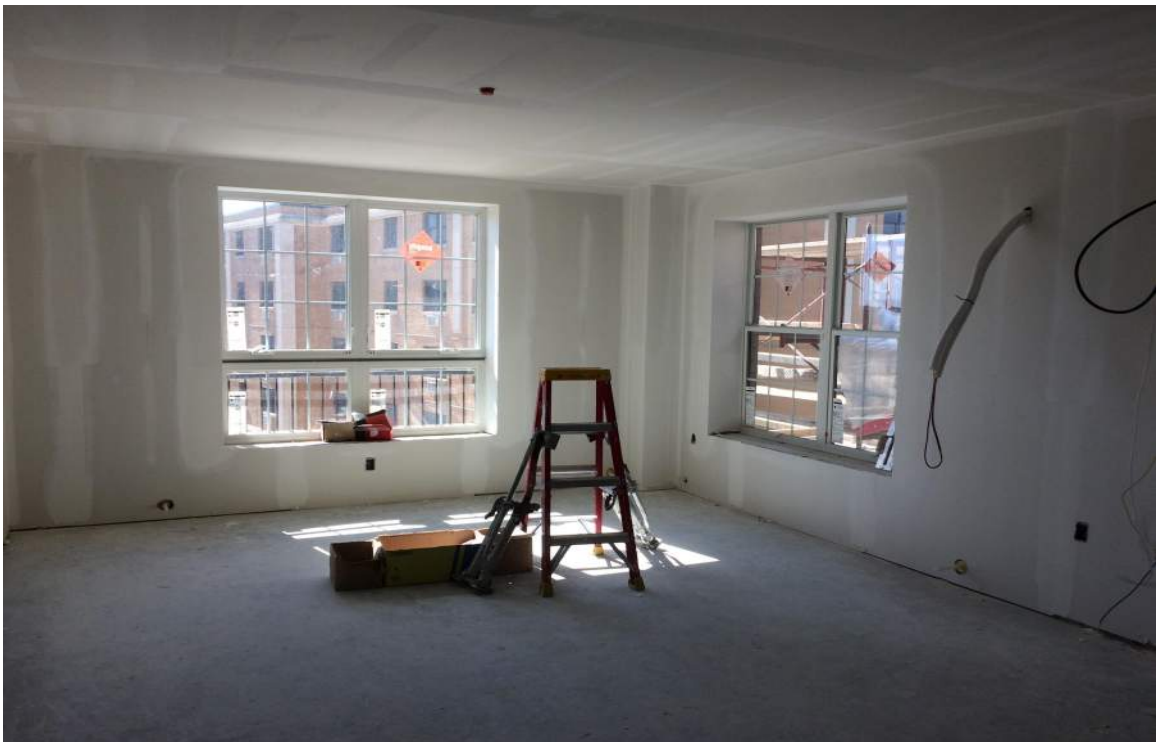
**B**

Typical resident apartment - Level 5

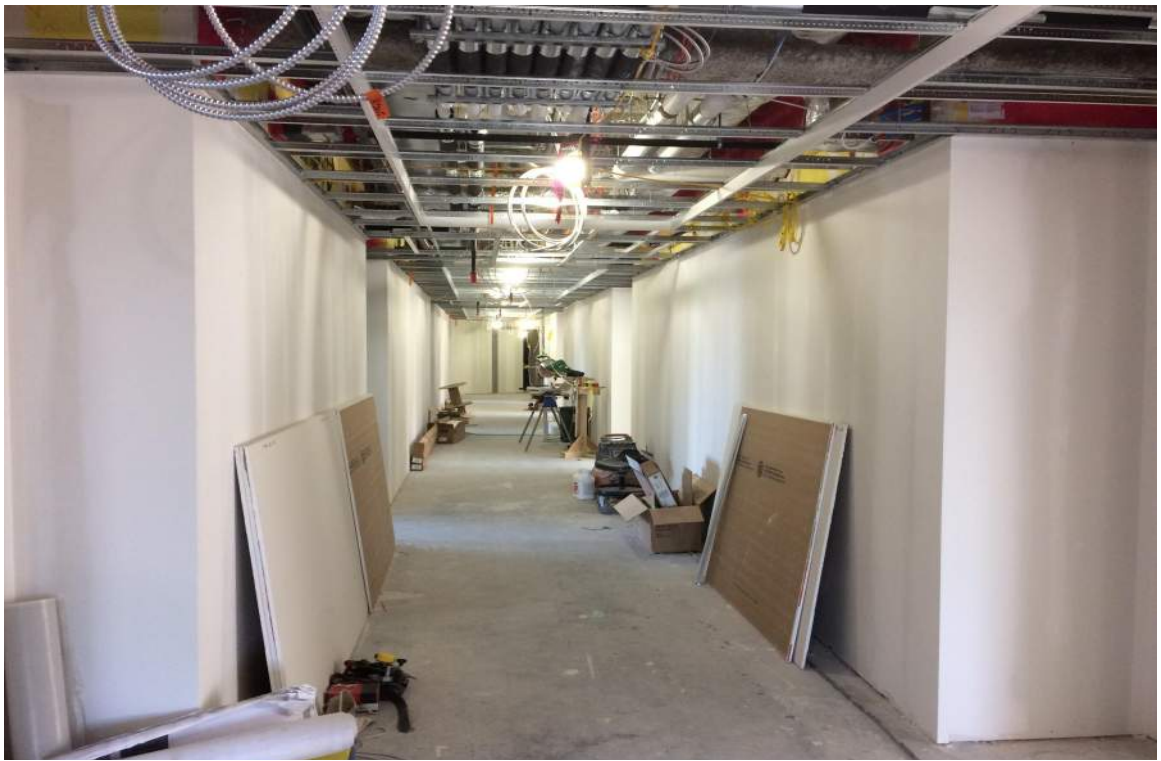
**A**

Level 4 corridor looking East

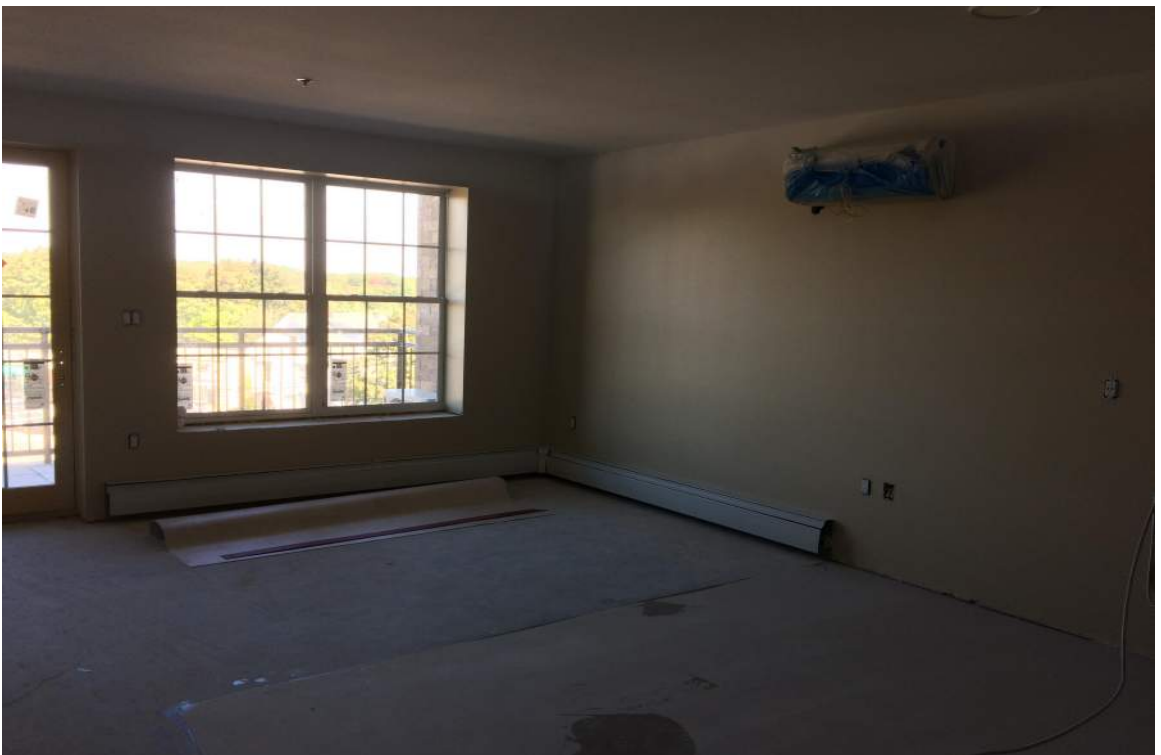
**B**

Typical resident apartment - Level 4

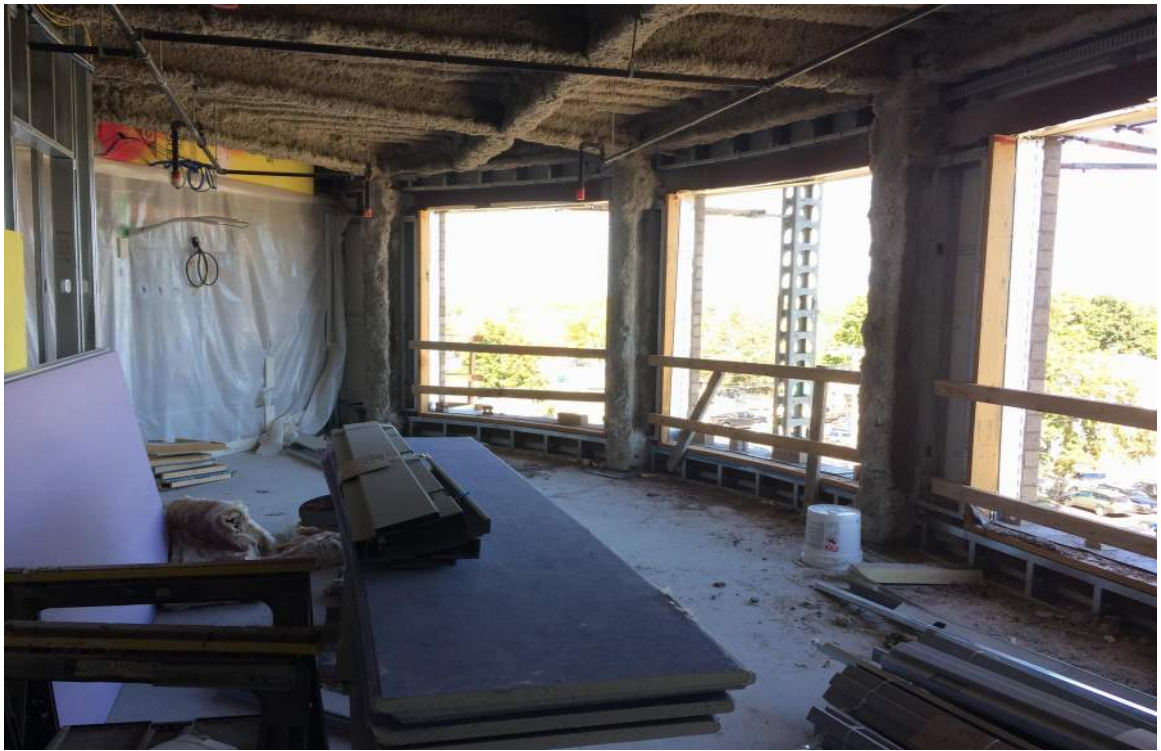
**A**

Level 4 Community Room

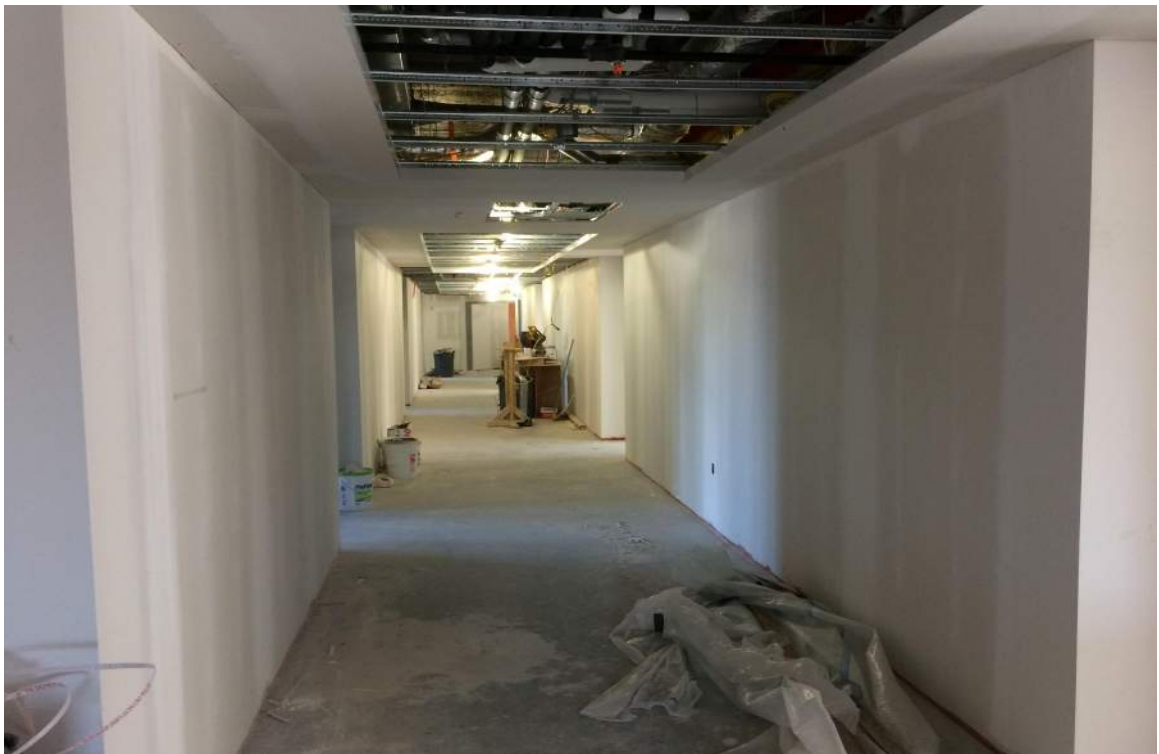
**B**

Level 3 corridor looking East

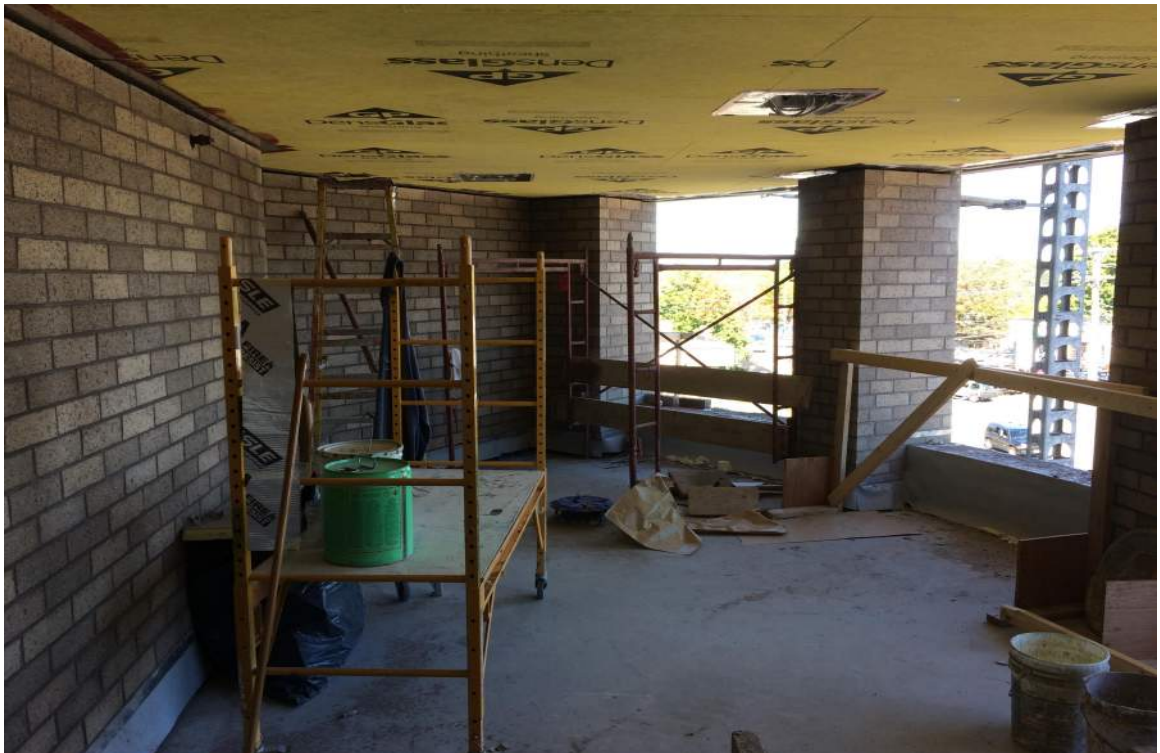
**A**

Level 3 Community Deck

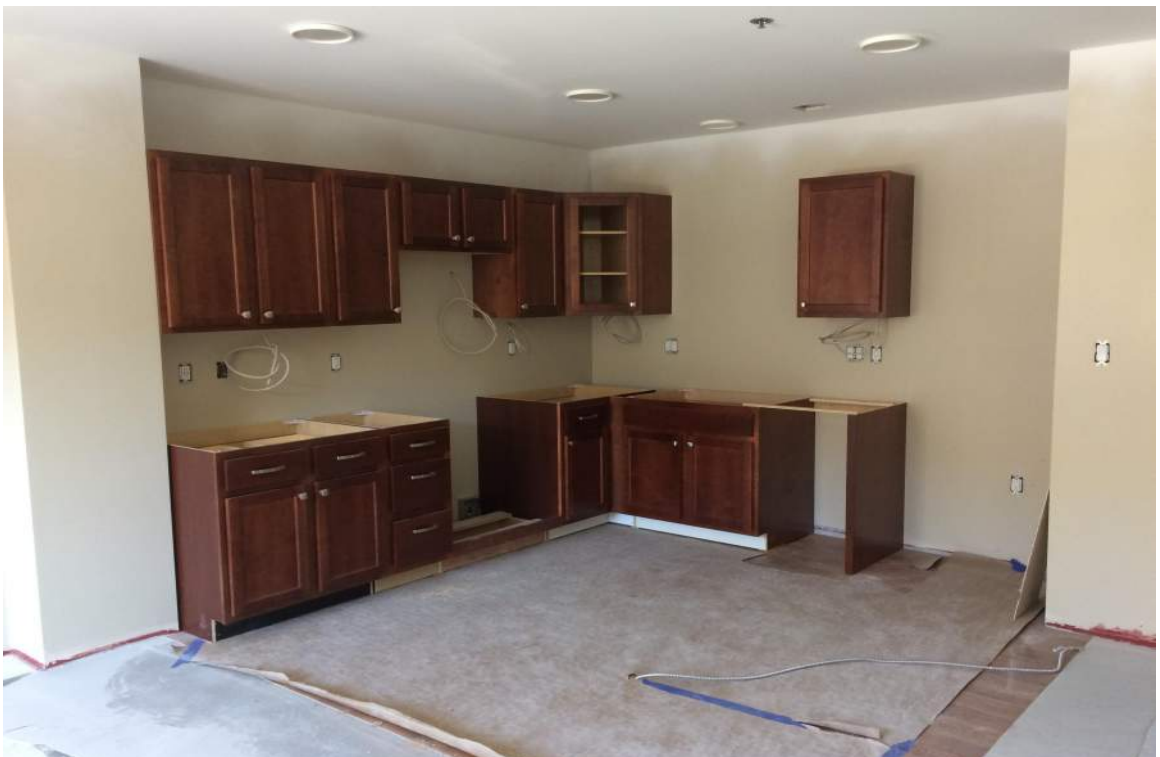
**B**

Typical resident apartment - Level 3

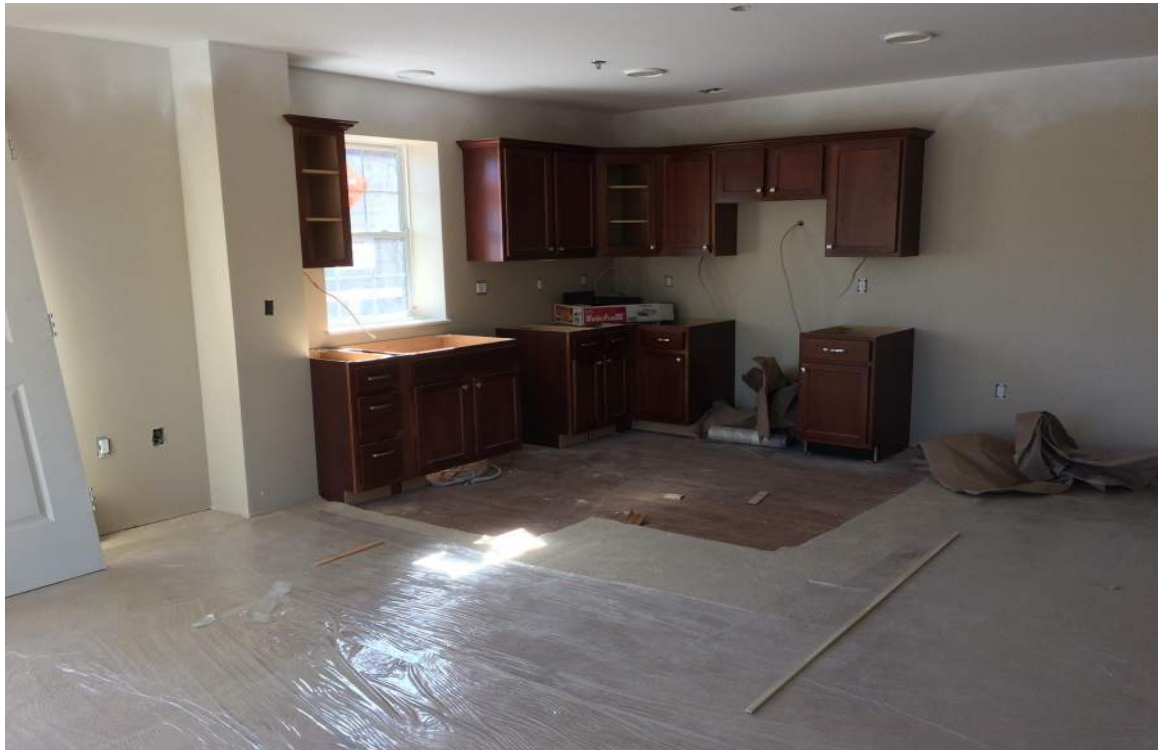
**A**

Typical resident apartment - Level 1

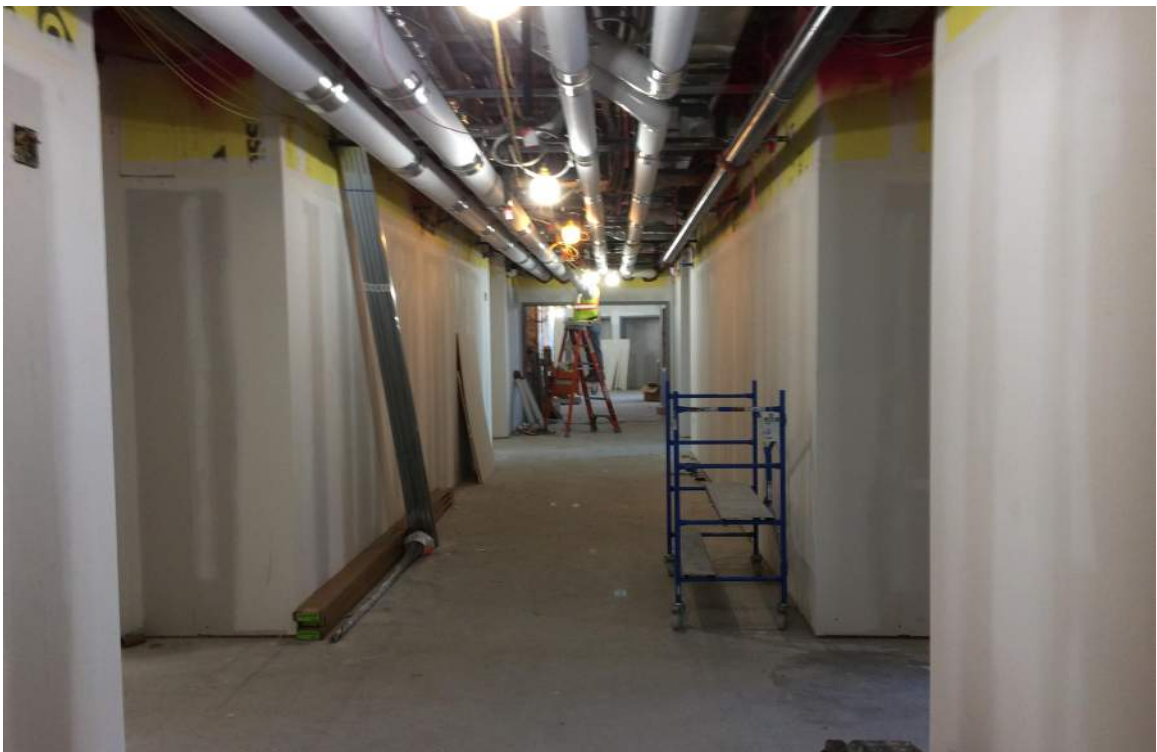
**B**

Level 1 corridor looking West

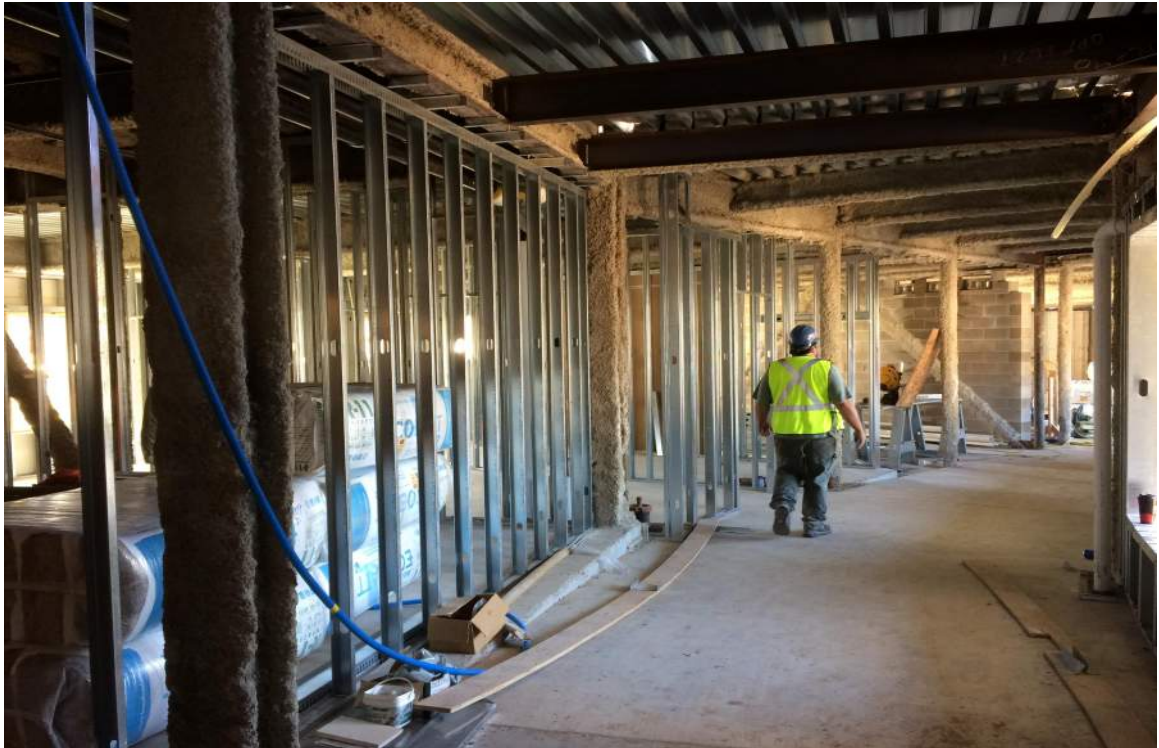
A

Connector corridor looking towards Main Street/Auditorium

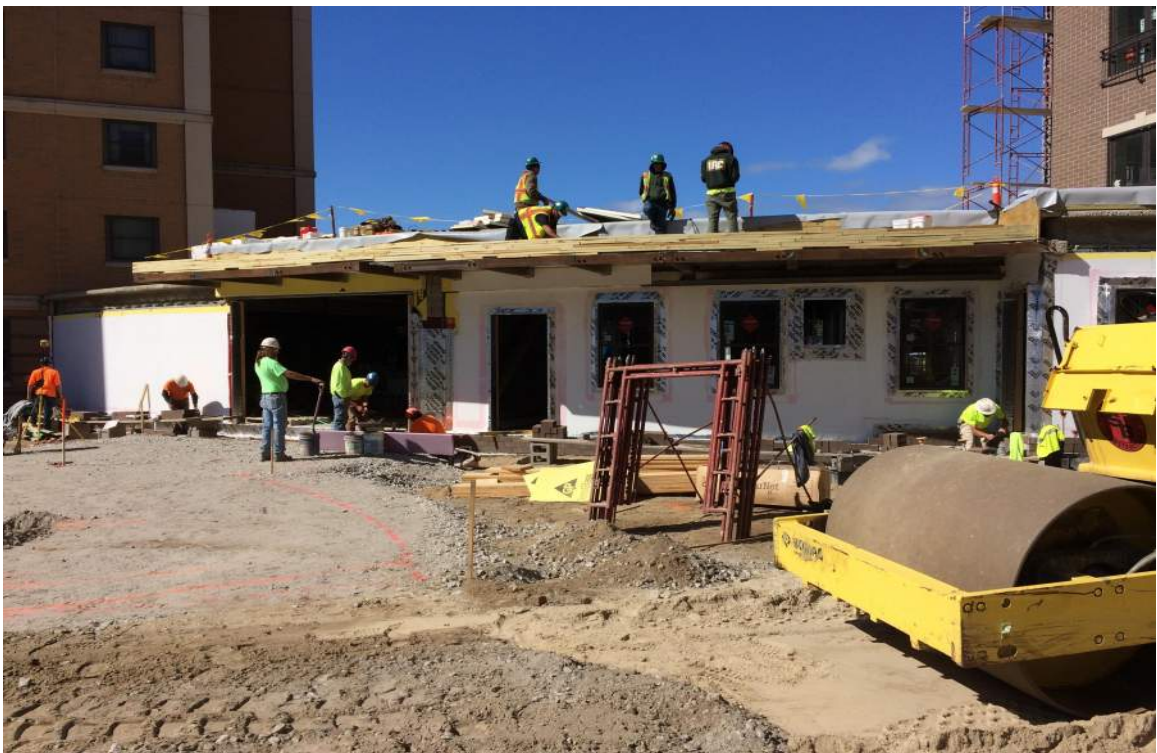
B

Connector from Courtyard

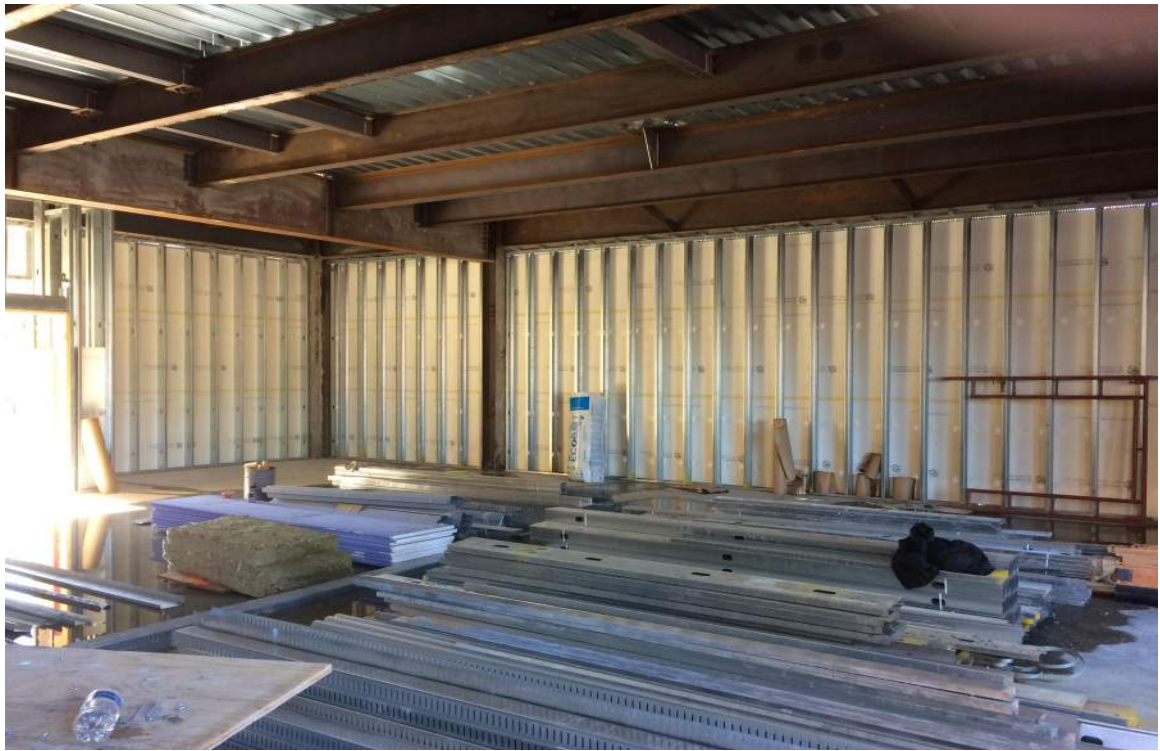
A

Auditorium

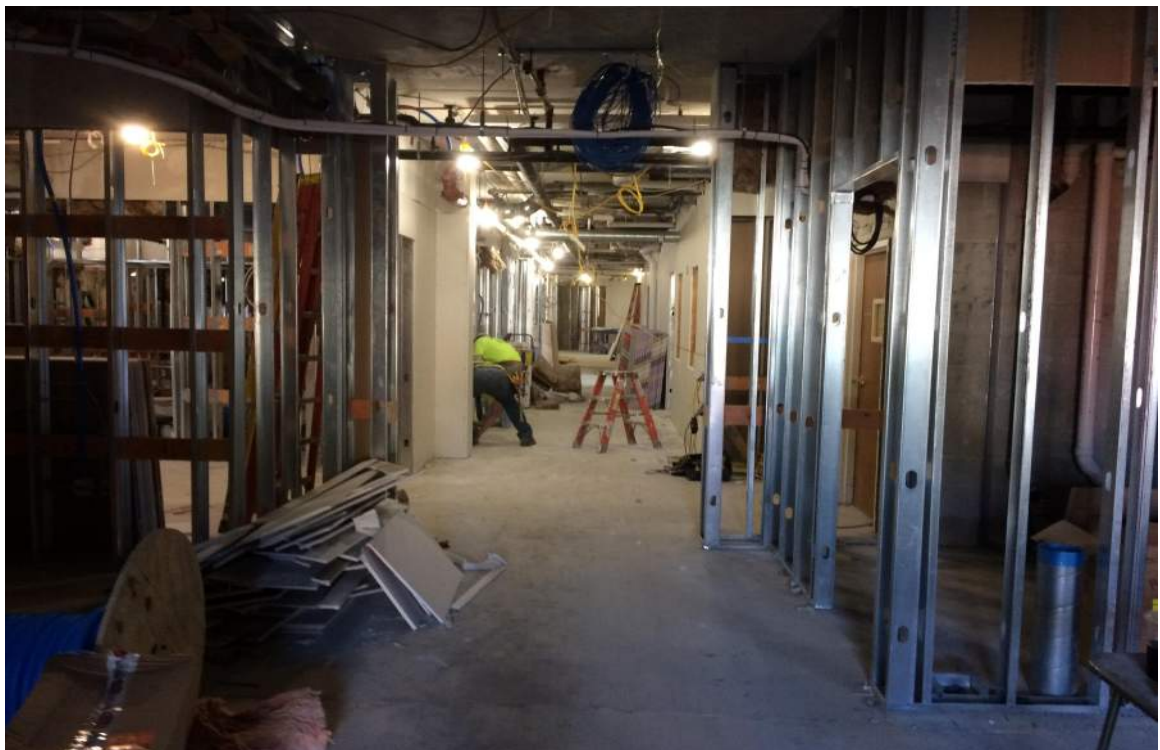
B

Main Street from outside the Auditorium looking towards existing reception/existing entrance

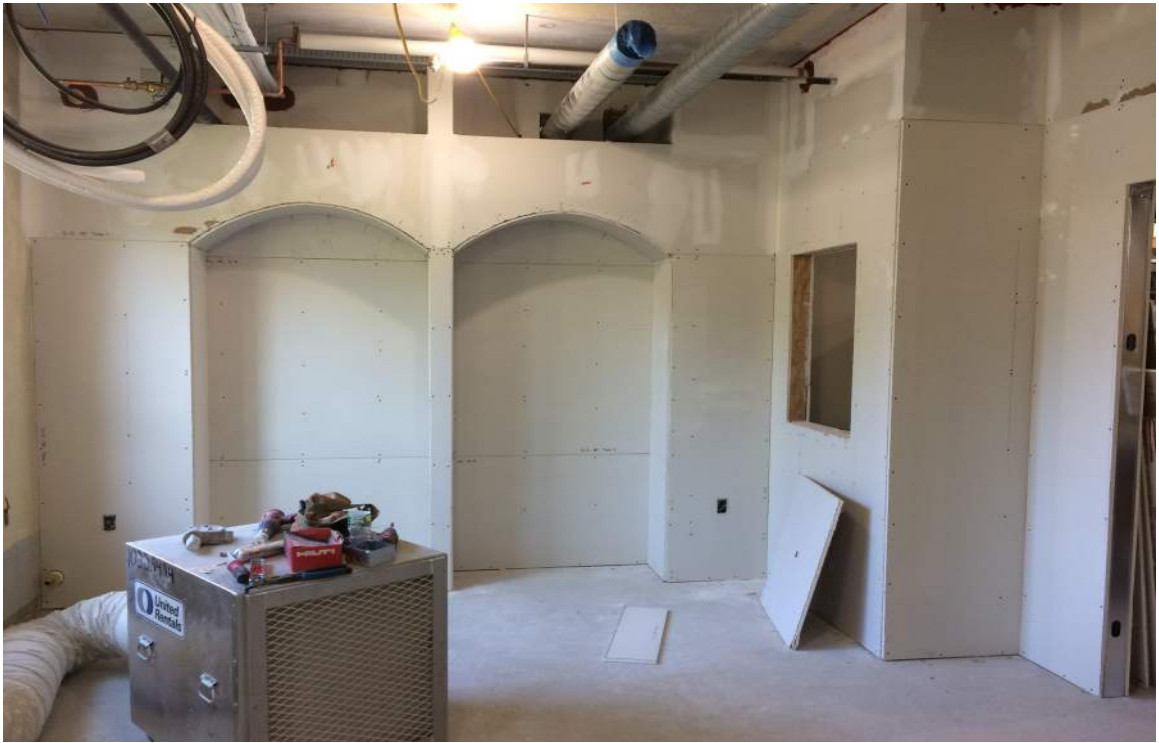
A

Resident Store

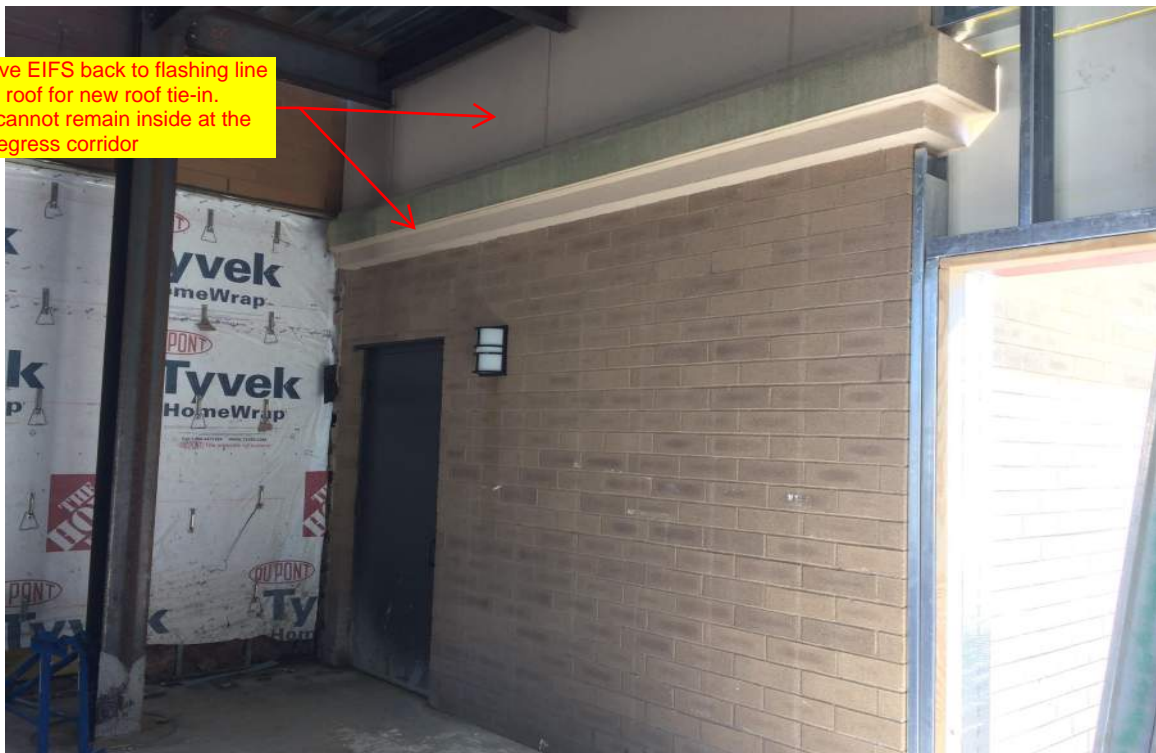
B

Item	Description	Status:
19.3	<b>Existing EIFS to new Connector Interface</b>  Remove all existing EIFS as required for all new roof tie-ins. All new roof tie-ins shall be flashed back to existing exterior sheathing. Remove existing EIFS in Stair Exit 153-A, and from all other interior spaces. Reference Photo 9B	Correct Work
19.4	<b>Auditorium - Existing Stair Expansion Joint</b>  Construction of the joint between the new auditorium and existing stairwell is lacking an expansion joint as detailed in the Drawings. Reference Photo 10A.	Correct Work

Existing egress stair wall at Auditorium

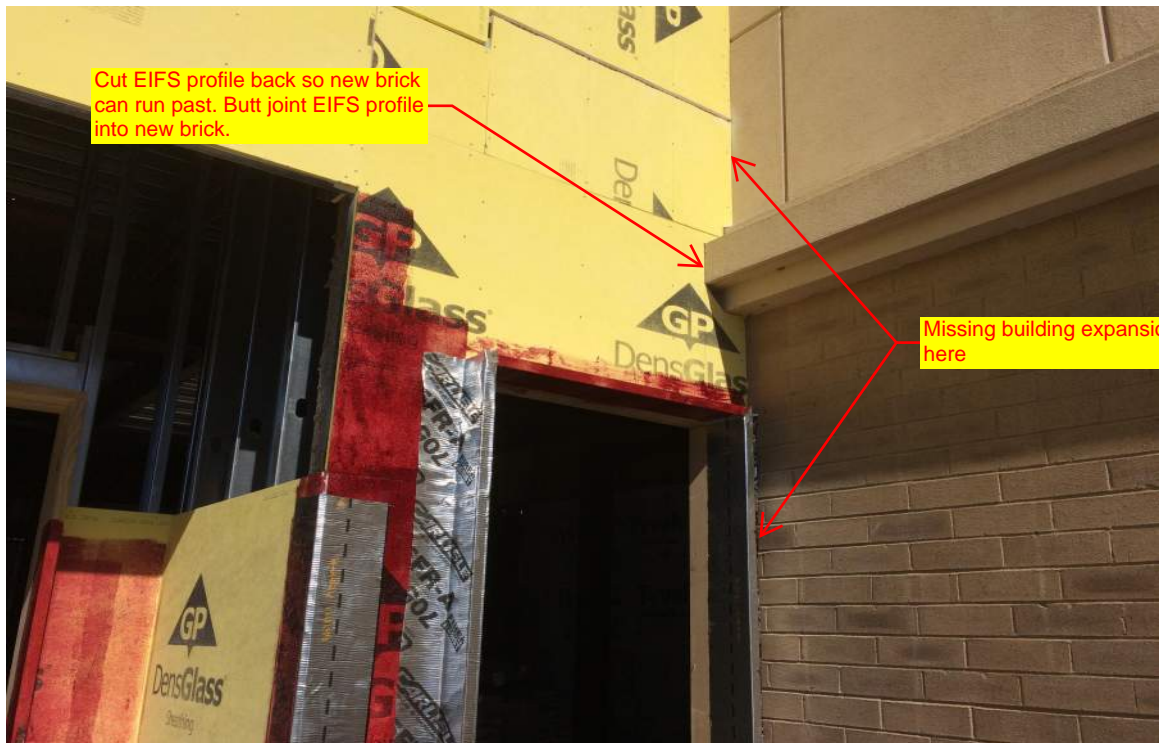
**A**

New-To-Existing building joint at Auditorium, near door 153A
