# Field Report

**The Park Danforth** **Project No:** 13-059-00  
**Portland ME** **Field Report No:** 20

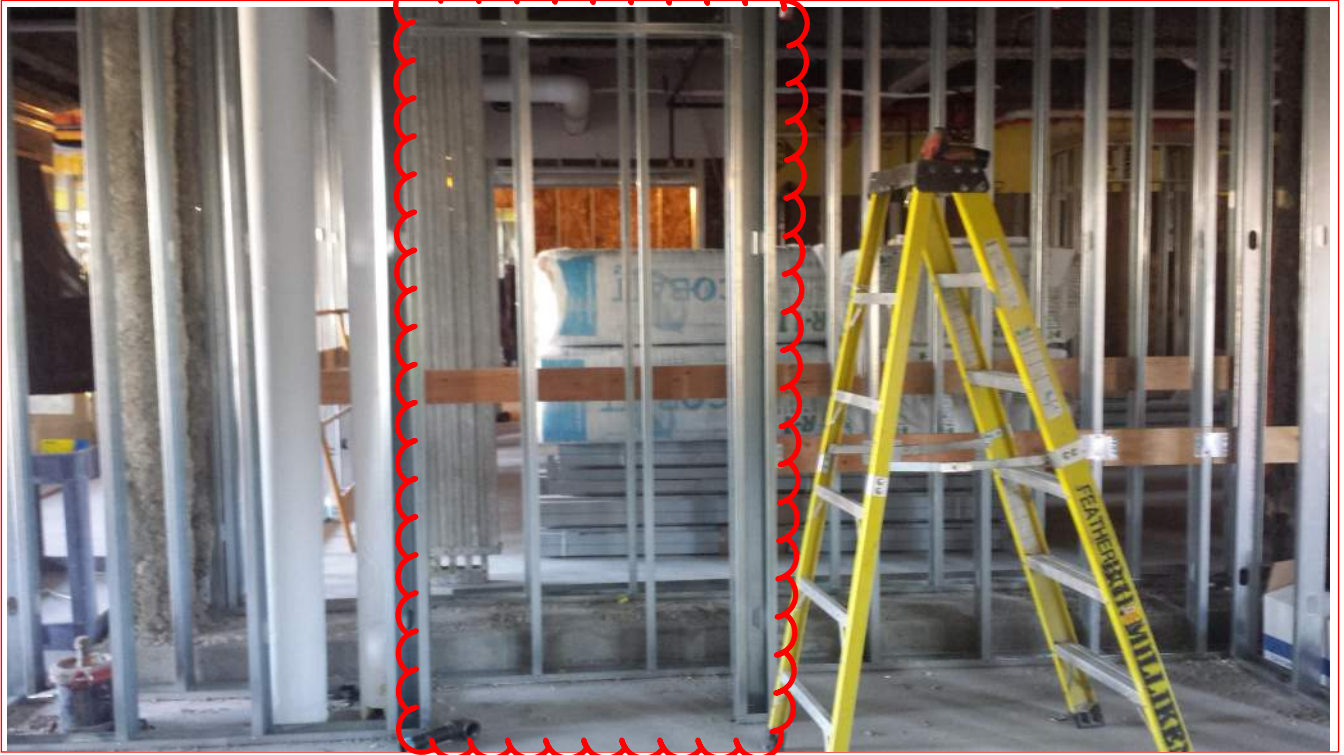
| Item | Description | Status: |
|---|--|---|
| 20.02 | Interior partition framing in Marketing Suite 151 is not the most recent floor plan. See SI 025 Marketing Suite Revisions and images A and B P15 of 19 | Correct Work |

Connector, Marketing Suite 151. See Note 20.02

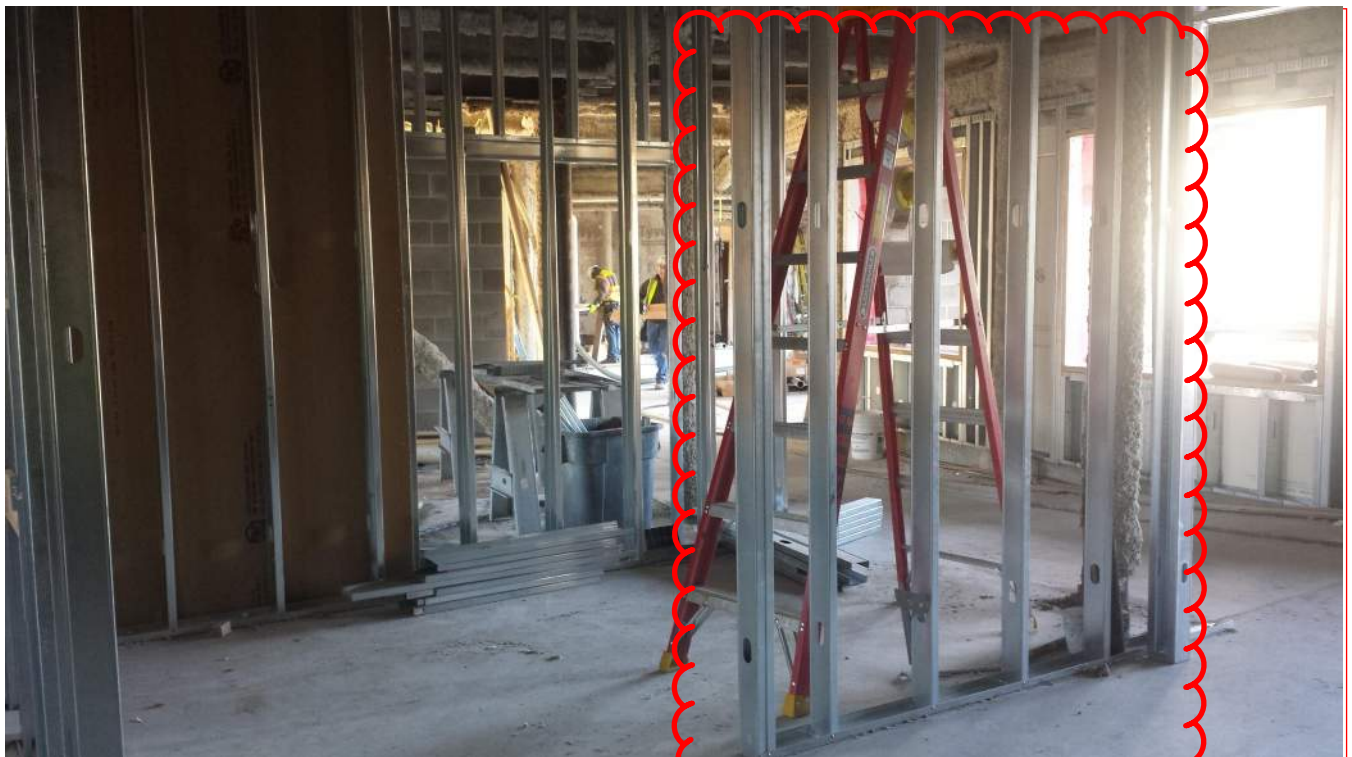
B

Connector, Marketing Suite 151. See Note 20.02

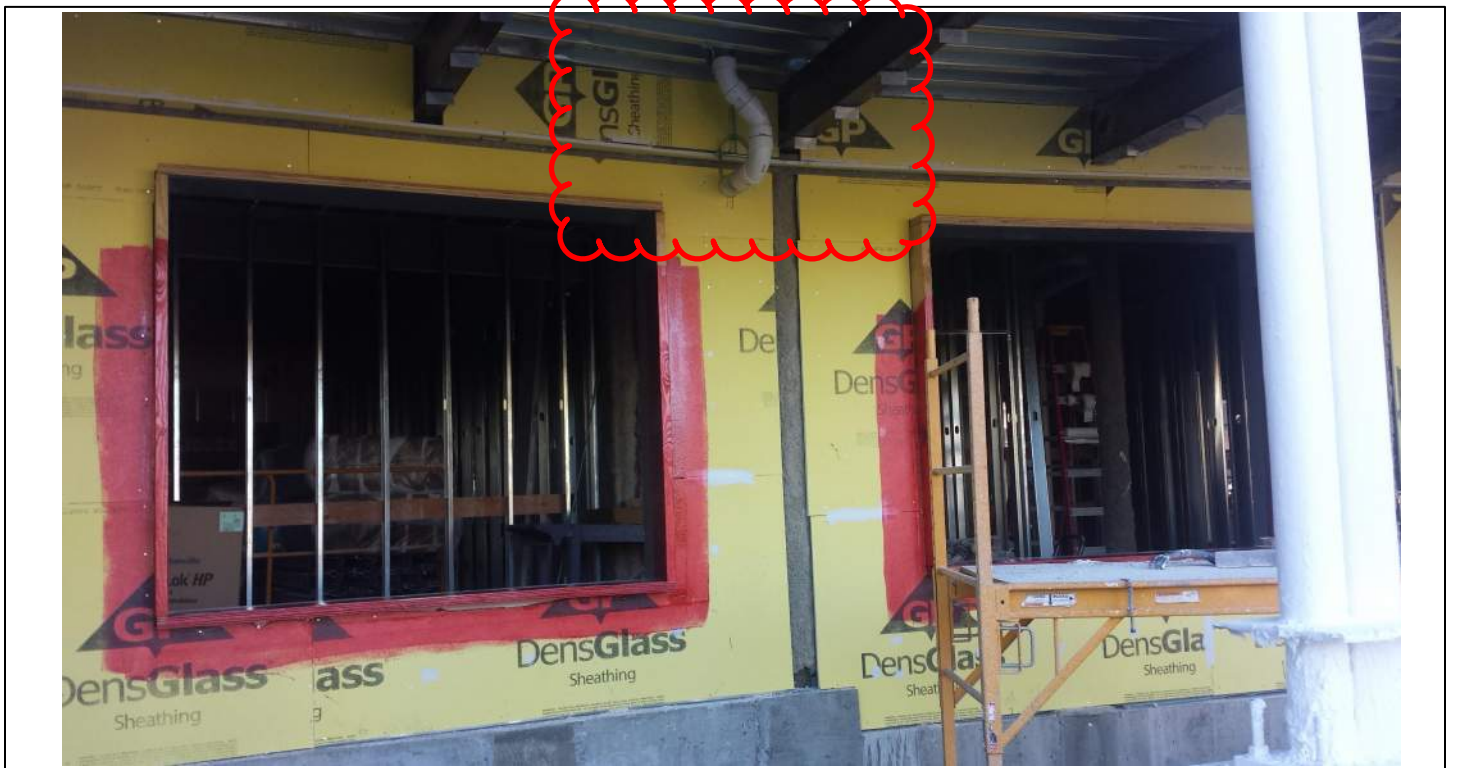
| Item | Description | Status: |
|---|--|---|
| 20.03 | Roof drain in connector (approx. grid lines R10 and R12) needs to be located as tight to underside of beam as possible. See images A and B P16 of 19 | Correct Work |

Connector, Farmer's porch, grid lines R.10 and R.12. See Note 20.03

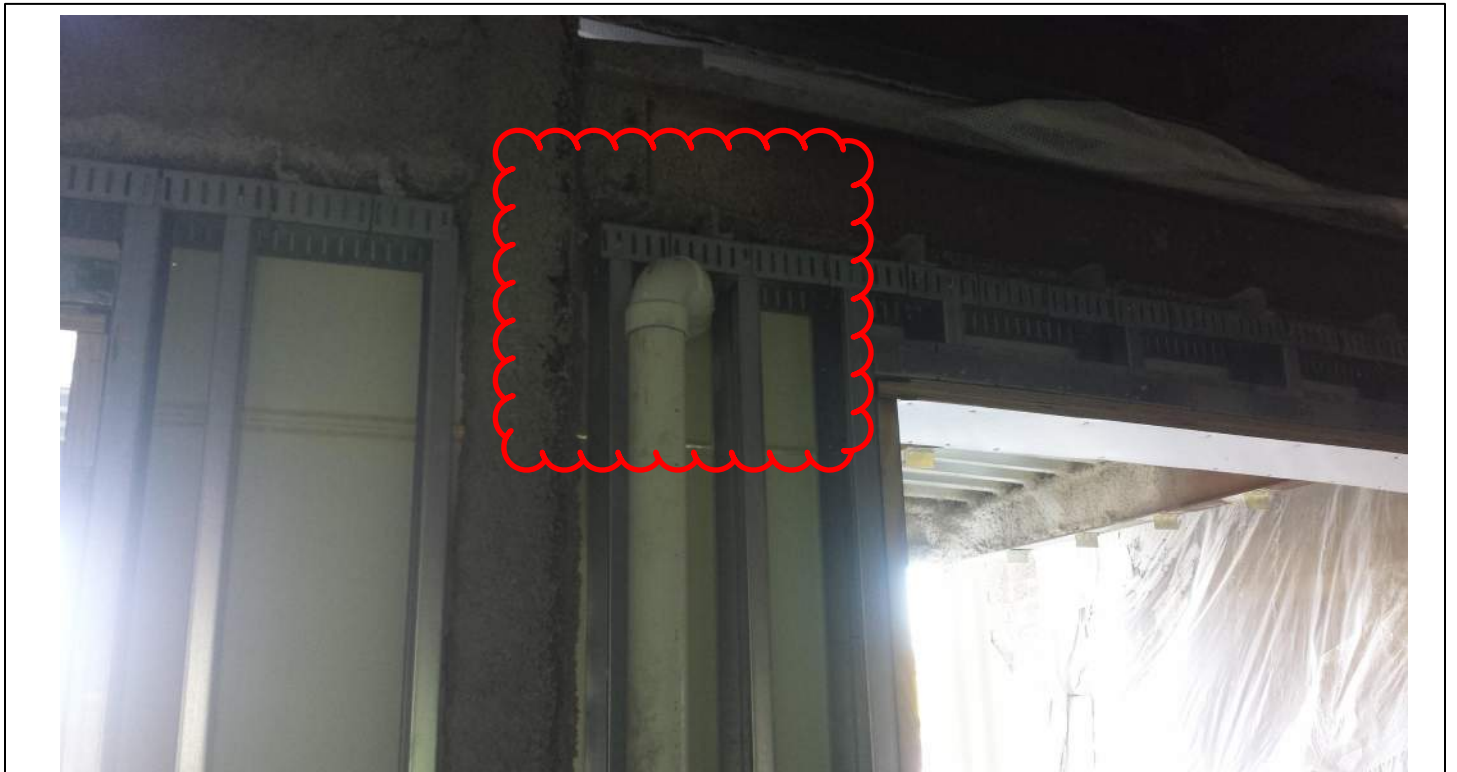
B

Connector, Farmer's porch, grid lines R.10 and R.12. See Note 20.03

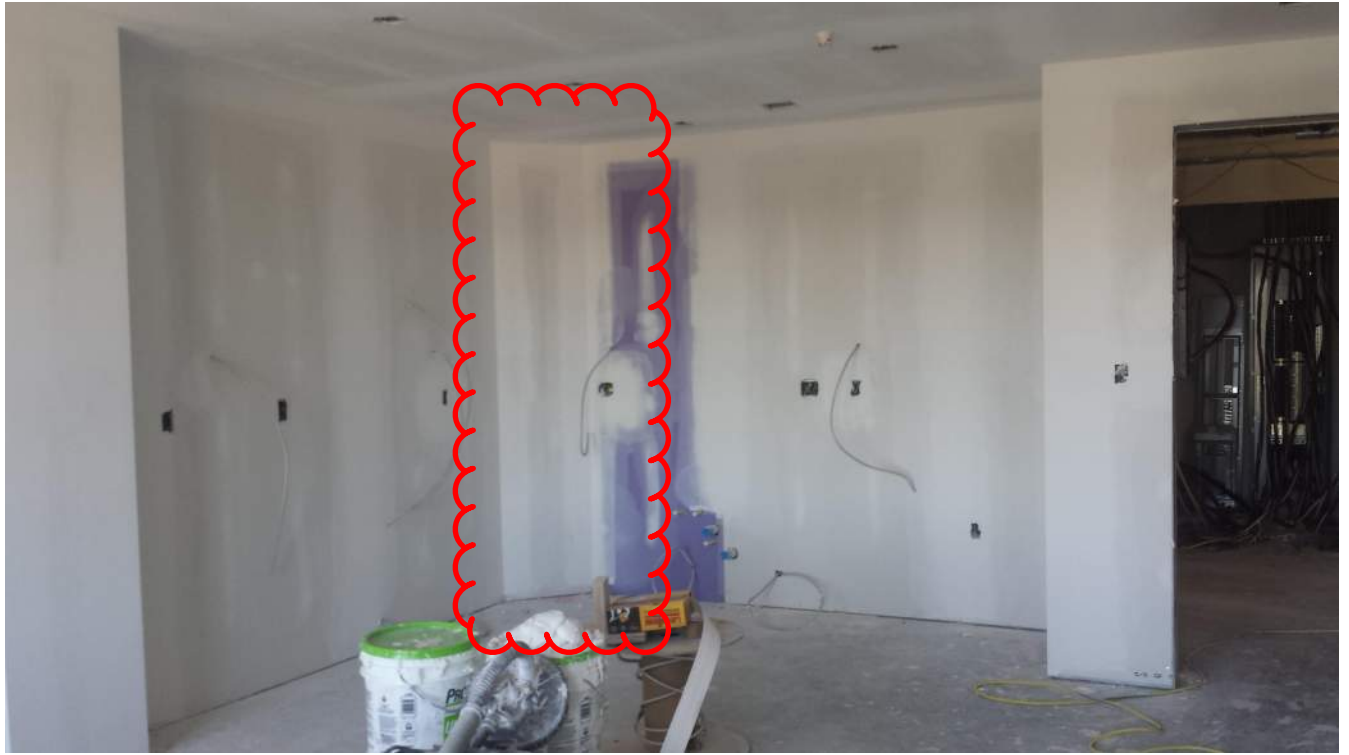
| Item | Description | Status: |
|---|--|---|
| 20.04 | Unit 1506, corner drywall needs to be wrapped as tight as possible to the column. Coordinate with Casework. See image A P17 of 19 | Correct Work |

Resident Unit 1506, see note 20.04

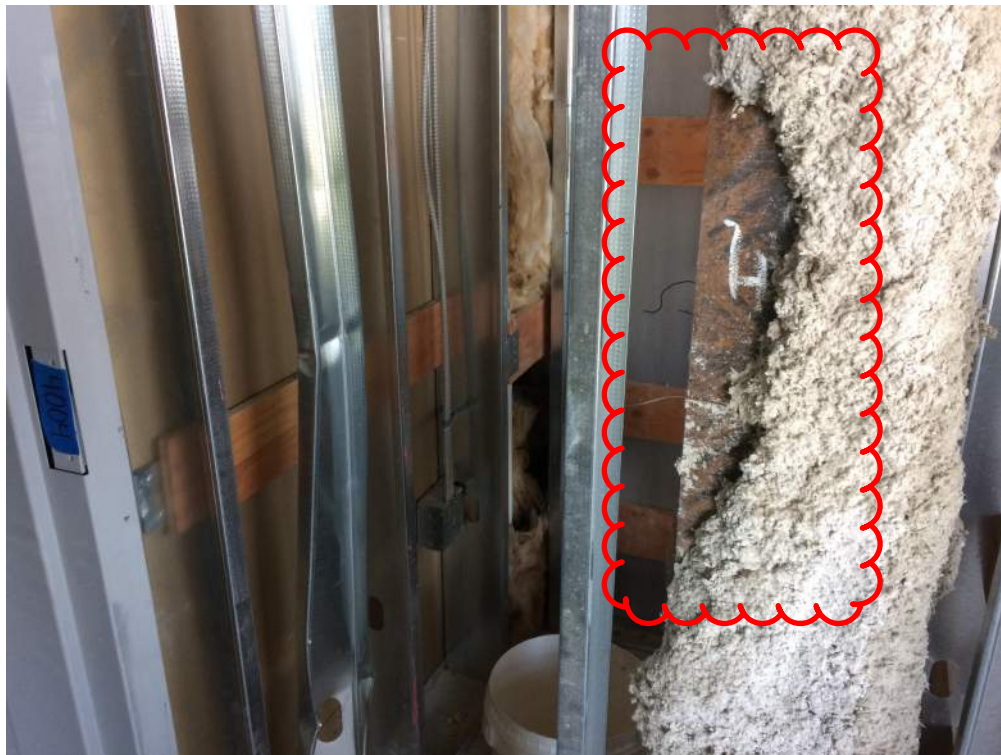
| Item | Description | Status: |
|---|--|---|
| 20.05 | Community Room 4004. Apply fireproofing to column before enclosing in drywall. See Image B P17 | Correct Work |

Group Room 4004, see note 20.05

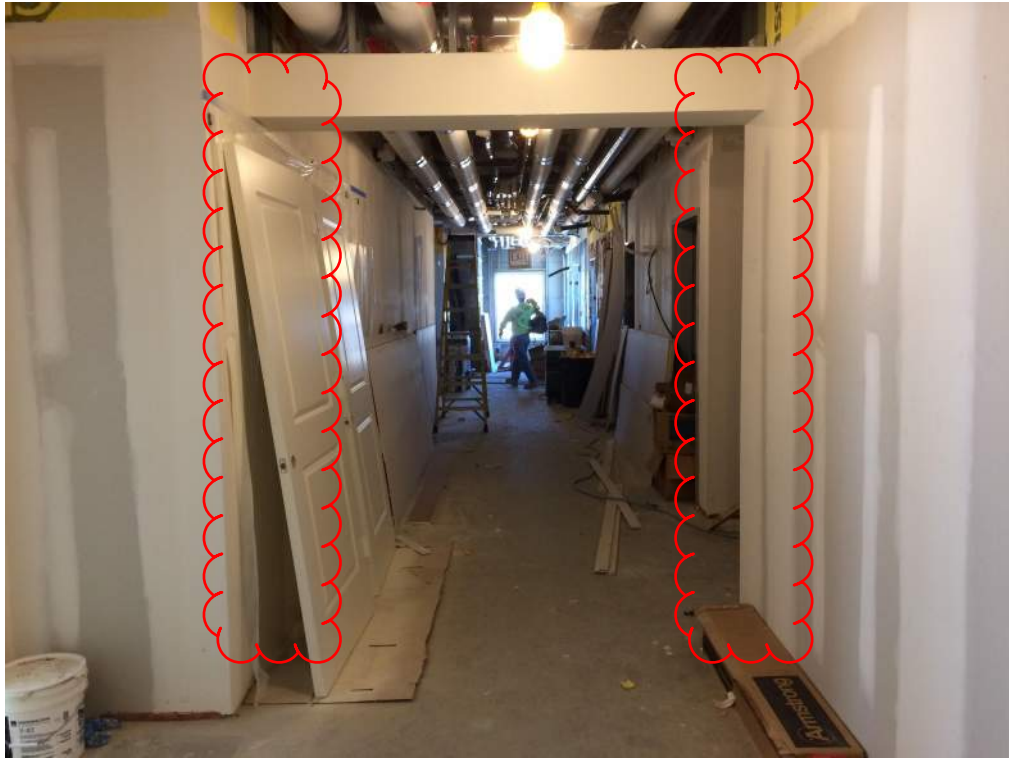
**A**

| Item | Description | Status: |
|---|--|---|
| 20.06 | Add pilasters in corridor 1001 between the Administration Suite and Unit 1103. Coordinate with GWB soffit. See image A P18 of 19 and reference drawing A1.1C | Correct Work |

Corridor 1001, See note 20.06

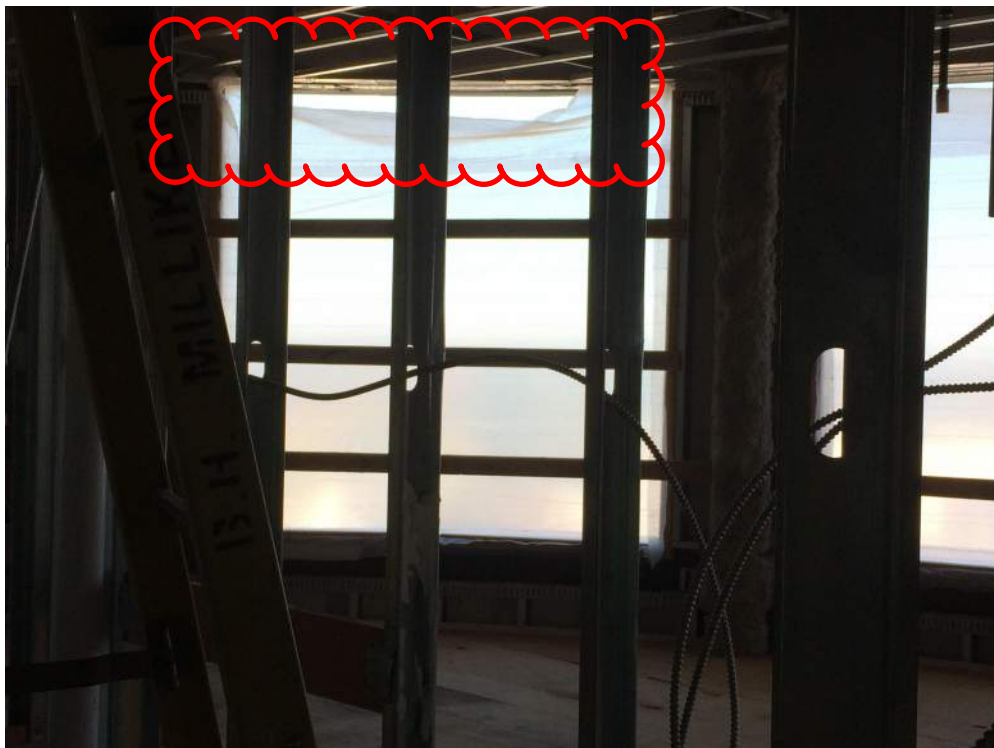
**B**

| Item | Description | Status: |
|---|--|---|
| 20.07 | Verify plastic sheeting in all openings to exterior are sealed to protect interior from water infiltration. See image B P18 of | CM follow up |

Community Room 5004, see note 20.07

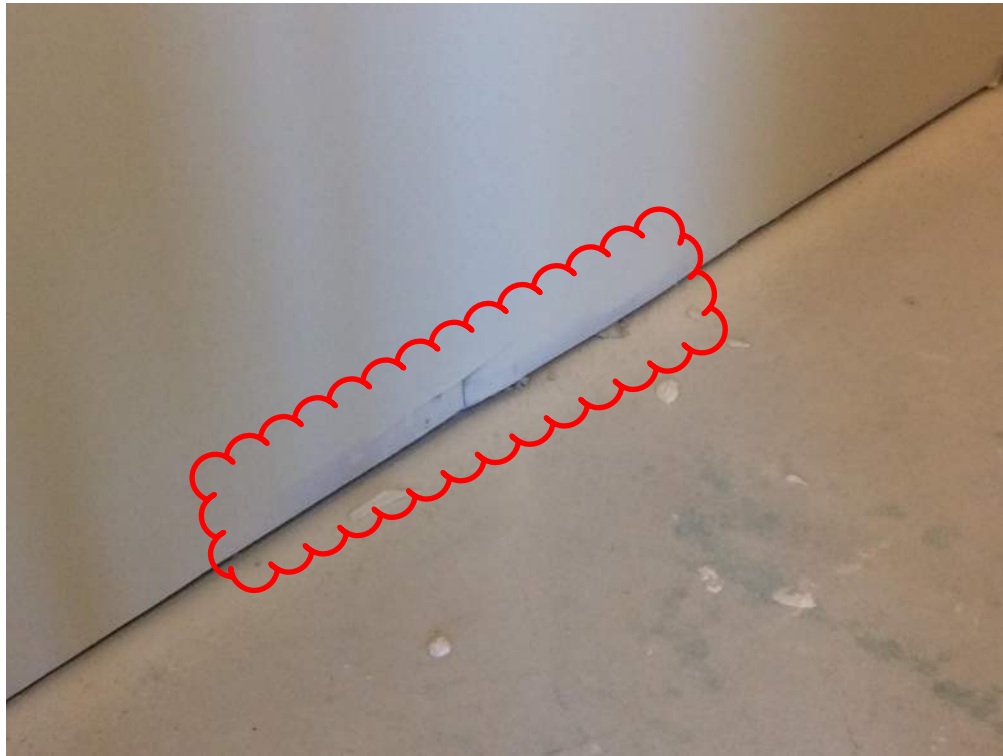
**A**

| Item | Description | Status: |
|---|--|---|
| 20.08 | Ensure smooth surface at base of wall for vinyl base/verify wall abnormalities will not telegraph through. | CM follow up |

GWB Base at floor slab. See Note 20.08

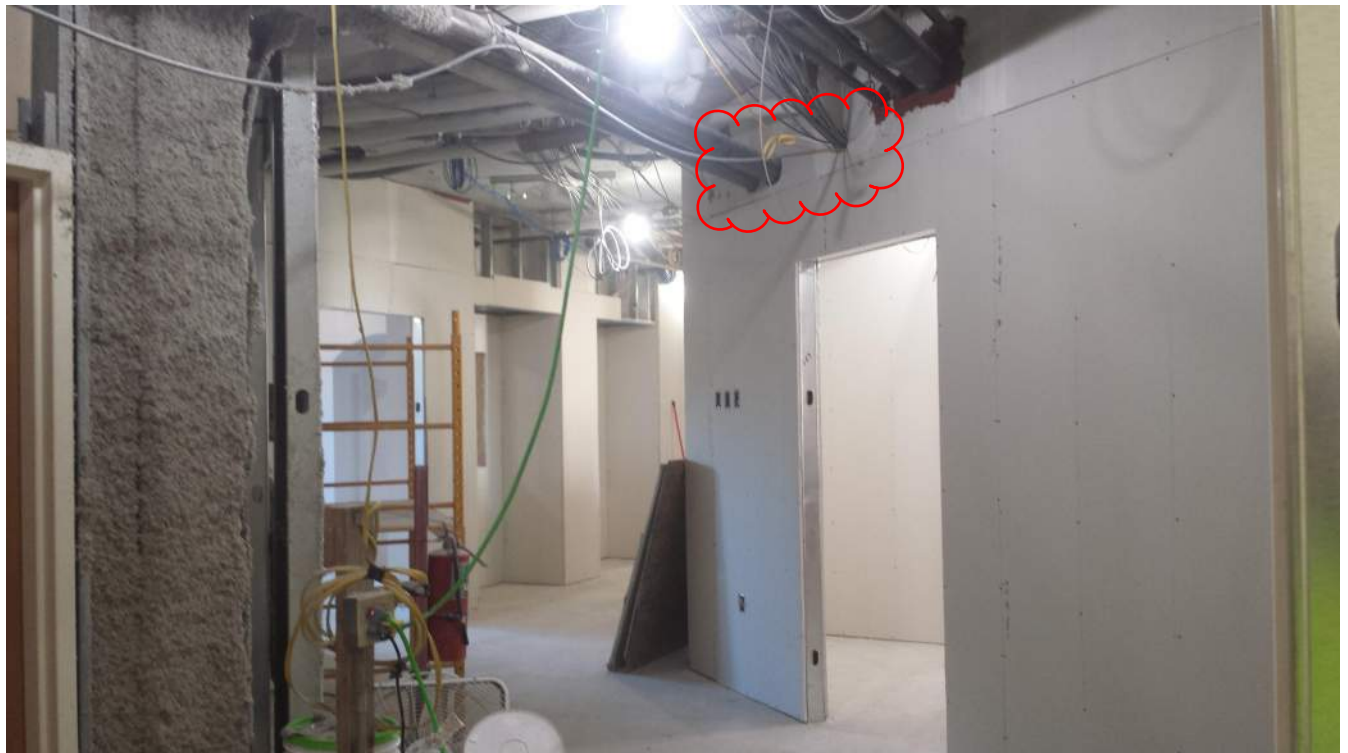
**B**

| Item | Description | Status: |
|---|--|---|
| 20.09 | Ensure all wall penetrations in rated walls on Main Street are fire sealed. See image B P19 of 19 for example. | Correct Work |

Main Street outside of Bistro (example) see note 20.09
