Field Report

The Park Danforth **Project No:** 13-059-00
Portland ME **Field Report No:** 21

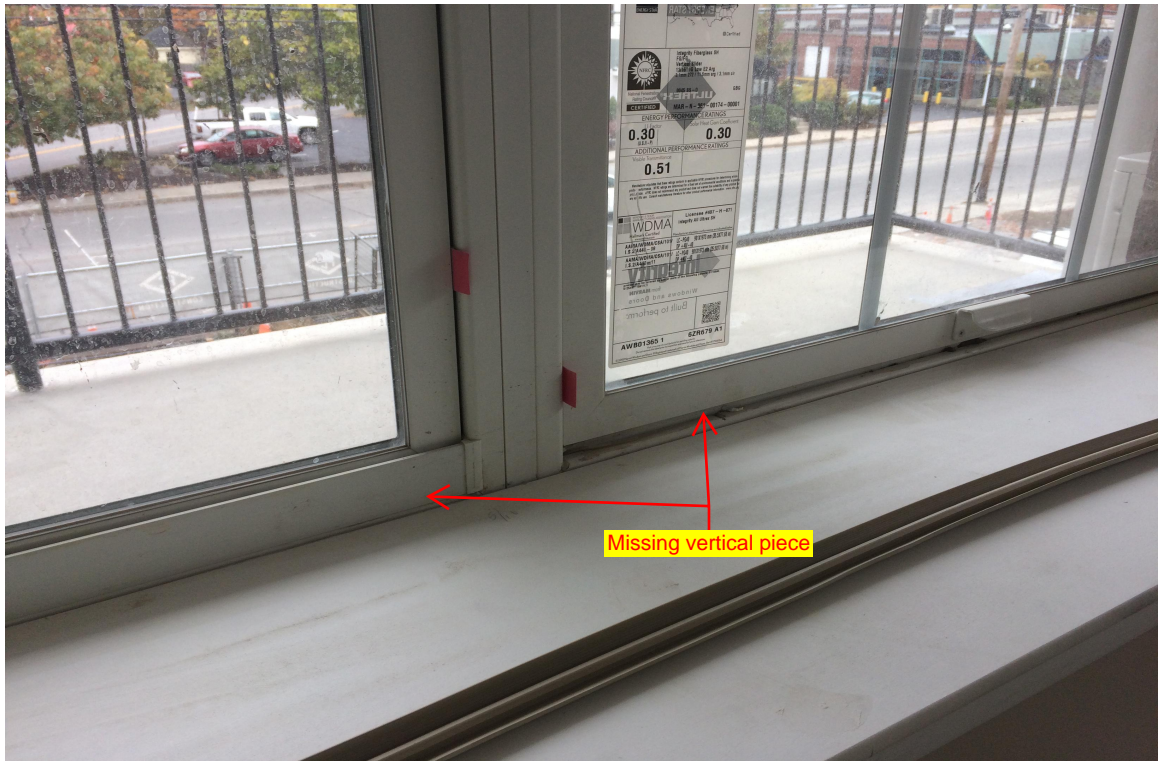
A

21.4	<p>Resident Apartment Windows</p> <p>Some windows appear to be missing the inside vertical stop. Reference attached photo</p>	Correct Work
21.5	<p>Water Infiltration Admin Suite</p> <p>Water appears to be working its way down to the Admin suite via the level 2 balconies above. Work in place shall be protected from water damage. Any areas exhibiting water damage shall be replaced (See attached photo)</p> <p>Spray fireproofing is missing on the underside of these level 2 balconies.</p>	Correct Work

Living room windows in Apartment 1209. Other apartments similar (Reference Item 21.4)

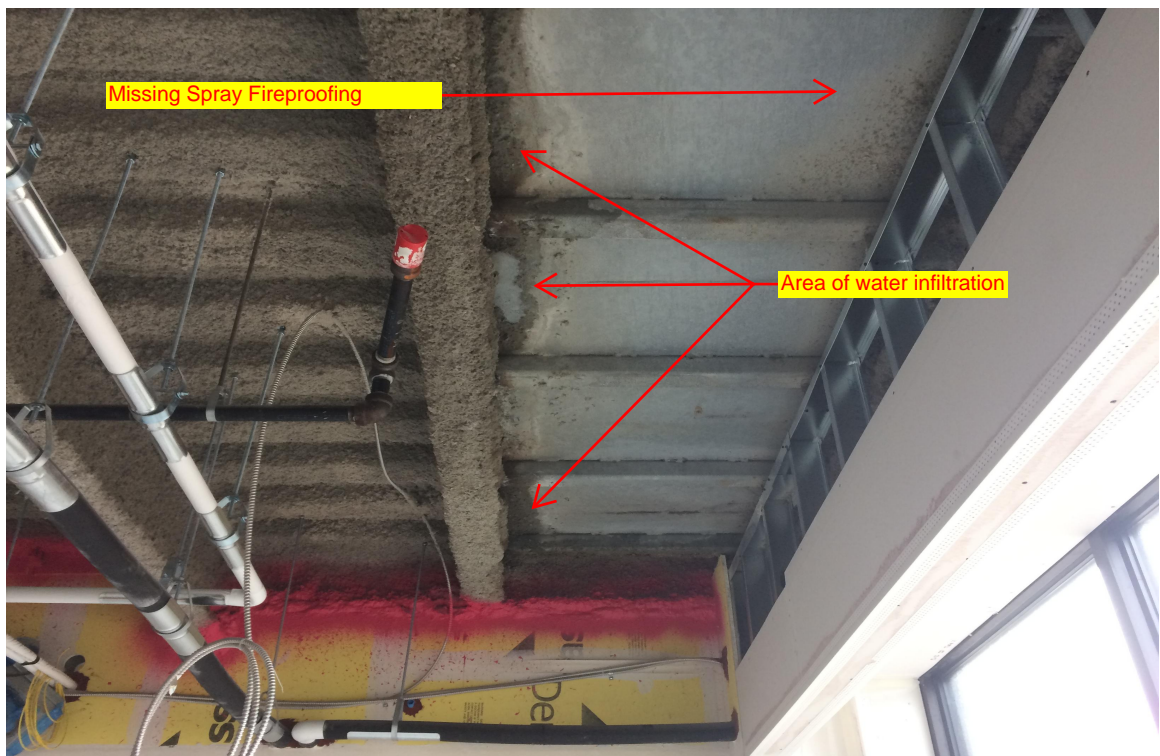
B

Ceiling in CEO 1009F. Other rooms below L2 balconies similar. Reference Item 21.5

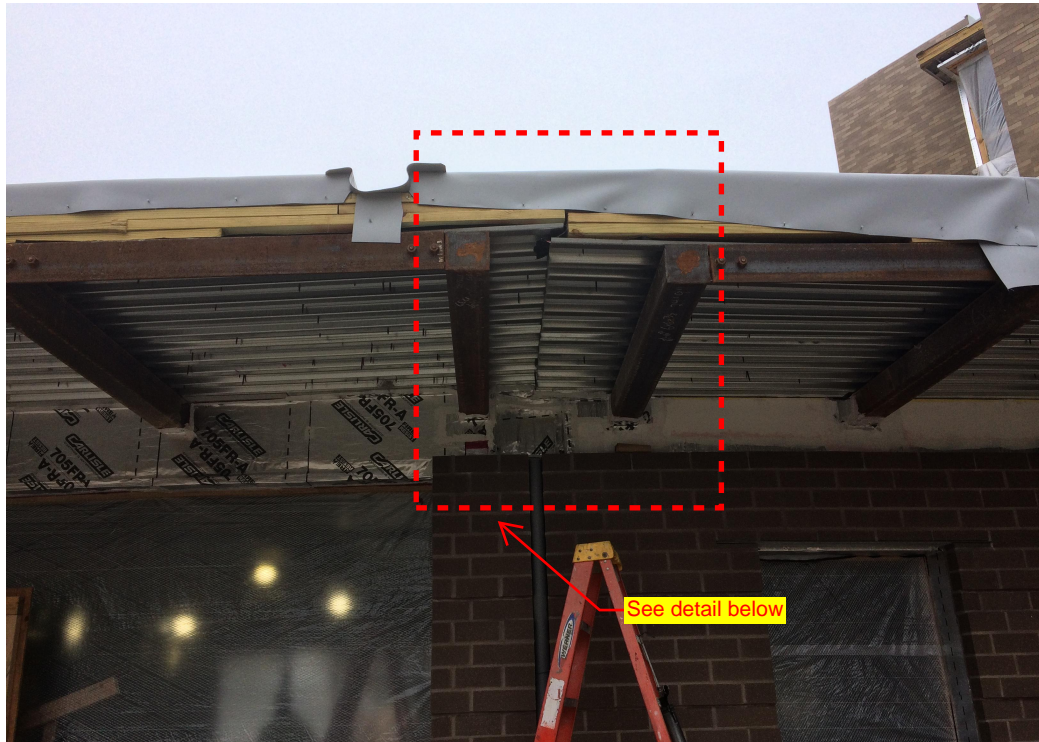
A

21.2	<p>Level 2 Trash Chutes</p> <p>The recycling door to the level 2 trash chute is incorrectly labeled "Rubbish"</p>	Correct Work
21.3	<p>Connector Canopy Expansion Joint (Courtyard Side)</p> <p>The expansion joint for the connector canopy is missing (Reference attached Photo) Construct in accordance with Sketches issued SI 009</p>	Observation

Canopy Expansion Joint - Reference Item 21.3

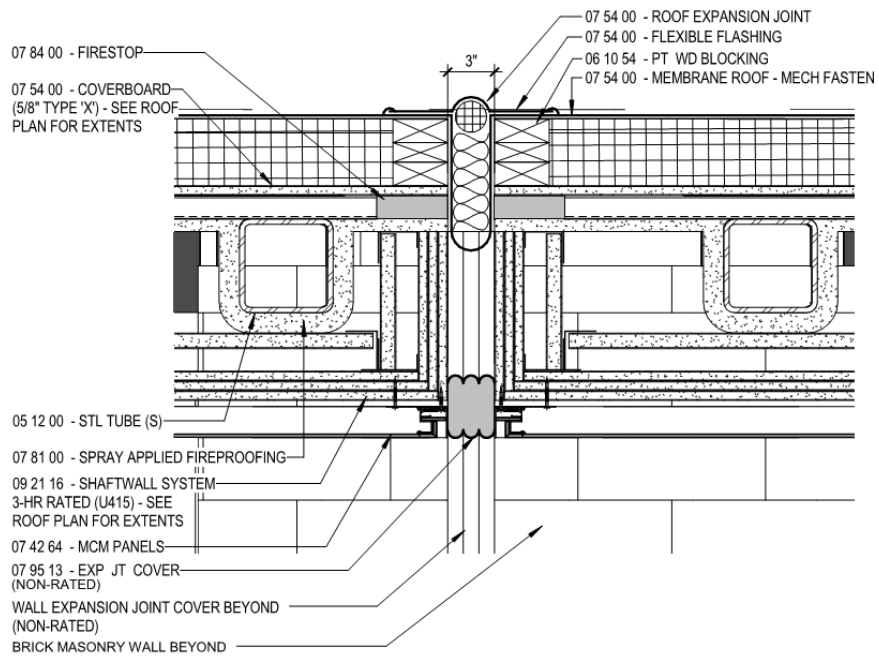
B

Sketch SK-SI-9.2 from SI 009 Issued 3/15/2016
