Field Report

The Park Danforth **Project No:** 13-059-00
Portland ME **Field Report No:** 22

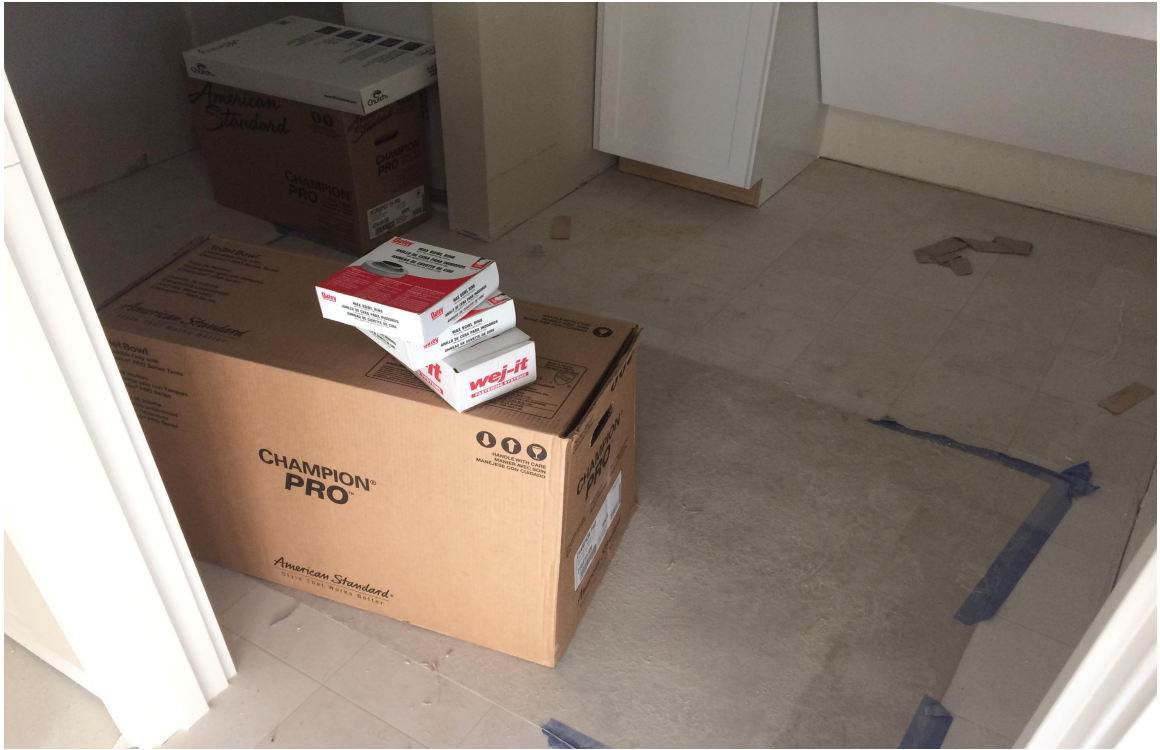
A

22.2	<p><u>Finish Flooring Protection</u></p> <p>Continue to protect carpeting and vinyl flooring in accordance with the Project Specifications. See attached Photos</p>	<div style="border: 1px solid black; padding: 5px; width: fit-content; margin: auto;">Correct Work</div>

Flooring protection in typical bathroom

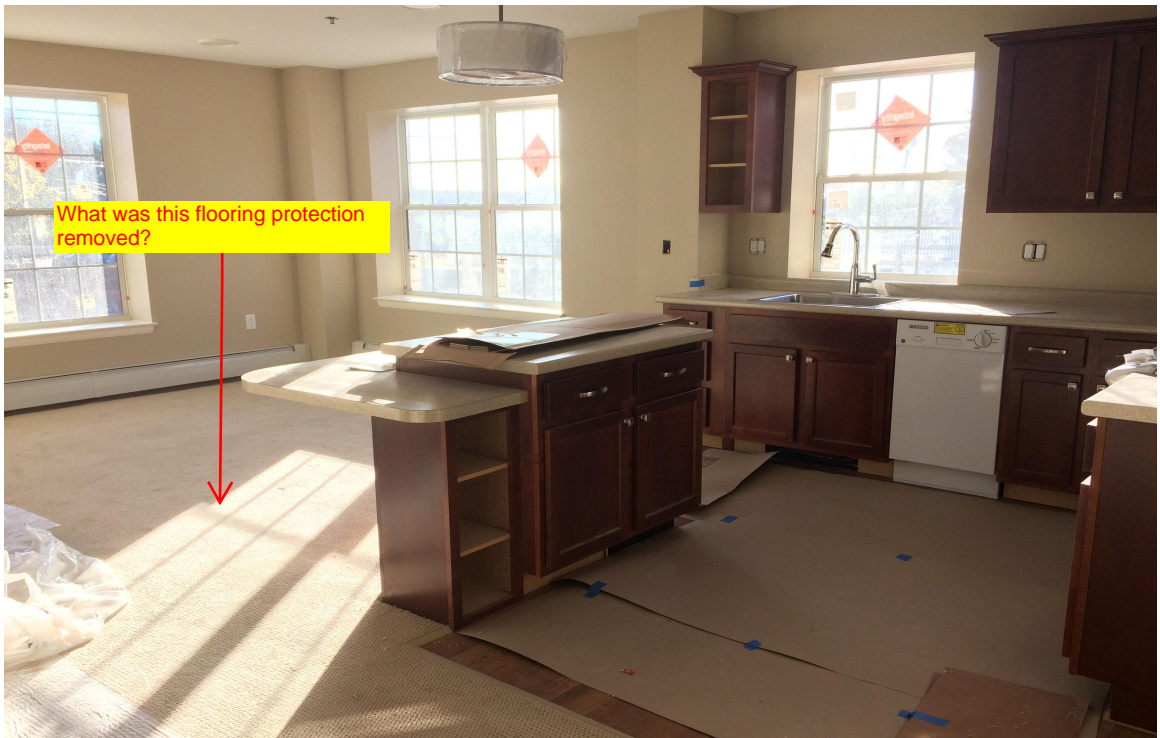
B

Corner Unit - Level 1 (Unit 1112)

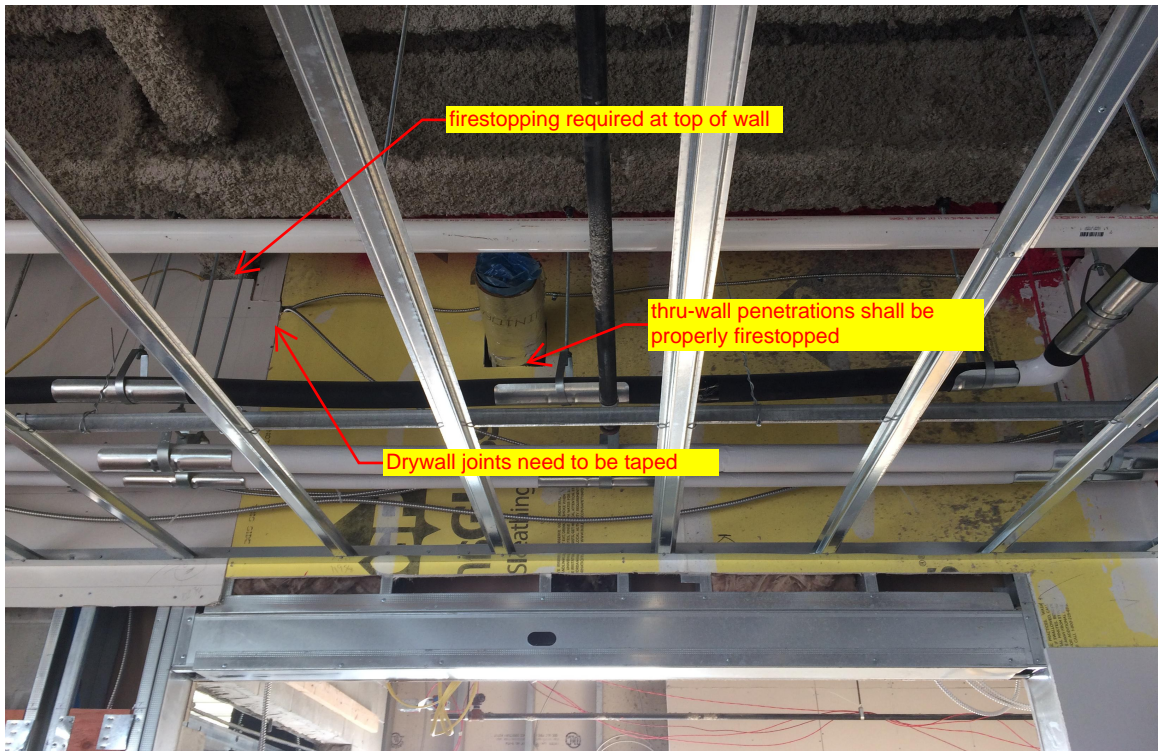
A

22.4	<p>Level 5 Community Room (5004)</p> <p>All above-ceiling drywall joints along the entry (rated) wall shall be taped per the partitions UL designation. All thru wall penetrations shall be properly fire sealed. See attached Photo.</p>	Correct Work

Level 5 Community Room above the room's entrance. Reference Item #22.4

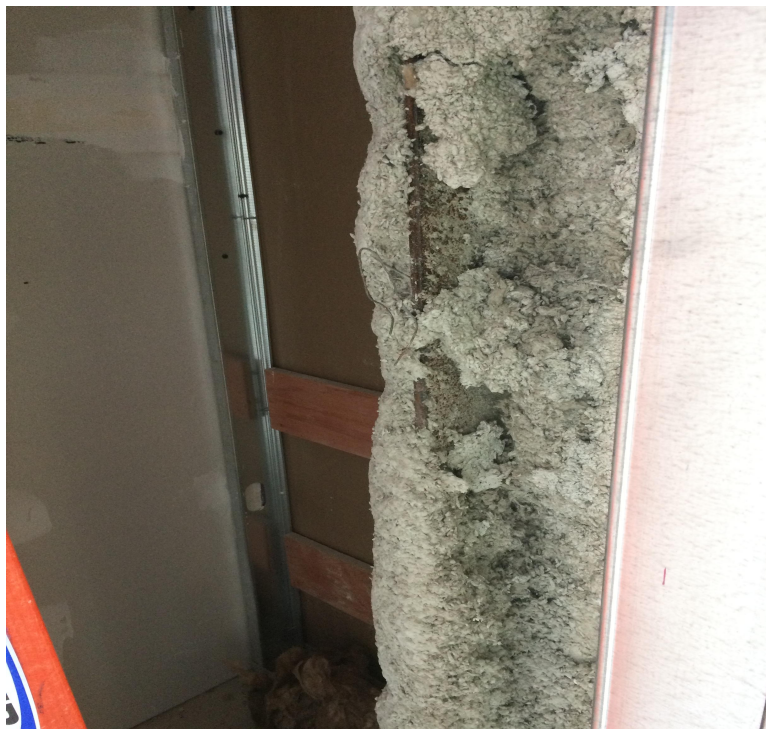
B

22.5	<p>Level 4 Group Room (4004)</p> <p>The wall that separates the Group Room from the toilet rooms/ante room is missing firestopping along the top of the wall. The drywall joint at the ceiling line also needs to be taped in accordance with it's UL design.</p> <p>Additionally, the column near door 4004 needs its spray fireproofing touched up prior to concealment in the wall.</p> <p>See attached photos.</p>	Correct Work

Steel column in Group Room 4004. Reference Item #22.5

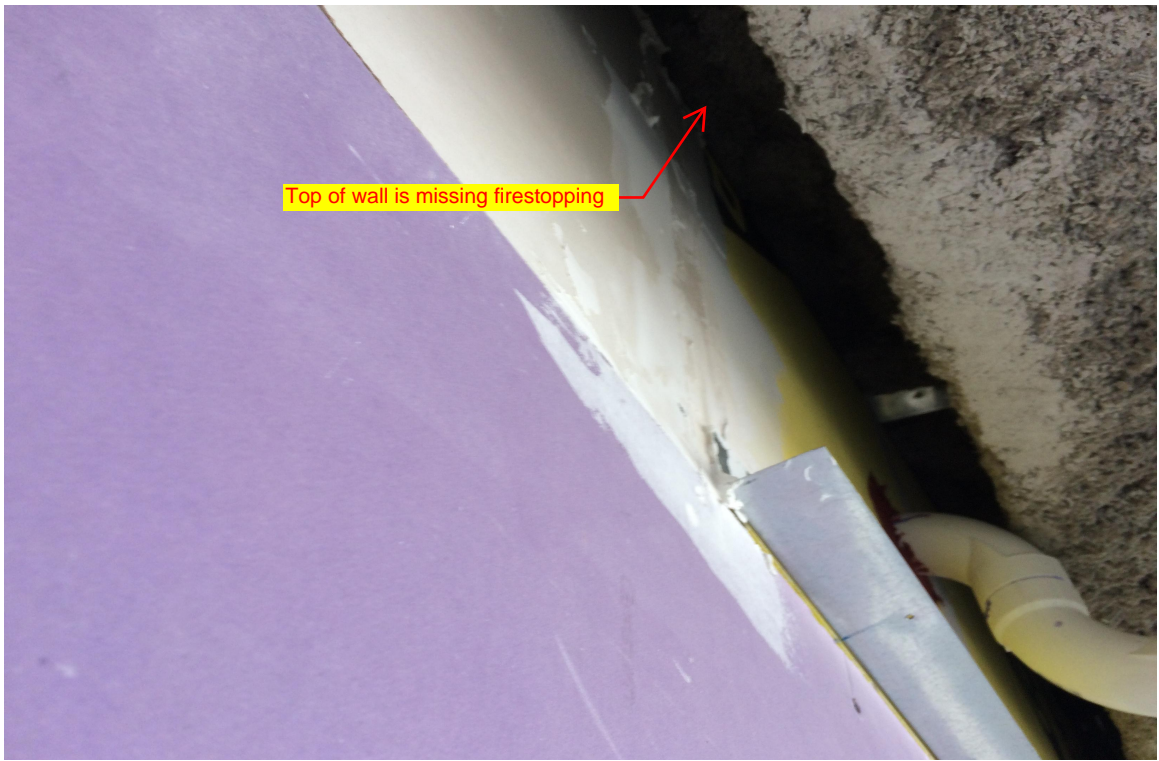
A

Group Room (4004) top of wall between group room and toilet rooms. Reference Item #22.5

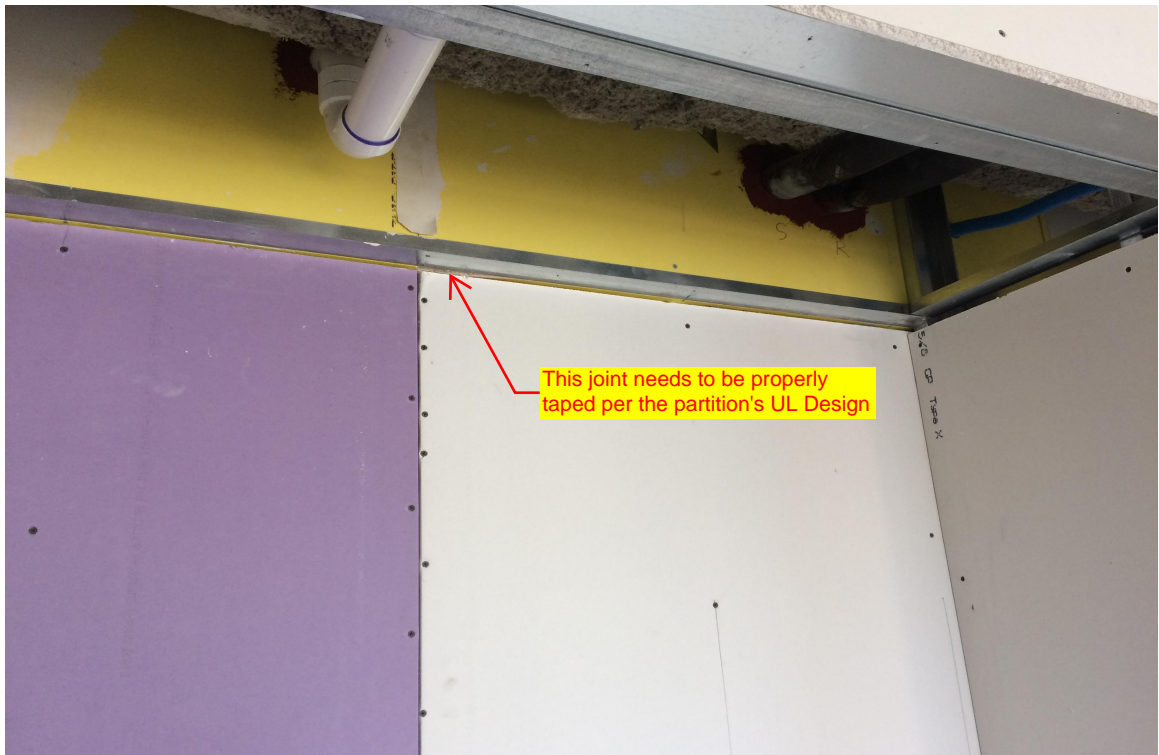
B

Group Room (4004) wall between group room and toilet rooms. Reference Item #22.5

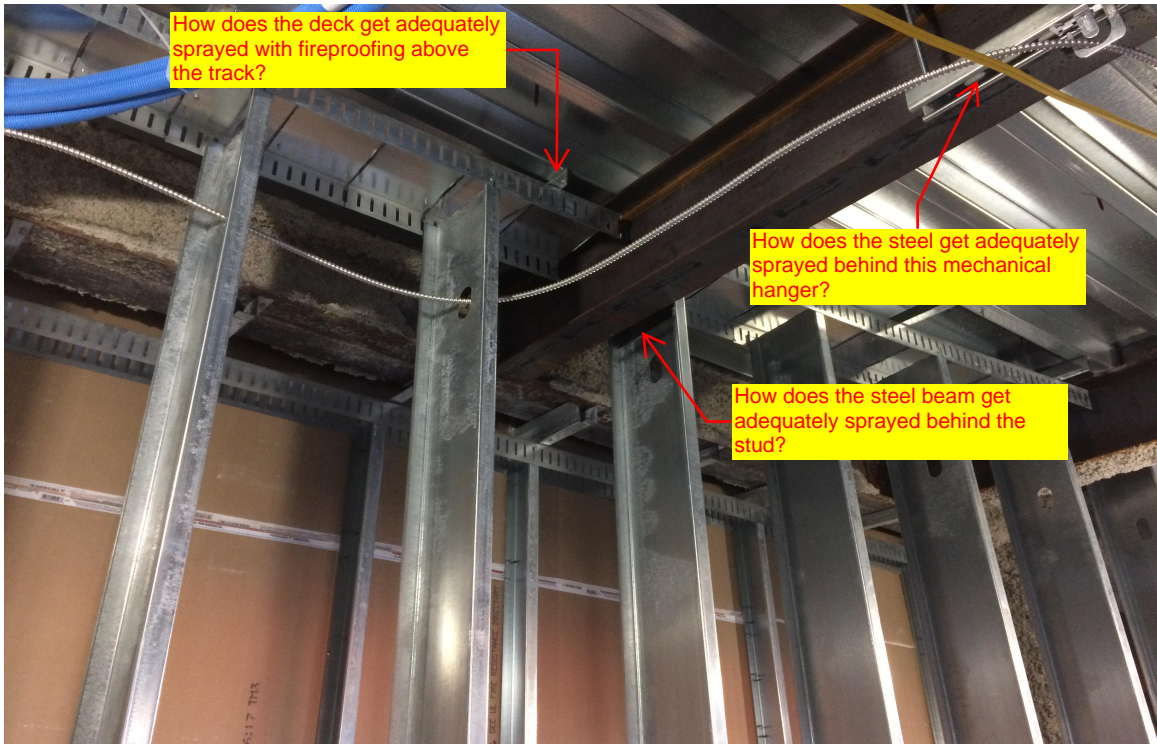
A

22.6	<p>Connector Steel Fireproofing</p> <p>Interior LGMF has been proceeding in areas of the connector that has yet to receive spray-applied fireproofing. Please note that all primary structural steel members and the metal roof deck shall receive 2-hour Spray-Applied Fireproofing. See attached photos.</p>	Observation

Fireproofing questions in Connector
