FIELD OBSERVATION REPORT 06-15-2016

Report Date: 06/15/2016

AEI Project Number and Name: 14018 – The Park Danforth

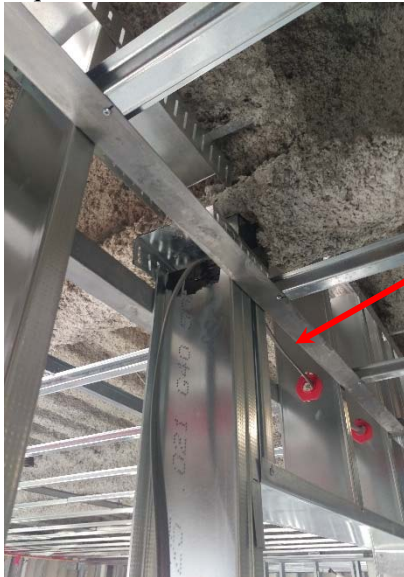
The power/control cable currently installed between the split-system air conditioner outdoor units and indoor units is type UF. This cable type is only permitted to be used in buildings permitted to be of Types III, IV, and V construction and is not permitted in Type I Construction. An armored or metal clad cable type is required.

Typical Type UF cable between units of ductless split air conditioners. This cable type is not permitted. Provide an armored or metal clad cable type.

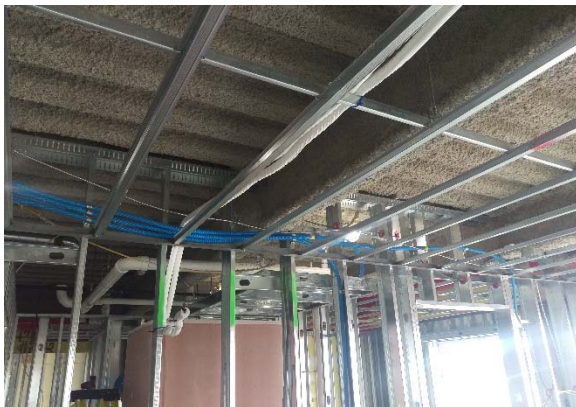
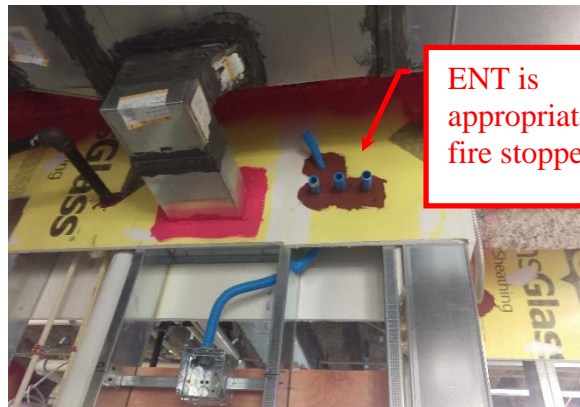
Electrical Nonmetallic Tubing (ENT) is installed for fire alarm and telecommunications raceways. AEI takes no exception to the use of ENT for this application provided it is acceptable to the Authority Having Jurisdiction.

ENT is appropriately fire stopped

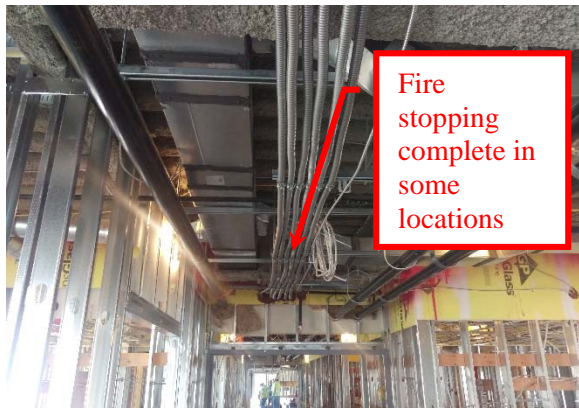
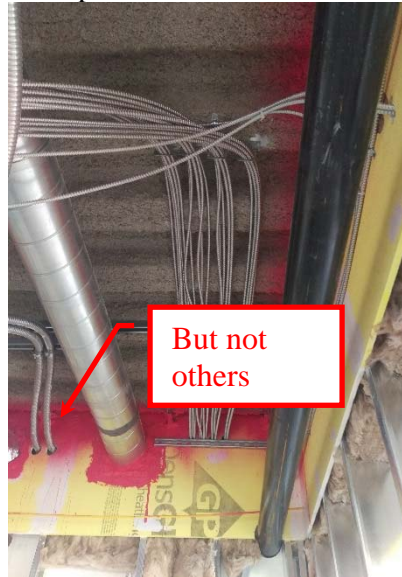
Installed feeders and branch circuit wiring is properly supported and appropriately bundled to avoid de-rating the conductors. Firestopping is in progress, but not complete.

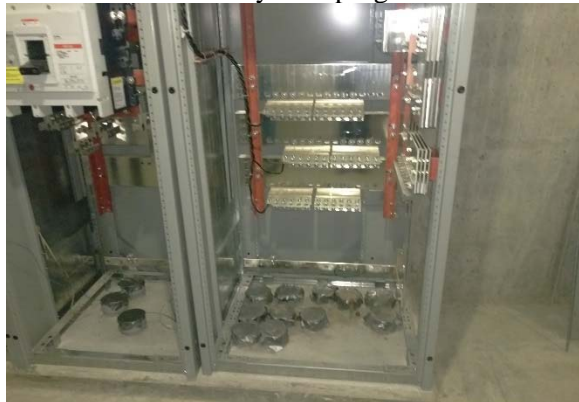
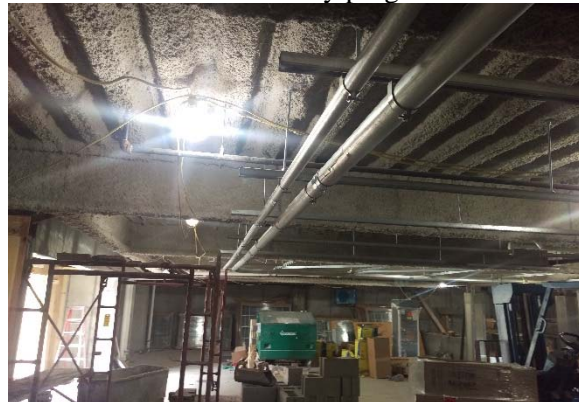
Garage Level

Switchboard assembly is in progress. Overhead conduit installation is in early progress.

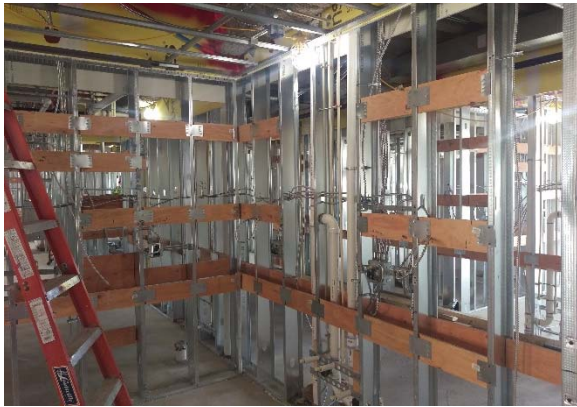
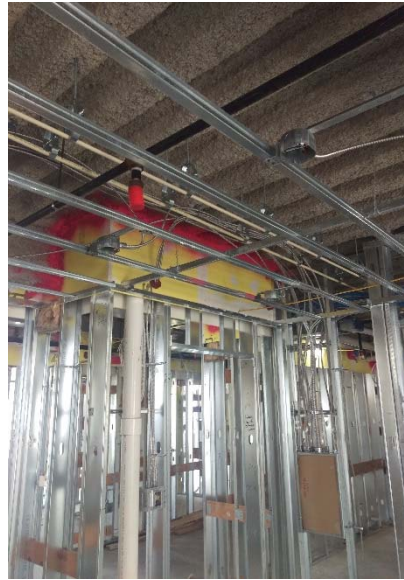
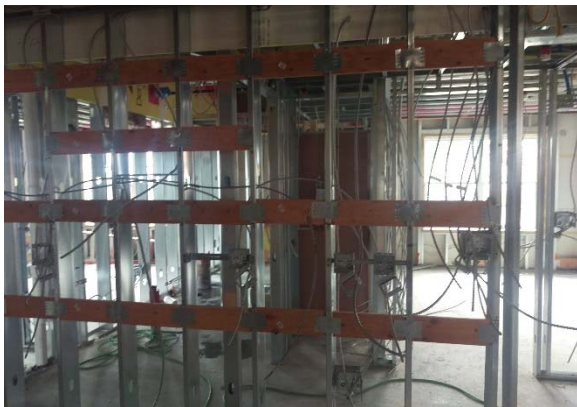
First, Second and Third Floors

Rough wiring in apartments appears generally complete on the first and second floors, and is in progress on the Third Floor.

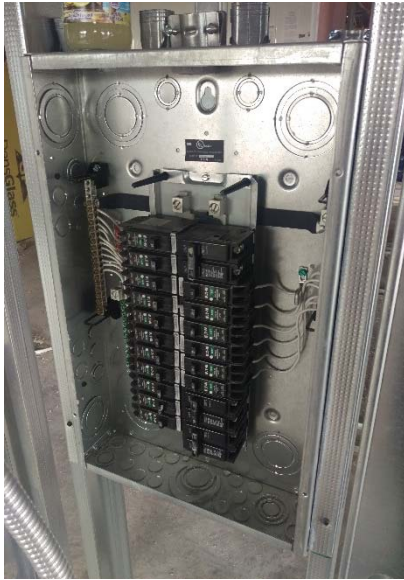
Fourth Floor

Installation of feeder cables to the apartment load centers is in early progress. Outlet and device boxes and loadcenter enclosures are installed

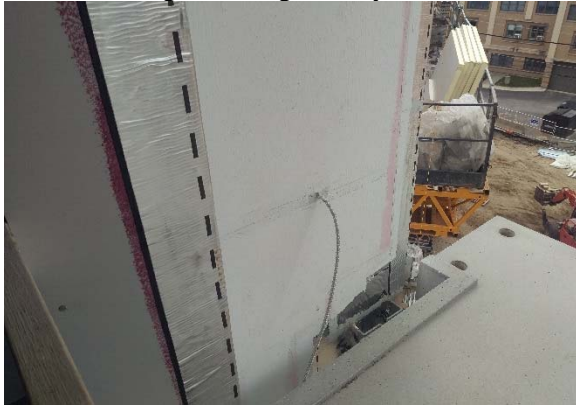
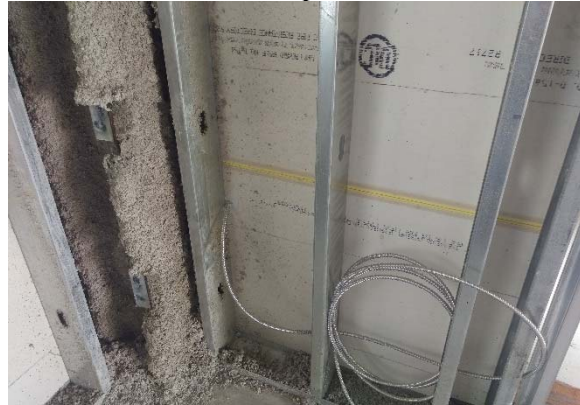
Fifth Floor

Electrical rough-in has generally not started, but MC cables to outdoor receptacles are installed and sealed.

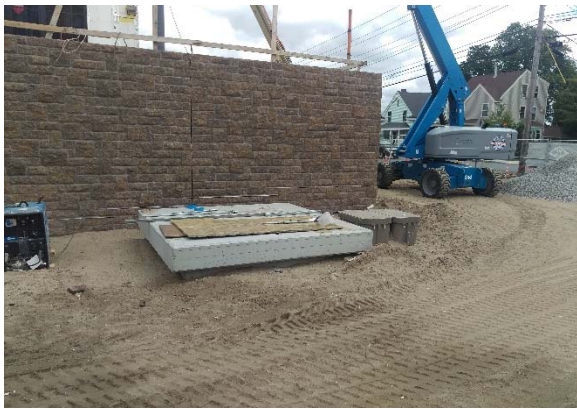
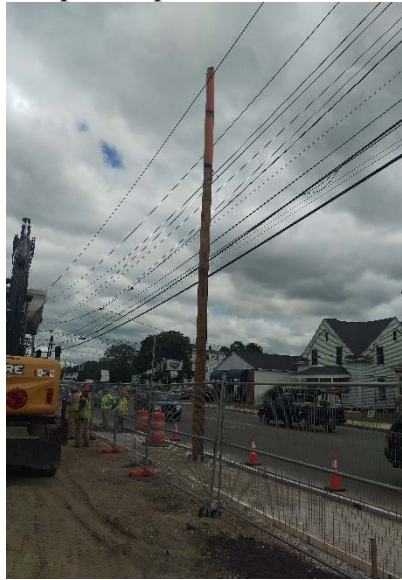
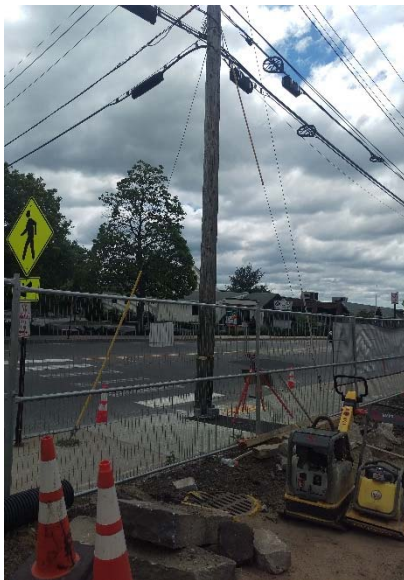
Outdoors

The utility transformer vault and communications pull boxes are installed. The utility riser pole is installed and power and communications conduits are stubbed up at the poles.
