FIELD OBSERVATION REPORT 06-15-2016

AEI Project Number and Name: 14018 – The Park Danforth

Contractor: PC Construction

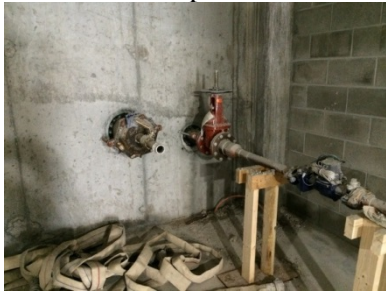
Domestic and Sprinkler entrance piping is in progress.

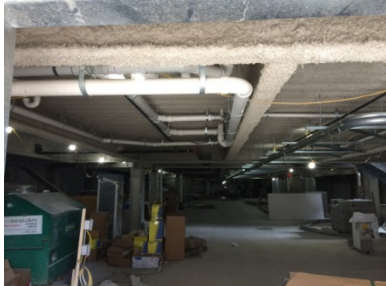
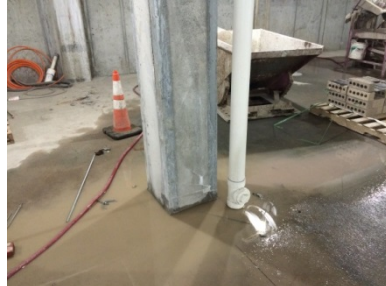
Piping in the Garage has been installed to maximize headroom, utilizing the precut holes in the beams. The vertical drops may be vulnerable to damage depending on where the parking areas are located.

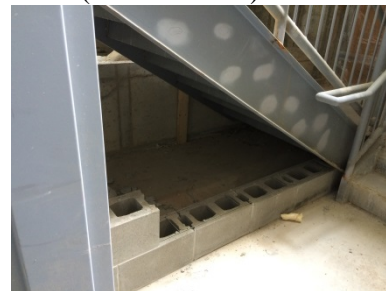
Verify that there is enough space in front of block to allow for the convection heater to be installed below the stairs. (See SKM-12.)

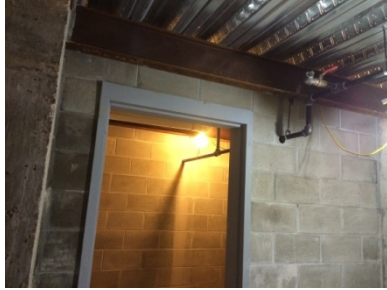
The sprinkler piping feeding the electrical room runs through the space and into the adjacent storage room. A dedicated line feeding only the electrical room is required.

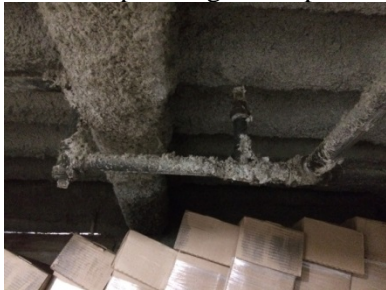
Clean fireproofing from sprinklers and piping.

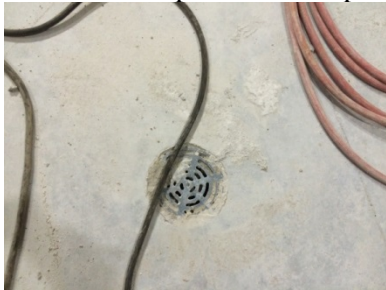
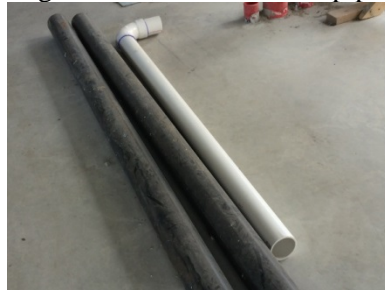
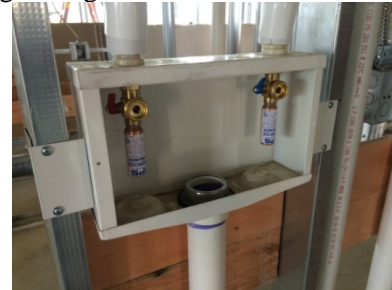
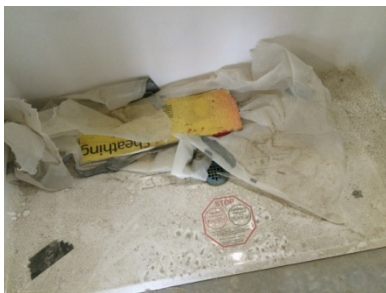
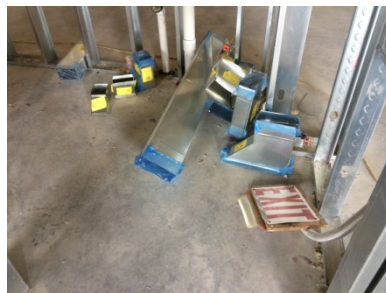
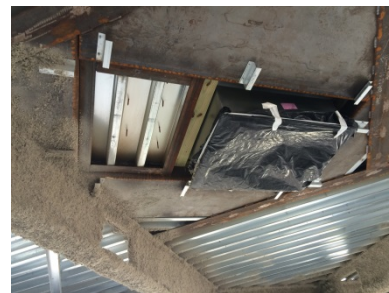
Provide cover/protection for plumbing fixtures, ductwork and piping during construction.

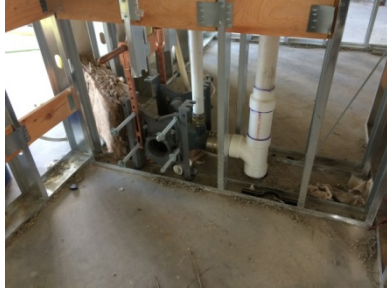
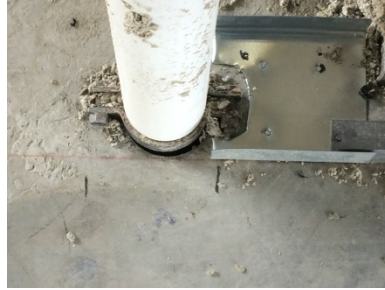
Verify Hilti sleeves have been installed at all floor penetrations or provide firestopping as required. Provide vertical support for all floor penetrations.

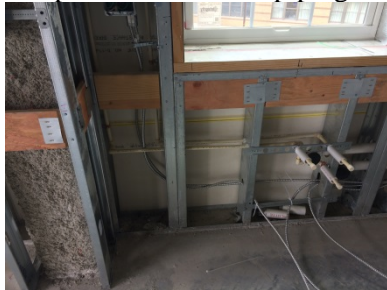
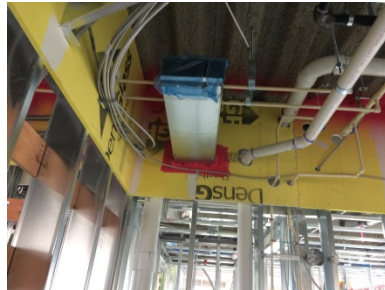
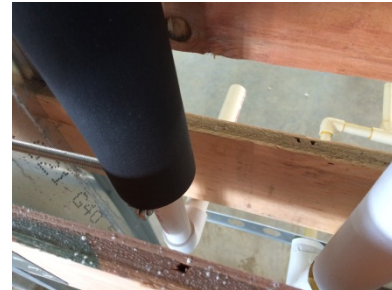
Complete insulation of piping.

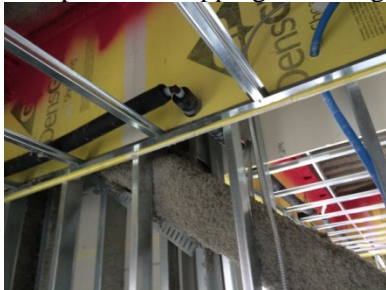
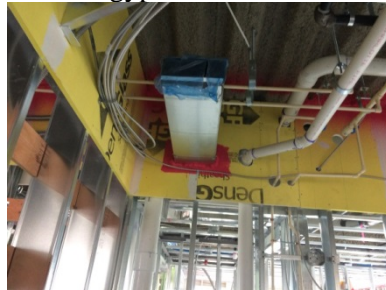
Complete firestopping, Seal large holes in gyp board where firestopping is required.
