FIELD OBSERVATION – SECOND FLOOR CEILING REPORT 07-11-2016

Report Date: 07/11/2016

AEI Project Number and Name: 14018 – The Park Danforth

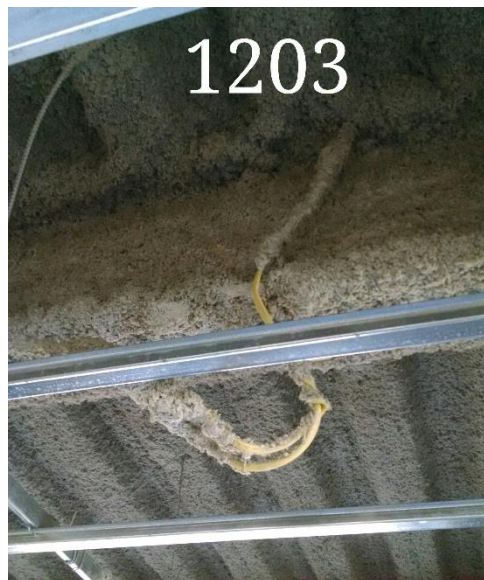
1. All temporary wiring must be completely removed prior to project close out. See below for an example.

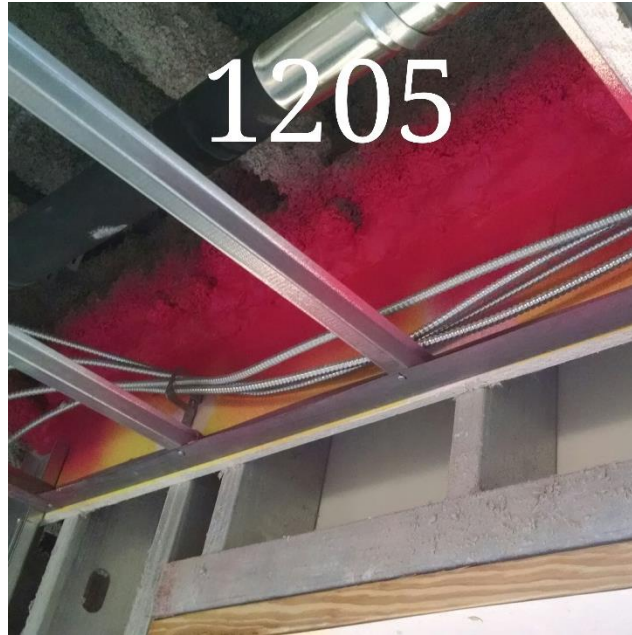
2. Support wiring so that it does not rest on hat channel. See below.

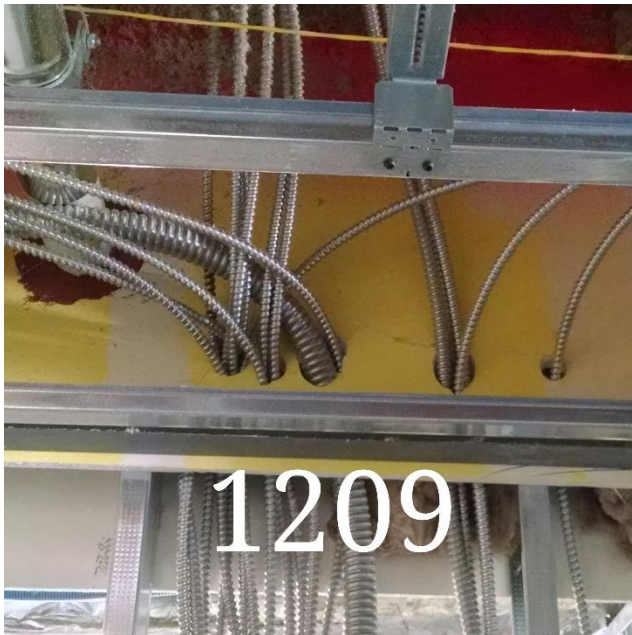
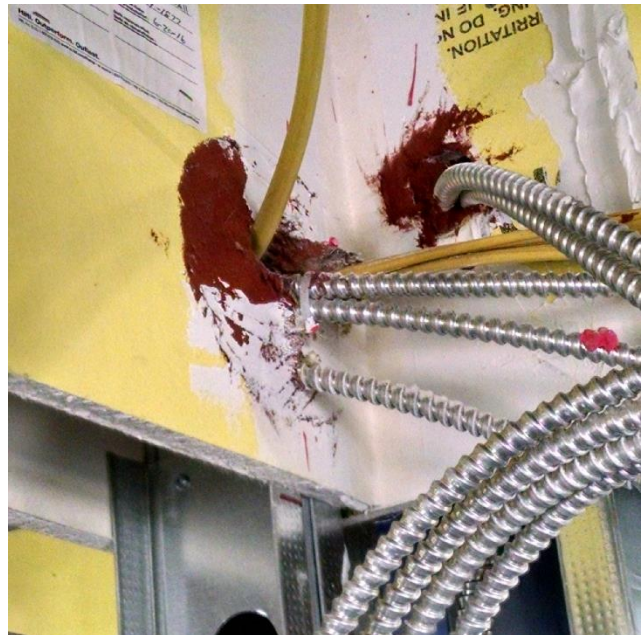
3. Fire caulk all penetrations through rated assemblies; re-apply when temporary wiring is removed. See below.

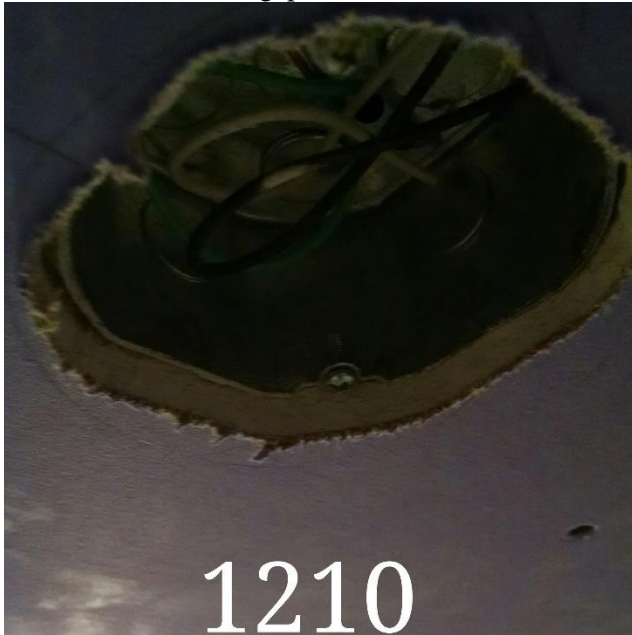
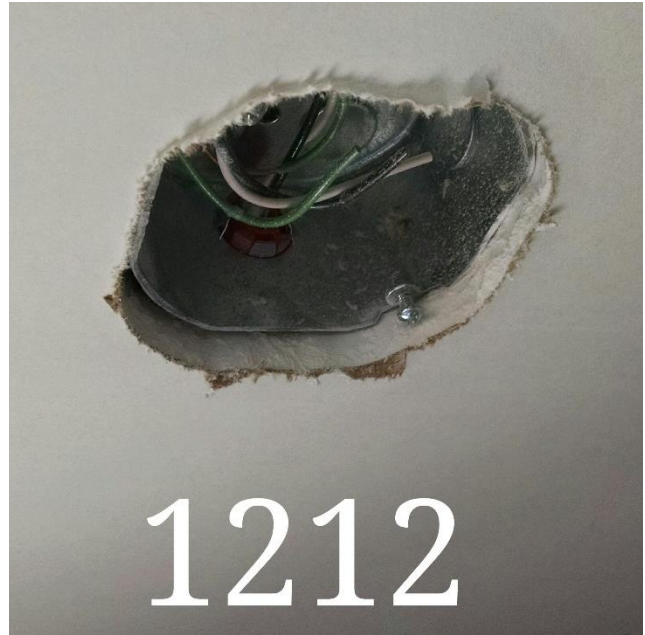
4. In areas where drywall is installed- particularly at ceilings- large gaps exist between the face of outlet boxes and the face of the drywall. Ensure any gaps that exist are code-compliant or take steps to eliminate the gaps. See below.
