FIELD OBSERVATION – SECOND FLOOR CEILING REPORT 06-15-2016

Report Date: 07/11/2016

AEI Project Number and Name: 14018 – The Park Danforth

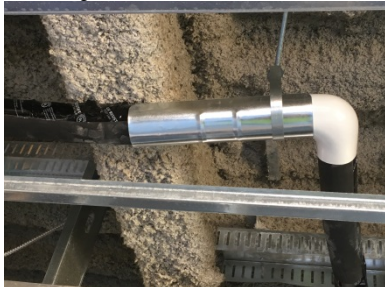
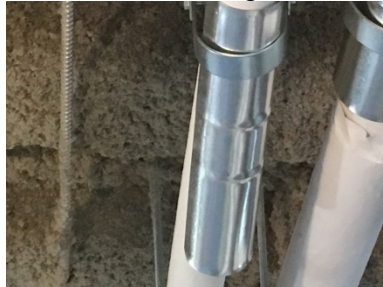
1. Adjust saddles to be centered below clevis hanger.

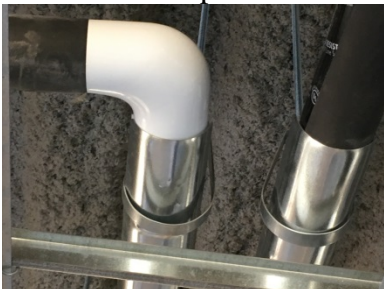
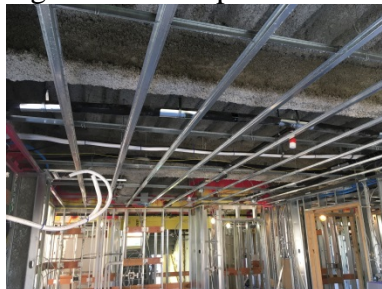
2. Adjust hangers so that piping is supported, and does not have any peaks or valleys in horizontal span and runs straight in vertical positions.

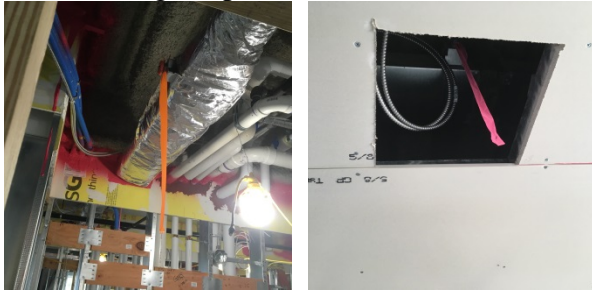
3. Verify all VD's are in accessible locations, either above acoustical tiled ceilings or have access panels coordinated with architect. Provide identification to locate each VD on ceiling according to spec section 230553.

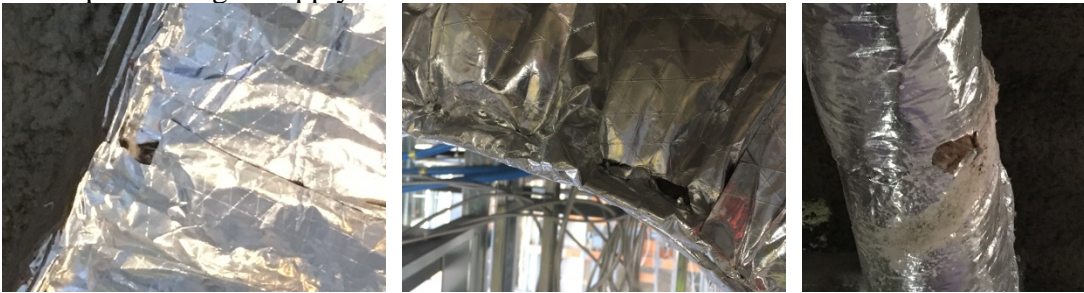
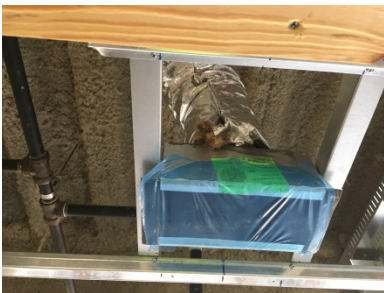
4. Repair damaged supply duct insulation.

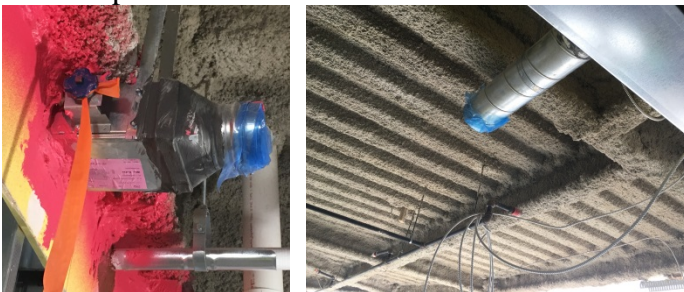
5. Complete exhaust duct installation.

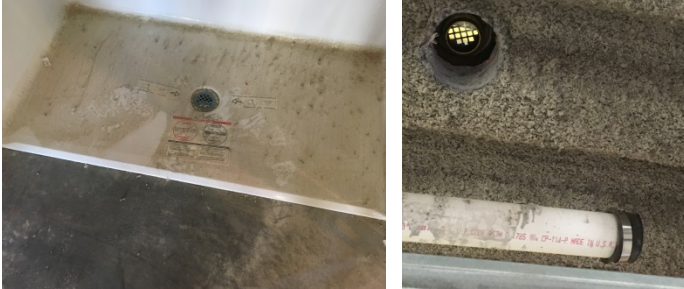
6. Provide protection for showers during construction. Complete shower installation.

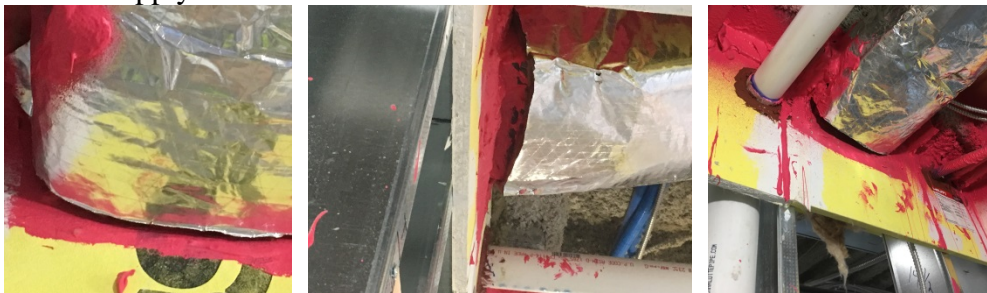
8. Seal supply duct insulation at fire rated wall.

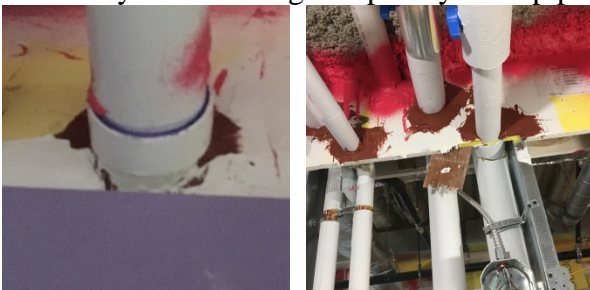
9. Verify fire caulking completely seals pipe penetrations.

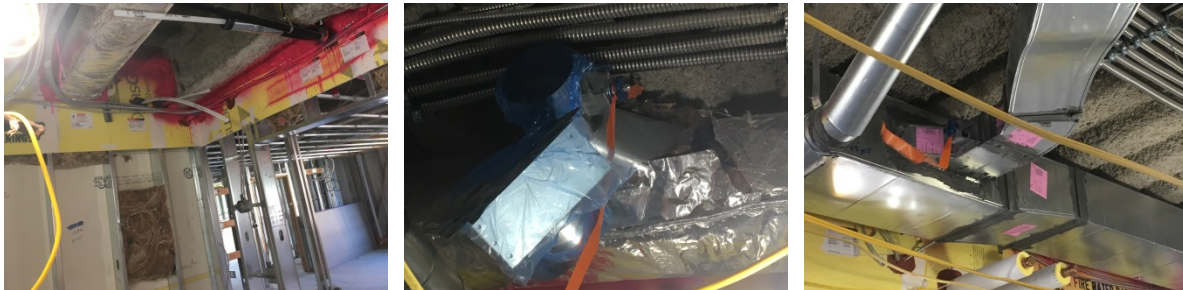
13. General Comment, Corridor: Complete pipe and duct routing and insulation.
