FIELD OBSERVATION – Third FLOOR CEILING REPORT

Report Date: 07/22/2016

AEI Project Number and Name: 14018 – The Park Danforth

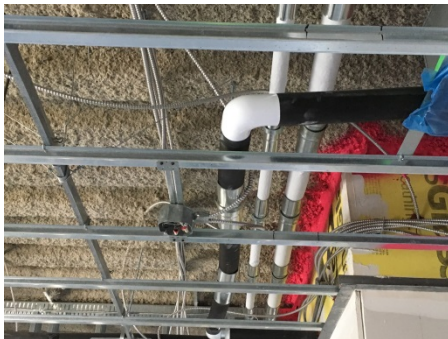
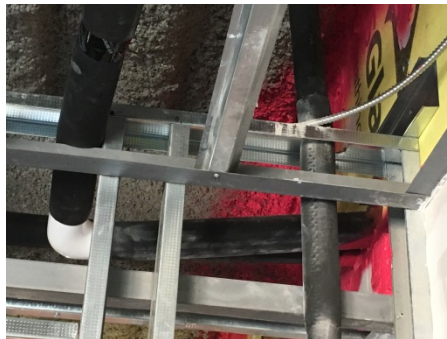
1. Install pipe hangers within 12” of horizontal elbows.

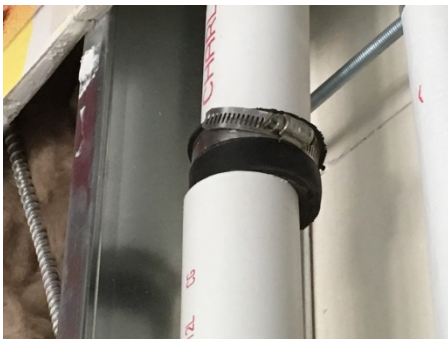
2. Repair?

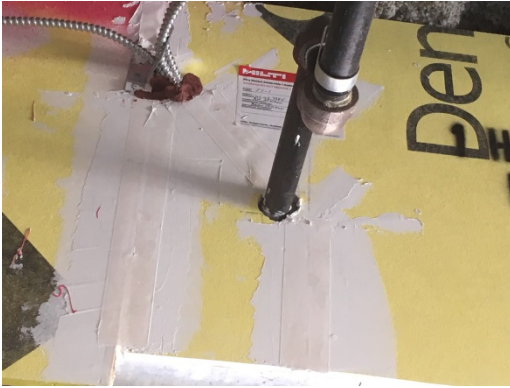
3. Provide fire caulking at sprinkler piping penetration.

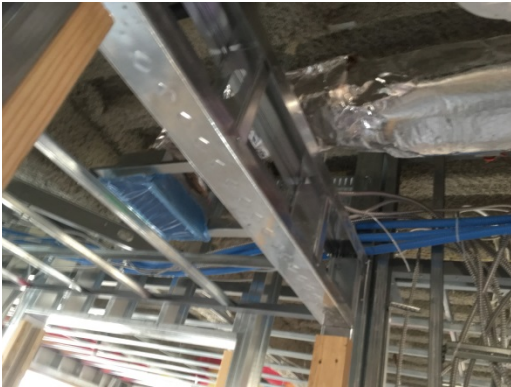
4. Repair damaged supply duct insulation.

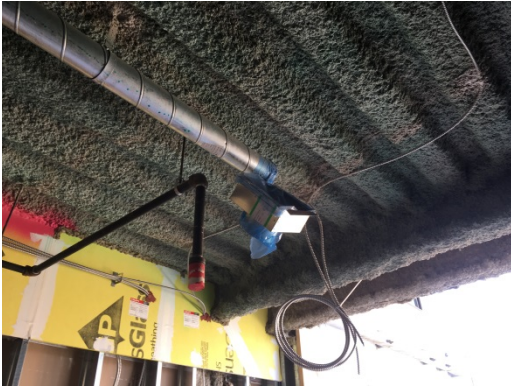
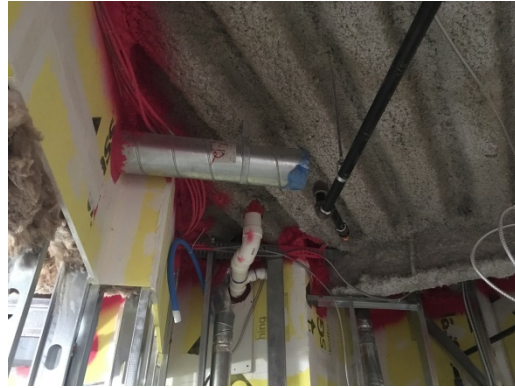
5. Complete exhaust duct installation.

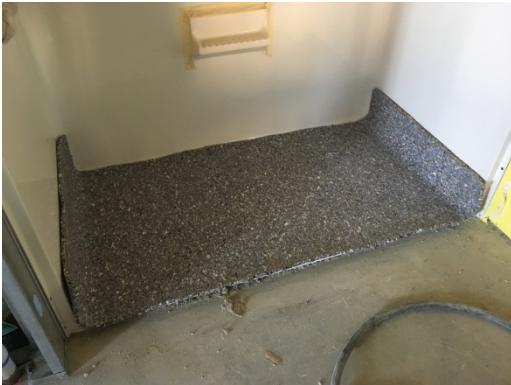
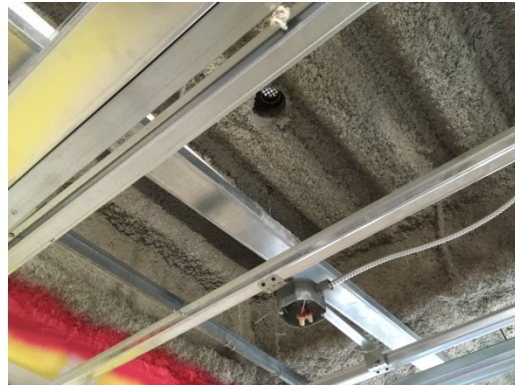
6. Provide protection for showers during construction. Complete shower installation from floor above. (Some showers were covered, thank you!!)

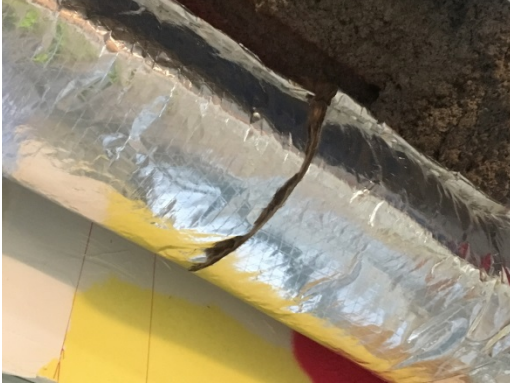
7. Tape seam of supply duct insulation.

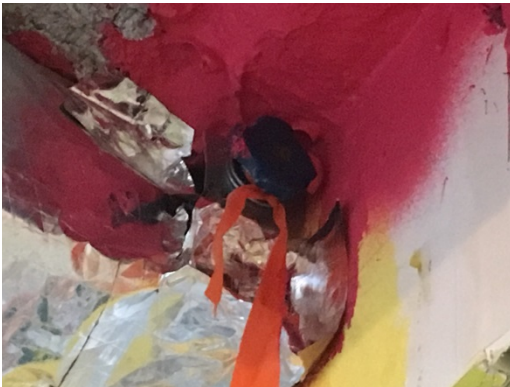
8. Verify fire caulking does not interfere with operation of volume damper.

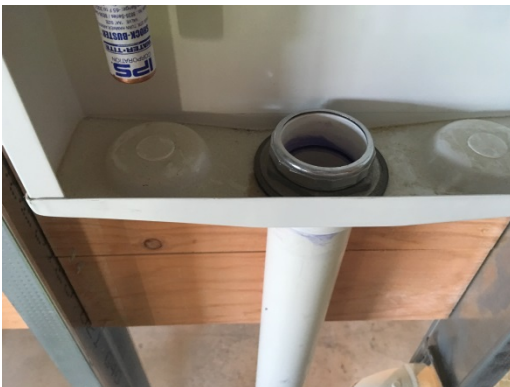
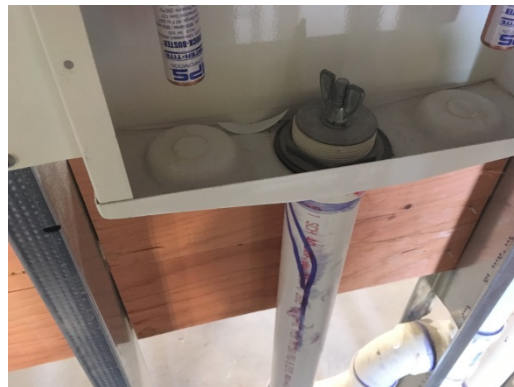
9. Cover washing machine standpipe during construction, some were covered, some not.
