FIELD OBSERVATION – THIRD FLOOR IN-WALL AND CEILING ELECTRICAL REPORT 07-25-2016

Report Date: 07/25/2016

AEI Project Number and Name: 14018 – The Park Danforth

Contractor: PC Construction

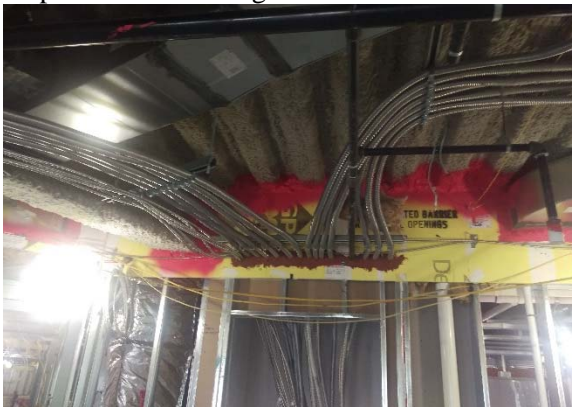
1. Temporary wiring and lighting fixtures are in place throughout the project. These shall be removed when no longer needed.
2. Firestopping is generally complete above ceilings, but generally incomplete below ceilings. Firestop all penetrations through rated walls.

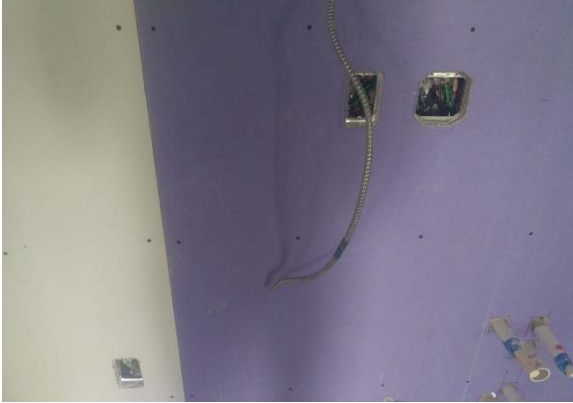
Unit 1300

1. Boxes in the wall abutting the corridor are recessed too far from the face of the wall.

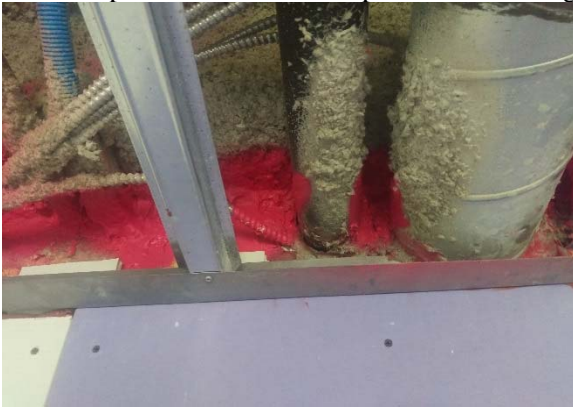
2. An air cap is visible at a cable penetration through the wall abutting the corridor.

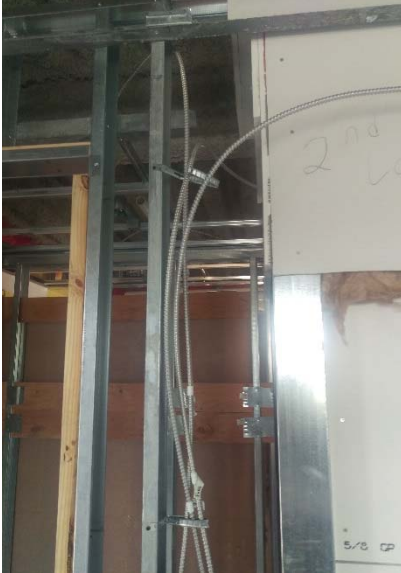
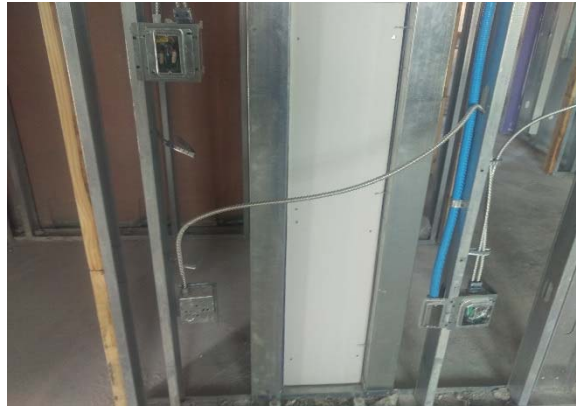
3. Some cables in the bedroom are not properly secured.

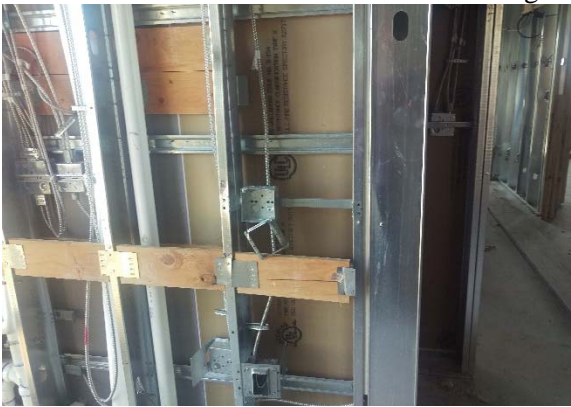
Corridor 3000

1. The area of rescue assistance call station rough-in near Unit 1300 is not complete.

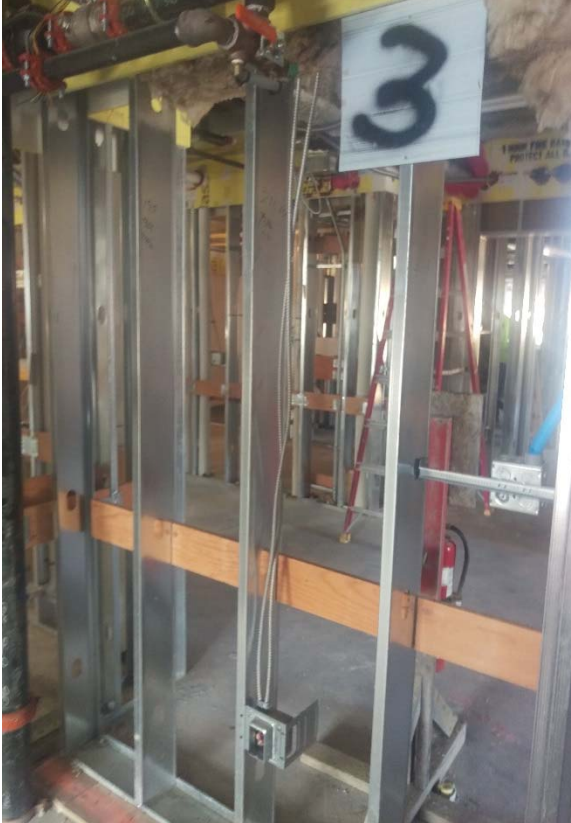
Stair A

1. MC cable is not properly secured at third floor landing receptacle.

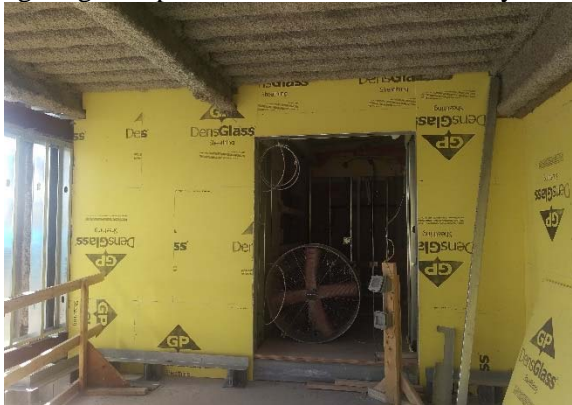
Community Deck 3004

1. Lighting, receptacle, and fire alarm are not yet roughed in.

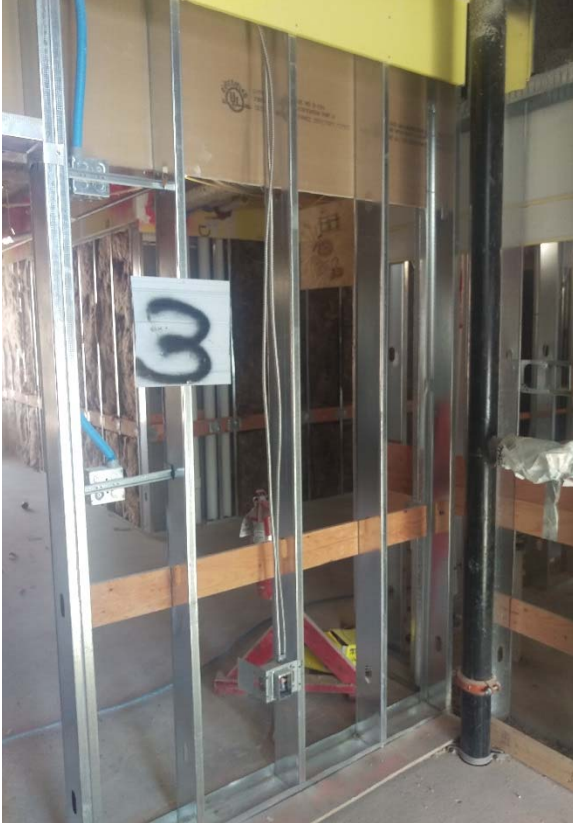
Stair B

1. MC cable is not properly secured at third floor landing receptacle.
