FIELD OBSERVATION –REPORT

AEI Project Number and Name: 14018 – The Park Danforth

Observations: 4th FLOOR Walk-through

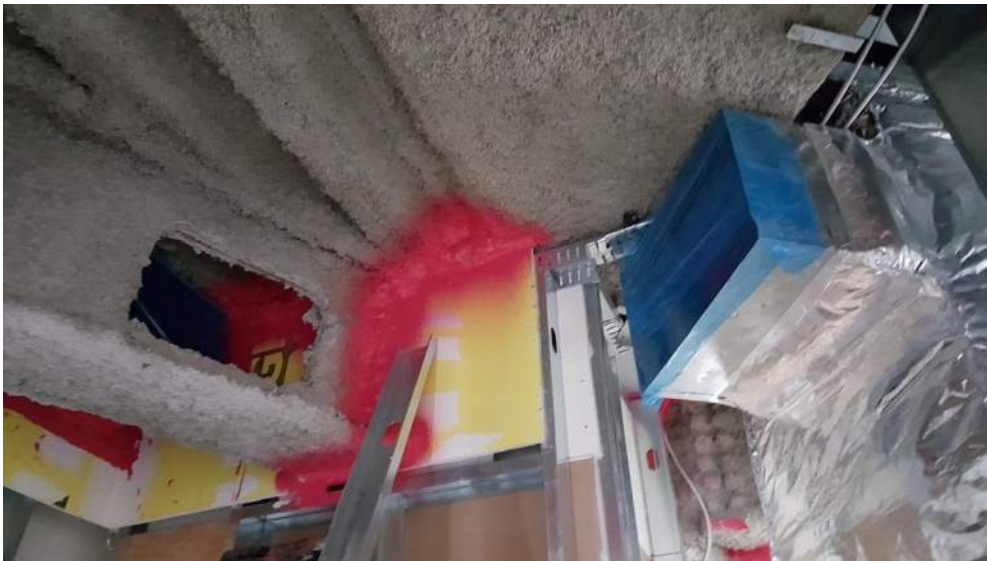
1. Label piping throughout.
2. The Portland plumbing inspector has inspected the piping according to Titan.
3. General Comment, Corridor: Complete pipe and duct routing and insulation.

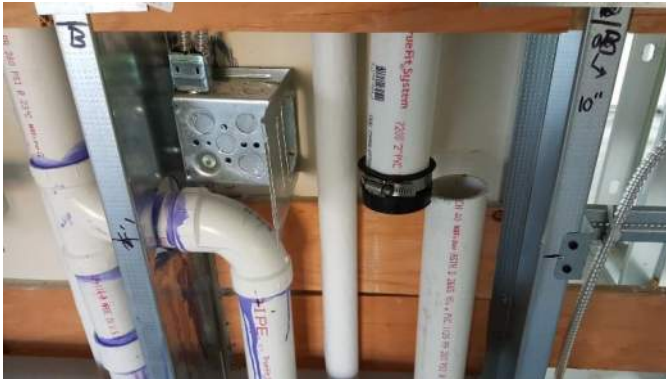
4. Complete piping, sample below:

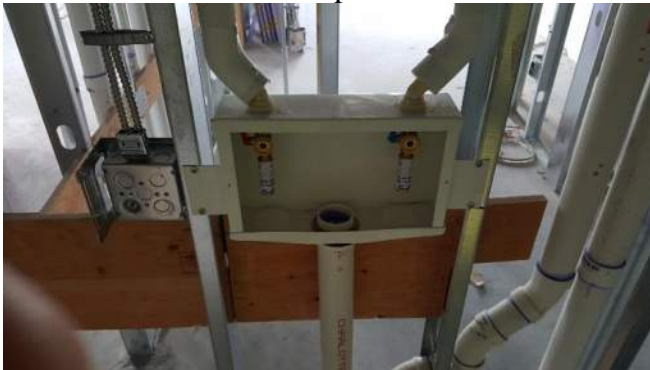
5. Valve box drains still not protected. Coordinate installation of washer, dryer, and AC drains.

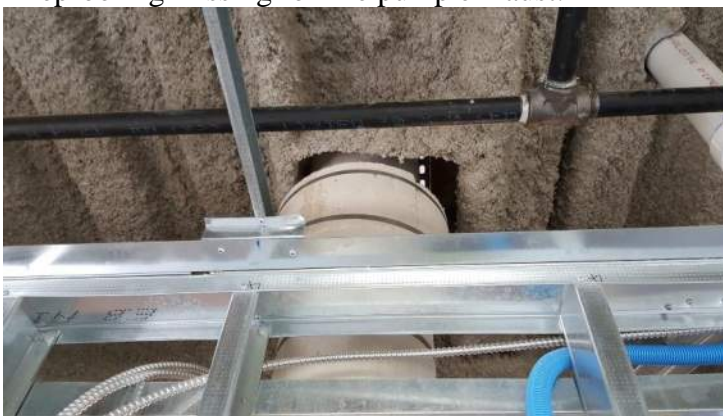
6. Fireproofing missing for fire pump exhaust.

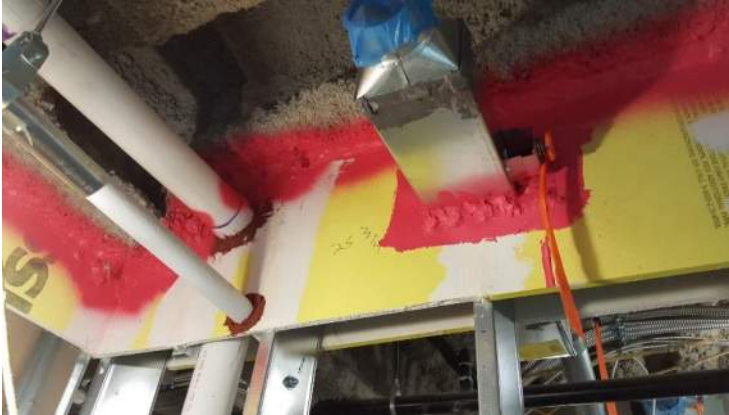
8. Fire proofing labeling is not consistent, many labels are missing.
