FIELD OBSERVATION – FOURTH FLOOR IN-WALL AND CEILING ELECTRICAL REPORT 08-02-2016

Report Date: 08/02/2016

AEI Project Number and Name: 14018 – The Park Danforth

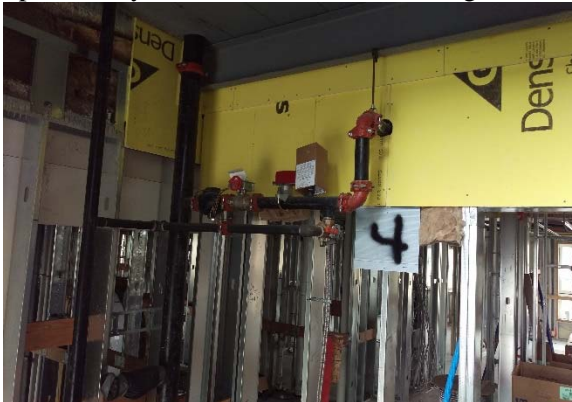
General

1. Temporary wiring and lighting fixtures are in place throughout the project. These shall be removed when no longer needed.
2. Cables are not yet terminated at the load centers in units 1400 through 1403.
3. Sprinkler system devices at stair landings are not yet roughed in for connection to fire alarm.

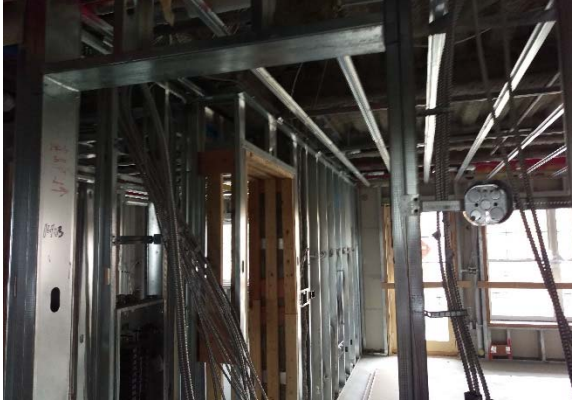
Unit 1403

1. Cables are not yet terminated at the lighting outlet box in the corridor.

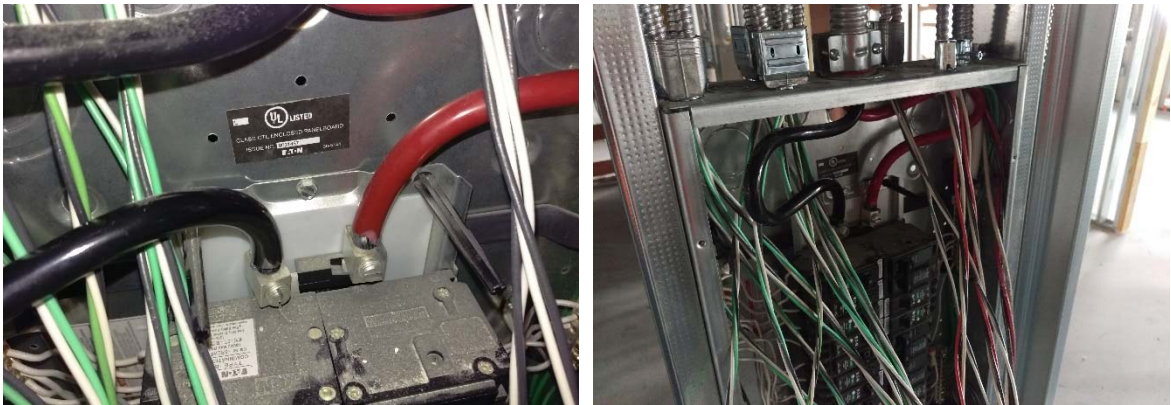
Unit 1404

1. A main-lug termination in the load center has bent the load center main bus. Replace load center interior.

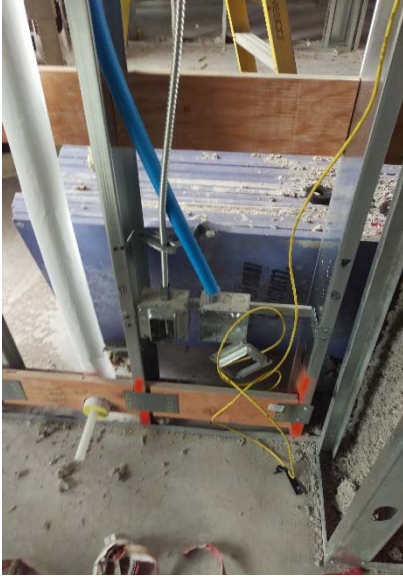
Unit 1407

1. Install plaster ring on Living Room telephone outlet box.

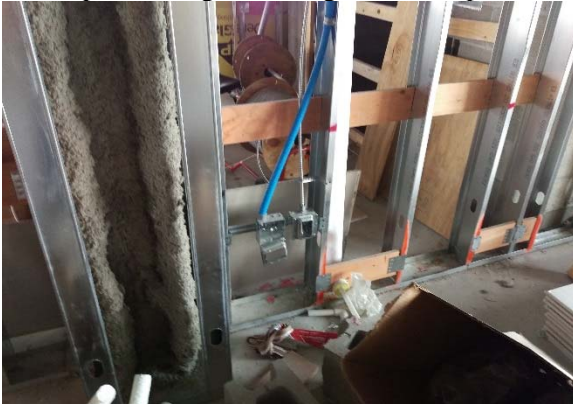
Unit 1408

1. Install plaster ring on Living Room telephone outlet box.

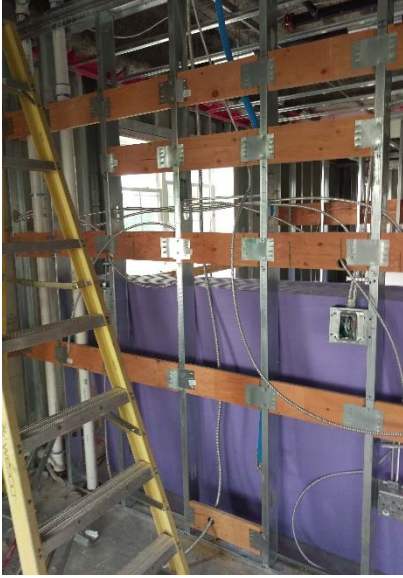
Units 1411 and 1412

1. The range cables are not properly secured.

(Unit 1412 pictured)

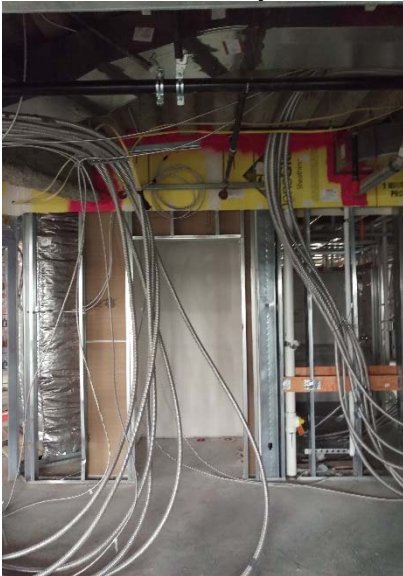
Elec 4002

1. Feeder cables are not yet run into the room. Firestop the cables when their installation is complete.

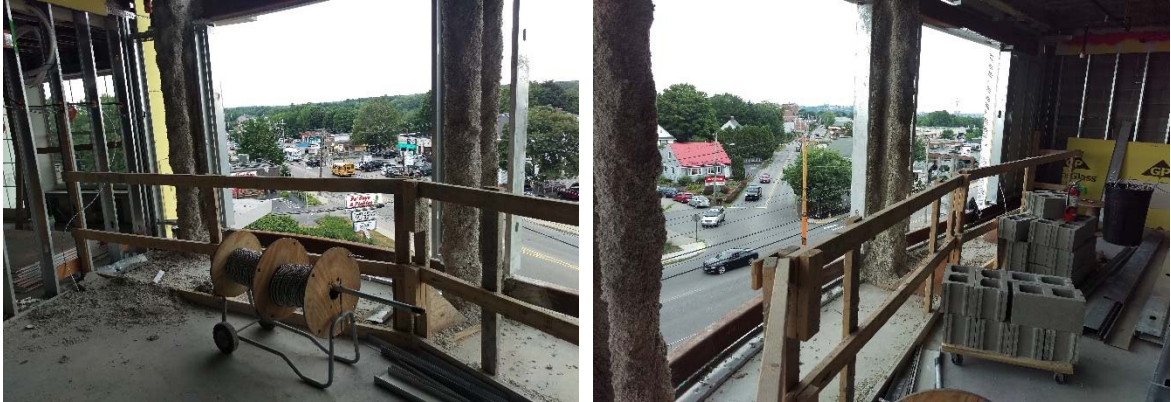
Group Room 4004

1. Rough-in of exterior wall is generally not complete.
