FIELD OBSERVATION – FIFTH FLOOR WEST IN-WALL AND CEILING MECHANICAL, PLUMBING AND SPRINKLER REPORT 09-13-2016

Report Date: 09/13/2016

AEI Project Number and Name: 14018 – The Park Danforth

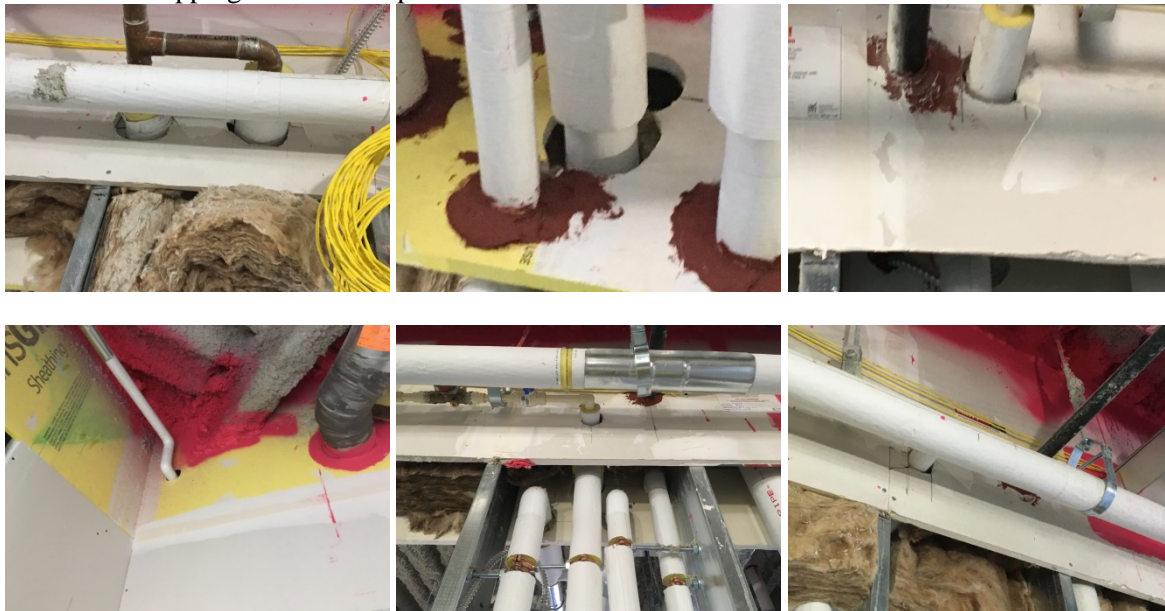
- Firestopping was not complete in several areas.

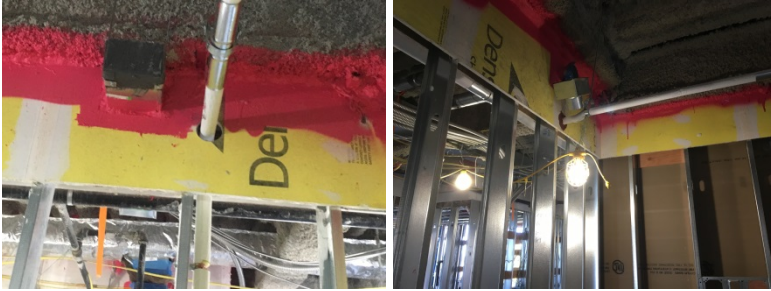
- Exhaust ductwork not complete

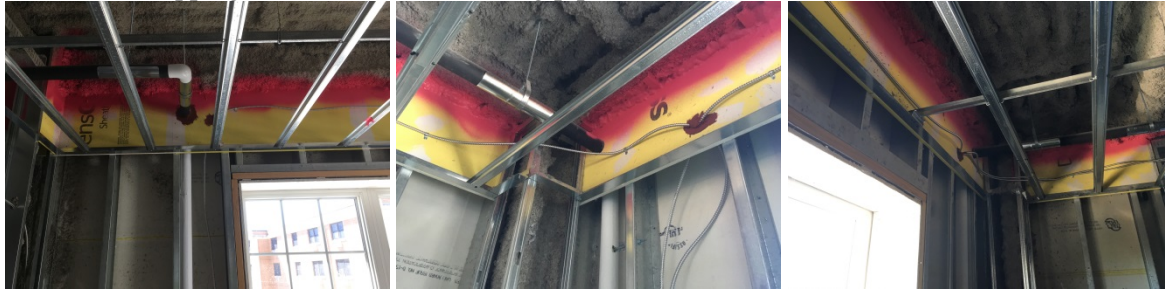
- Firestopping not consistent for heating pipes in exterior walls.

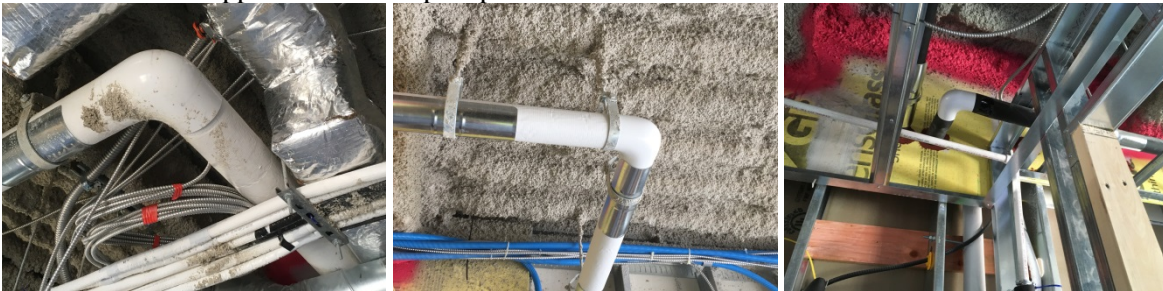
- Provide support for elbows per specs.

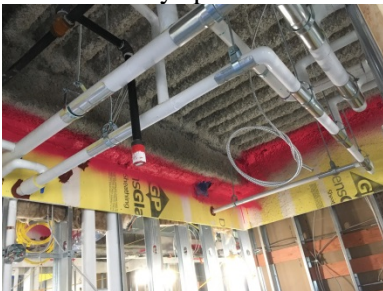
- Verify sprinkler head is not too far away from wall in bathrooms.

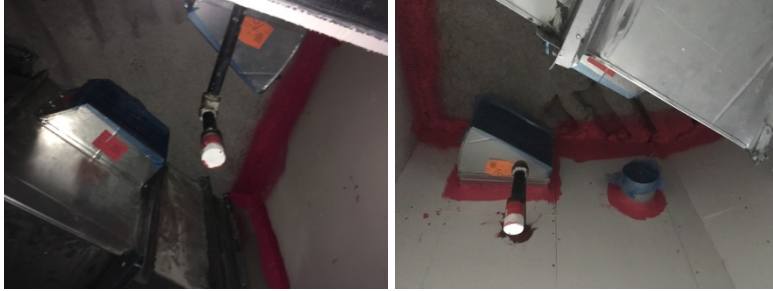
HSKG 5008

- Ductwork was not complete

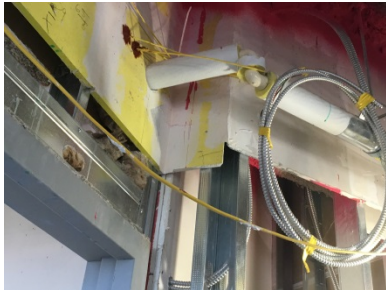
Corridor

- Insulation on elbows missing.

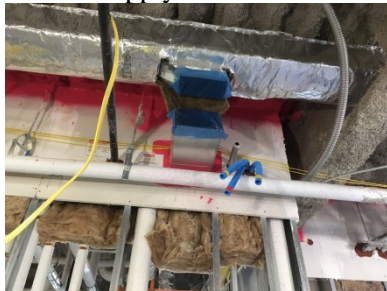
Unit 1501

- Supply duct elbow missing.

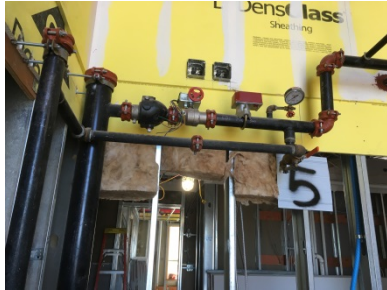
Stair A

- Raise sprinkler zone control valve and drain higher to avoid accidental or intentional handling of equipment.
