Project:	Park Danforth
Location:	Portland, ME
Becker Job No:	3422

OBSERVATION REPORT

Cast in Place Concrete

Date:	04-27-16
Time:	3:00 PM
Temp:	65° F
Weather:	Sunny

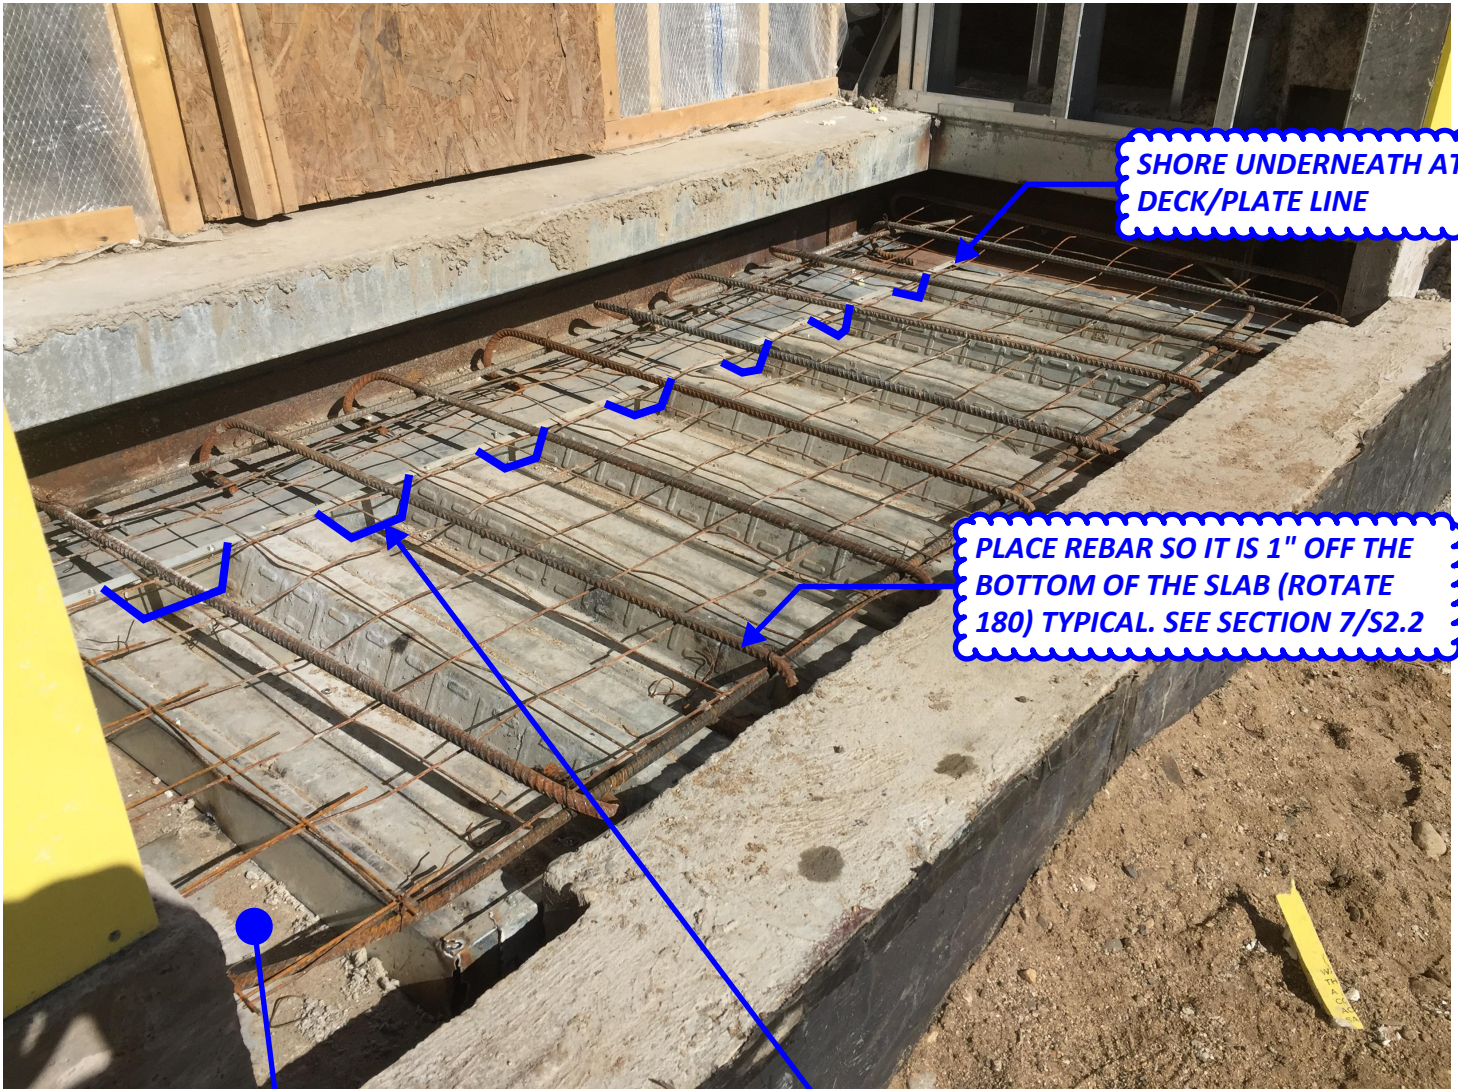
Deck construction of the depressed exterior slabs on H line from 8-8.5 and 9-10 were constructed improperly. Section 9/S3.3 was applied to the strong direction of the deck on G.8 line resulting in the deck being cut back from the support beams on G.8 line and a deck filler plate installed from the edge of the deck to the beam. At this location the GC has shored the deck for concrete placement. Additionally the rebar was installed at the top of the slab instead of at the bottom do to a conflict with the deck closure plate. The deck closure plate should be cut out at each deck flute to allow the rebar to be installed 1" from the bottom of the slab. The shoring shall remain in place until the slab has cured. I notified Andrew from PC of my findings. Please see attached markup for clarification.

SHORE UNDERNEATH AT DECK/PLATE LINE

PLACE REBAR SO IT IS 1" OFF THE BOTTOM OF THE SLAB (ROTATE 180) TYPICAL. SEE SECTION 7/S2.2

(2)#5 WITH 180 HOOKS IN BOTTOM OF SLAB WHERE DECK PLATE IS PARALLEL WITH DECK PER SECTION 9/S3.3

CUT OUT DECK CLOSURE STRIP AT EACH DECK FLUTE SO REBAR CAN BE 1" FROM BOTTOM OF SLAB TYPICAL.
