<b>OBSERVATION REPORT</b>
Structural Steel

<b>Project:</b>	Park Danforth
<b>Location:</b>	Portland, Maine
<b>Becker Job No:</b>	3422

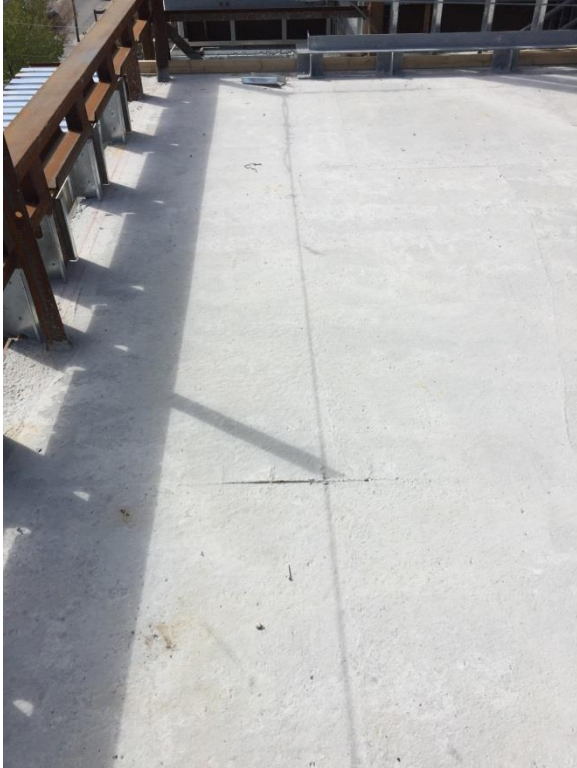
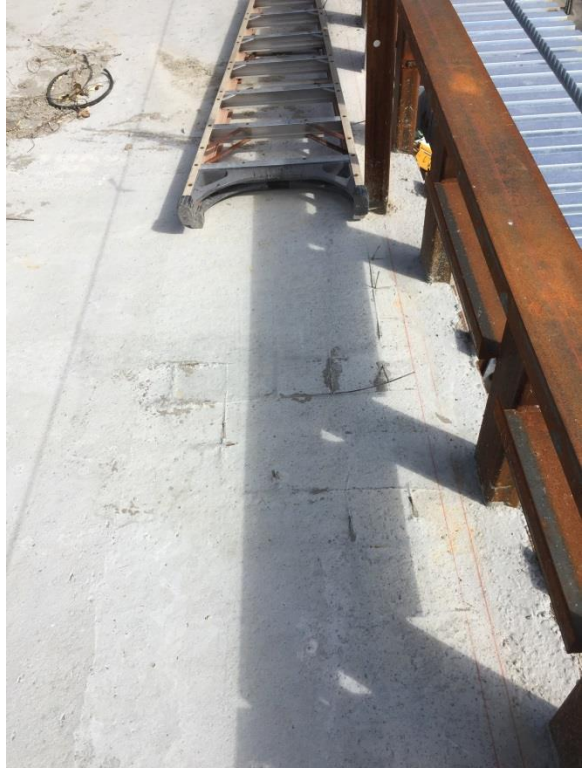
While on site I noticed at the 5<sup>th</sup> floor roof top garden small areas where welded wire fabric was exposed in the finished slab (see attached pictures). The welded wire fabric is used for crack control and not structural reinforcement therefore this is not a structural issue but a serviceability issue. In order to mitigate any corrosion issues before the paver system is applied the exposed welded wire fabric should be cut flush with the concrete slab and coated with cold applied asphalt emulsion.

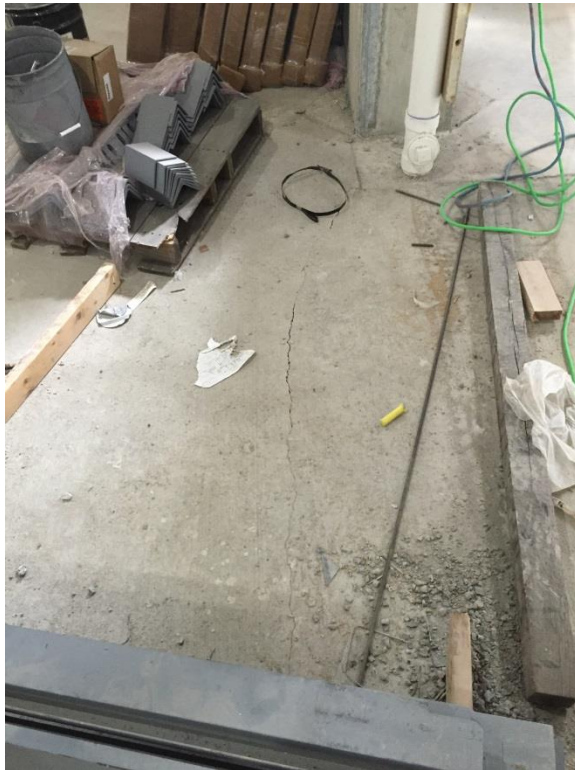
In the garage near stair B there is a slab crack along grid 9 that does not follow the contraction joint (see attached picture). This is not a structural issue but an aesthetics issue the crack should be filled with sealant.
