Project:	Park Danforth
Location:	Portland, ME
Becker Job No:	3422

OBSERVATION REPORT

Cast in Place Concrete

Date:	11-17-15
Time:	8:00 AM
Temp:	34° F
Weather:	Sunny/Clear

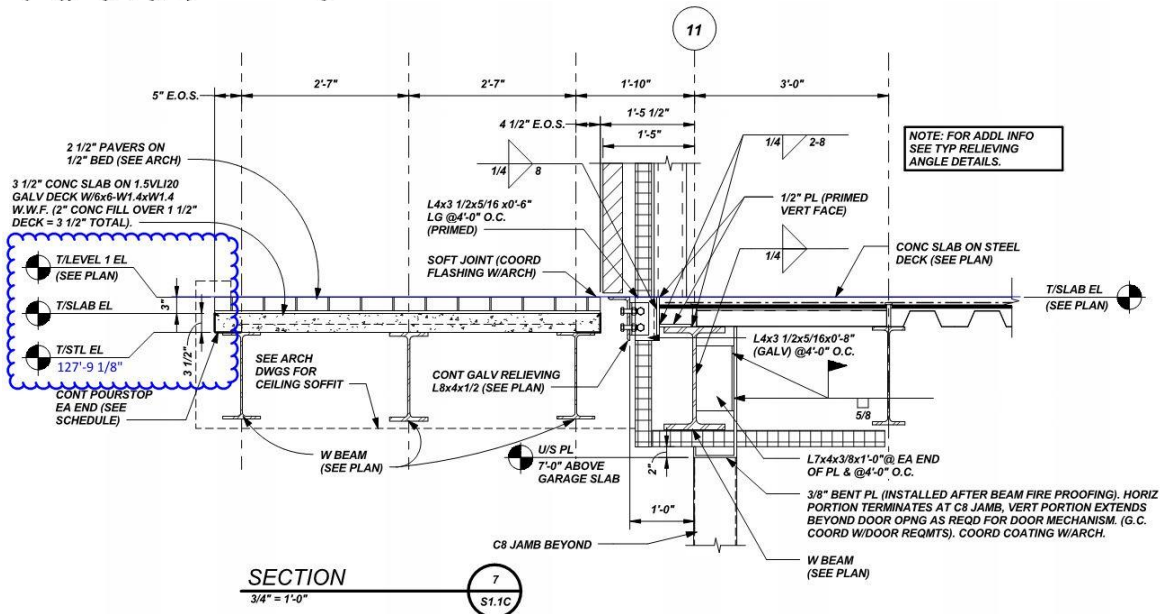
GC note the bearing plate elevations of the beams over the garage entry that pocket into walls G and F are shown at the wrong elevation on the A.B. submittal (off 1"). Additionally the wall height of G and F is at the wrong elevation (off 1"). Convey this information to Giles before wall erection. See section 7/S3.3, section 8/S2.2 and attached for clarification.
