## Field Report

**Project:** Park Danforth New Residence Wing  
**Project #:** 3422  
**Date/Time:** Friday July 8, 2016 9am  
**Participants** Paul Becker (BSE), Ken Theriault (PC)

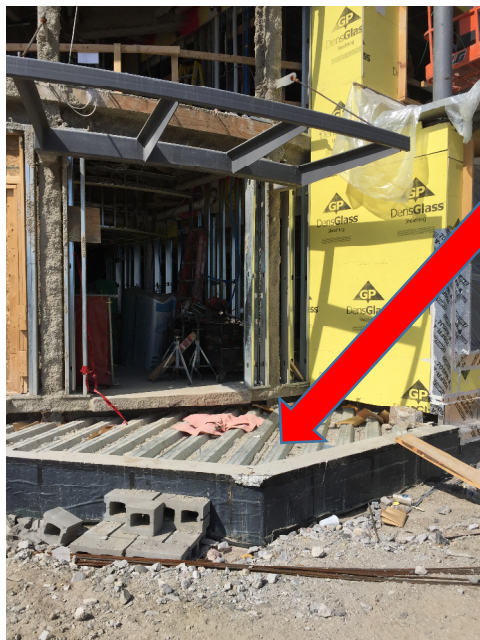
Visited the site to review the existing structure in the vicinity of the A5 Line by the exterior “knuckle” in the building. Earlier in the week the fifth floor balcony column at A5 Line became free during erection and fell to the ground, striking the foundation at the prominent building corner at the intersection of A and E lines. The top of the foundation wall was spalled due to the impact.

**Location of Foundation damage  
at the intersection of A and E  
Lines**

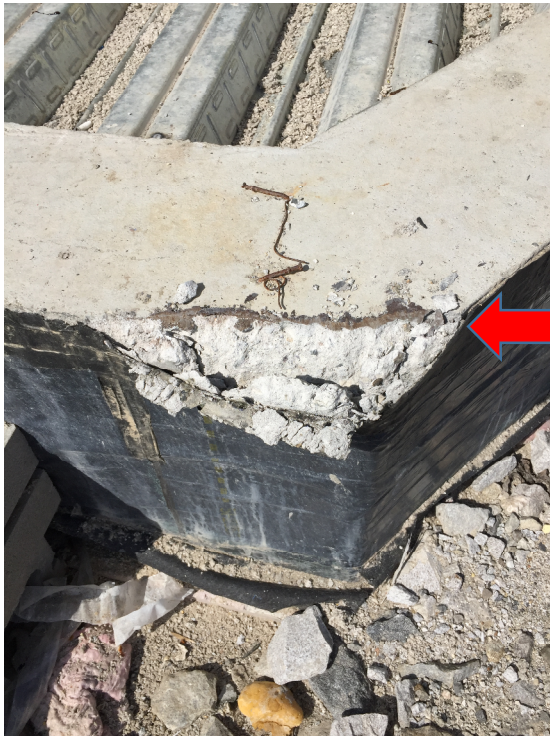
Close up of foundation wall spall

Please refer to below sketch for repair recommendations.
