Field Report

Project: Park Danforth Renovations and Additions
Project #: 3422
Date/Time: 12/30/15 – 5:00 PM
Participants Dan Burne, P.E.

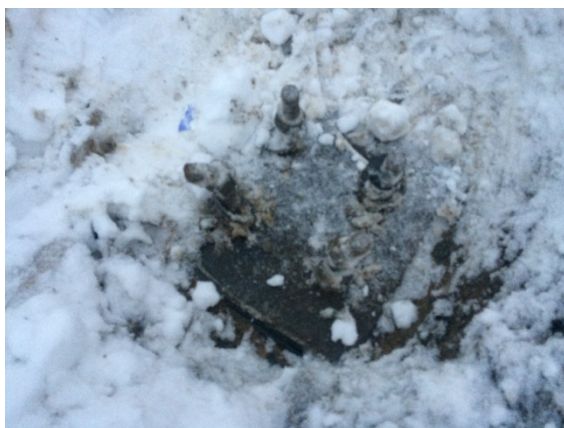
Anchor Group at Column F8

Without the specified plate washers, much thinner standard washers were reportedly procured elsewhere and used above leveling nuts and below anchor rod nuts. At the time of my visit, the column tipping was thought to be initiated at column G8, which is a shear lug location utilizing leveling nuts (versus leveling plates used at non-shear lug locations). The column base plate was supported on the leveling nuts and washers only. Shim stacks or wedges had not been installed below base plate. It was discussed that this column likely settled over the washers pushing the washers through the base plate holes and was able to tip as the same washers could pull through the base plate holes as it began to rotate. The neighboring column at F8 could be pulled with it for the same reason, allowing the washers to be pulled through the base plate holes.

As the crane was still attached, we were informed that the steel could be laid down relatively gently without much damage to the structural steel. Steel damage was observed at various beam to column clip angles. Not all steel was inspected due to the position in the steel pile. Damage to the anchor bolt groups was observed at both column locations in the form of bent and broken anchor bolts. No damage to the foundation was observed and we have requested the GC review further after removal of snow, etc. While on site we requested that any columns still supported by leveling nuts and thin washers be shimmed with steel shims and that all top washers be replaced systematically with the specified plate washers. We issued anchor bolt repairs on 1/4/16.
