CONSTRUCTION OBSERVATION REPORT

Project: The Park Danforth

S.W.COLE Project No.: 14-0065.2

Date: 7/5/16

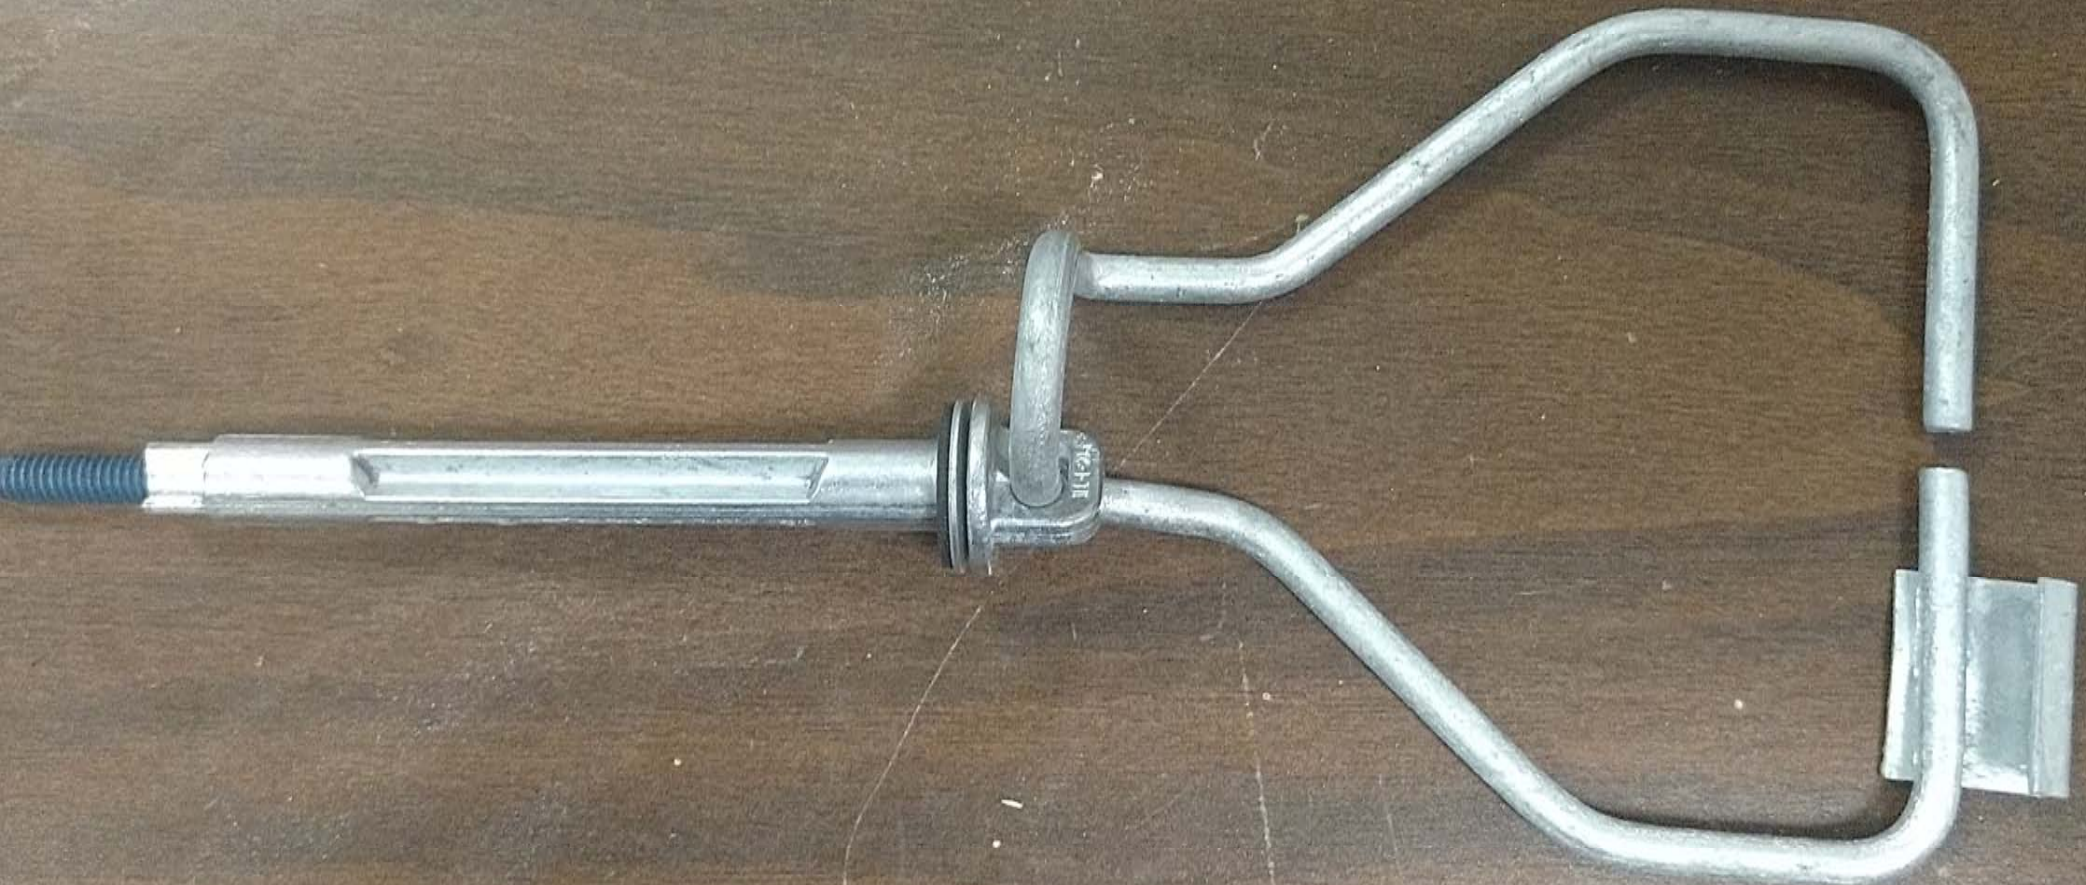
Heckmann Pos-I-Tie & Seismic Triangle - galvanized
utilized for masonry veneer anchors

Masonry veneer anchorage @ 16" O.C. E.W.

through light gage framing members typical

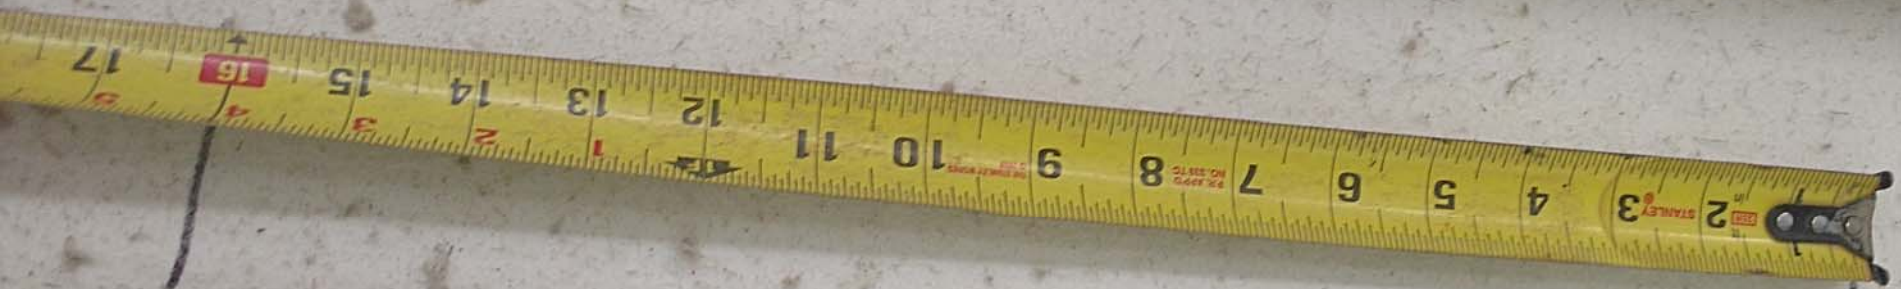
Masonry veneer anchorage not observed to be at 8" O.C. at perimeter of openings and end of panels

Prior to leaving the site we discussed observations with Custom Masonry (Bill) and PC (Kemp) and understand going forward anchors will be spaced as detailed in the project specifications.
