Field Report

The Park Danforth **Project No:** 13-059-00
Portland ME **Field Report No:** 23

To: Mark Donovan **Time of Visit:** 8:30 AM
 PC Construction **Date of Visit:** 11/8/2016
 131 Presumpscot Street **Weather:** Sunny, Clear (40F-60F)
 Portland ME

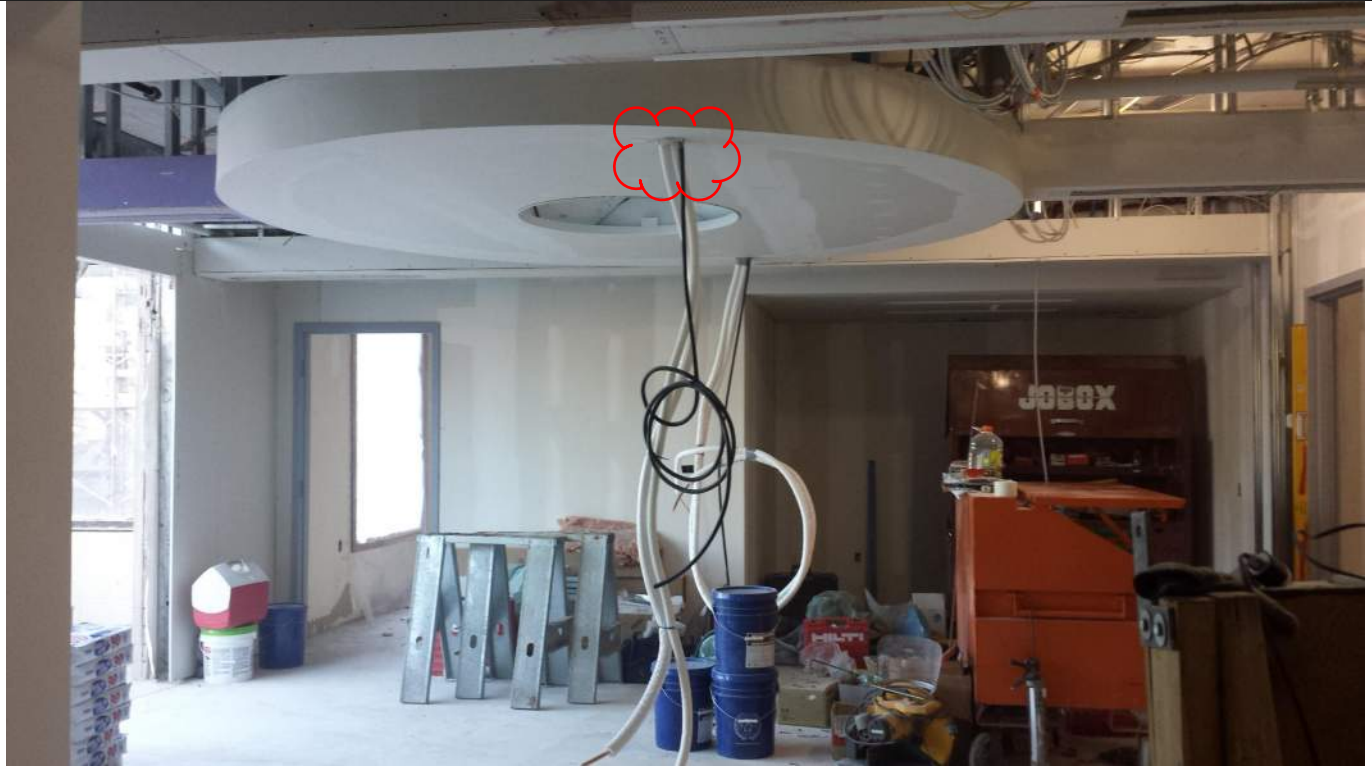
23.02	In the Wellness Center 126, AC ceiling cassettes should be mounted in the ACT ceiling, not the drywall cloud. See image A P 12 of 17	CM follow up

See note 23.02.

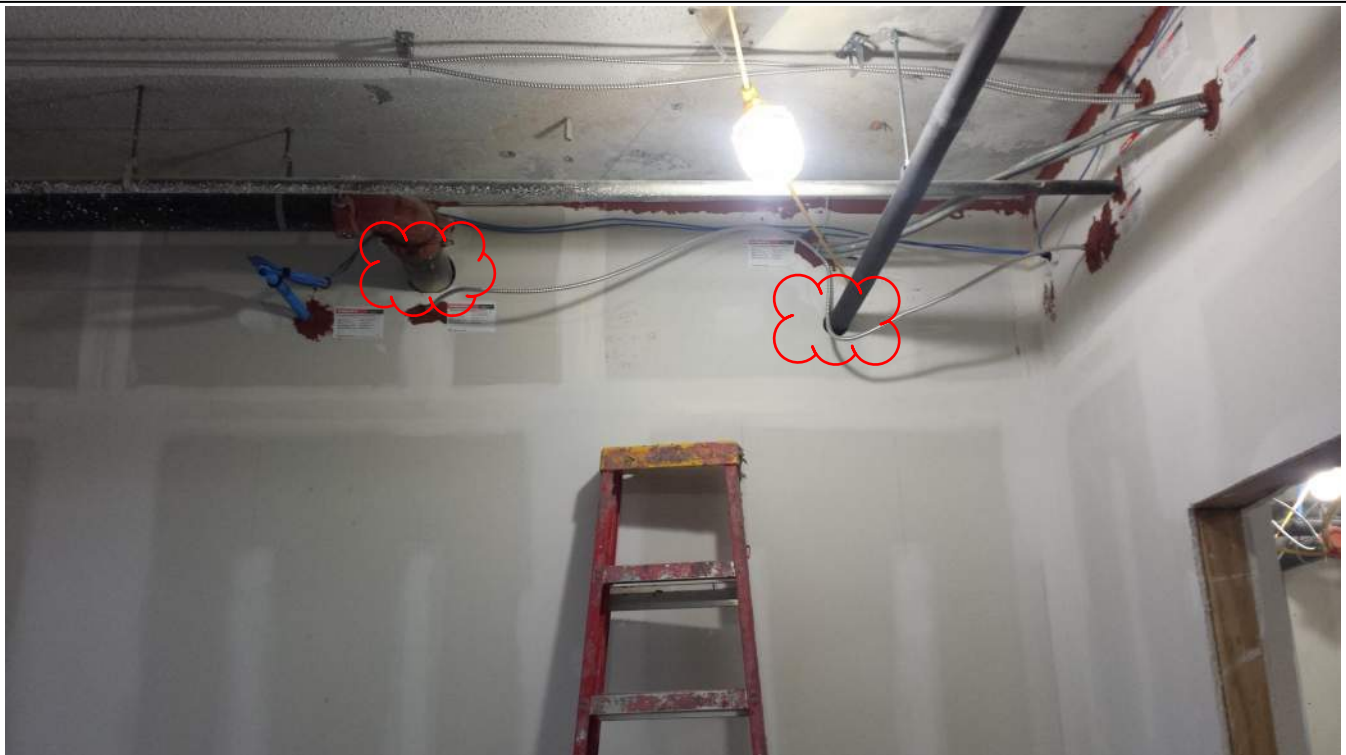
23.03	Wall penetrations between the Beauty Salon and the Stair tower should be consistently tagged and sealed. See image B P12 of 17.	Correct Work
23.04	Firespray underside of roof deck in connector and untreated columns. See Images A and B P13 of 17.	Correct Work

See note 23.03. Beauty Salon 128 shown.

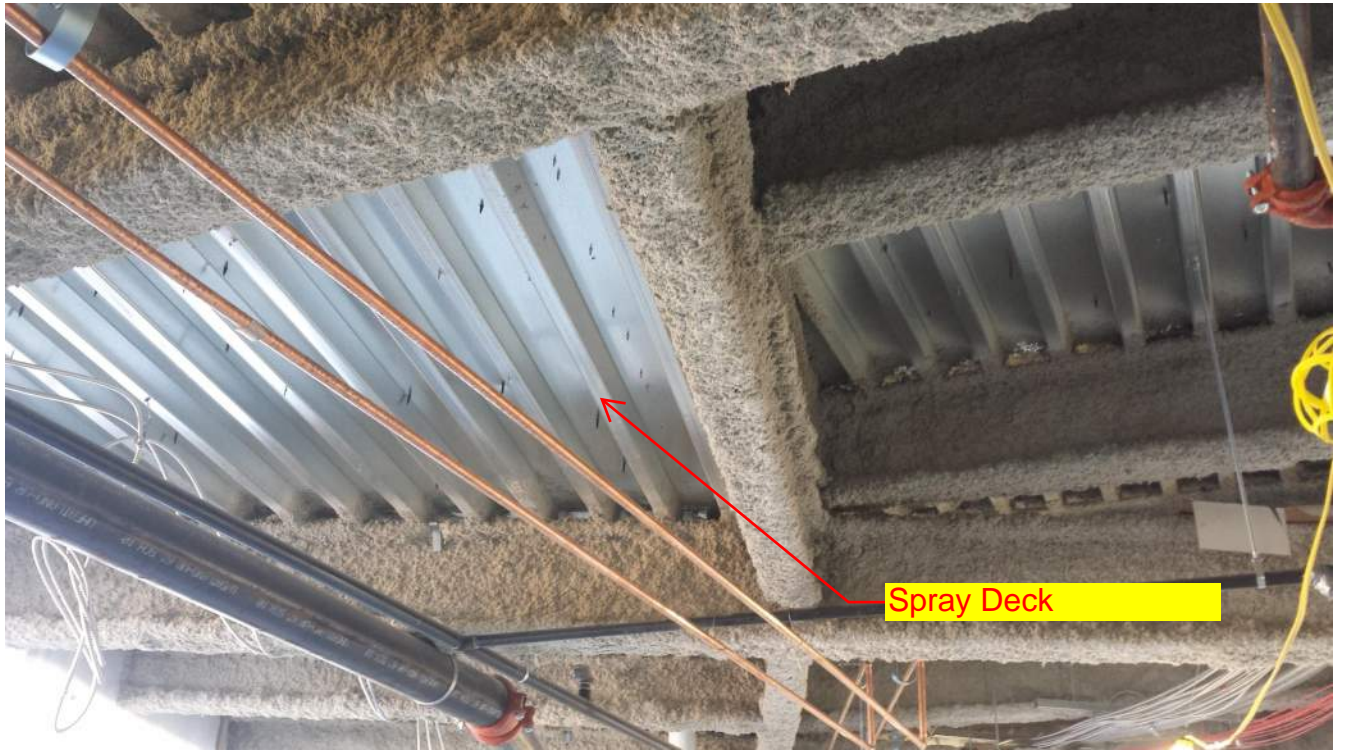
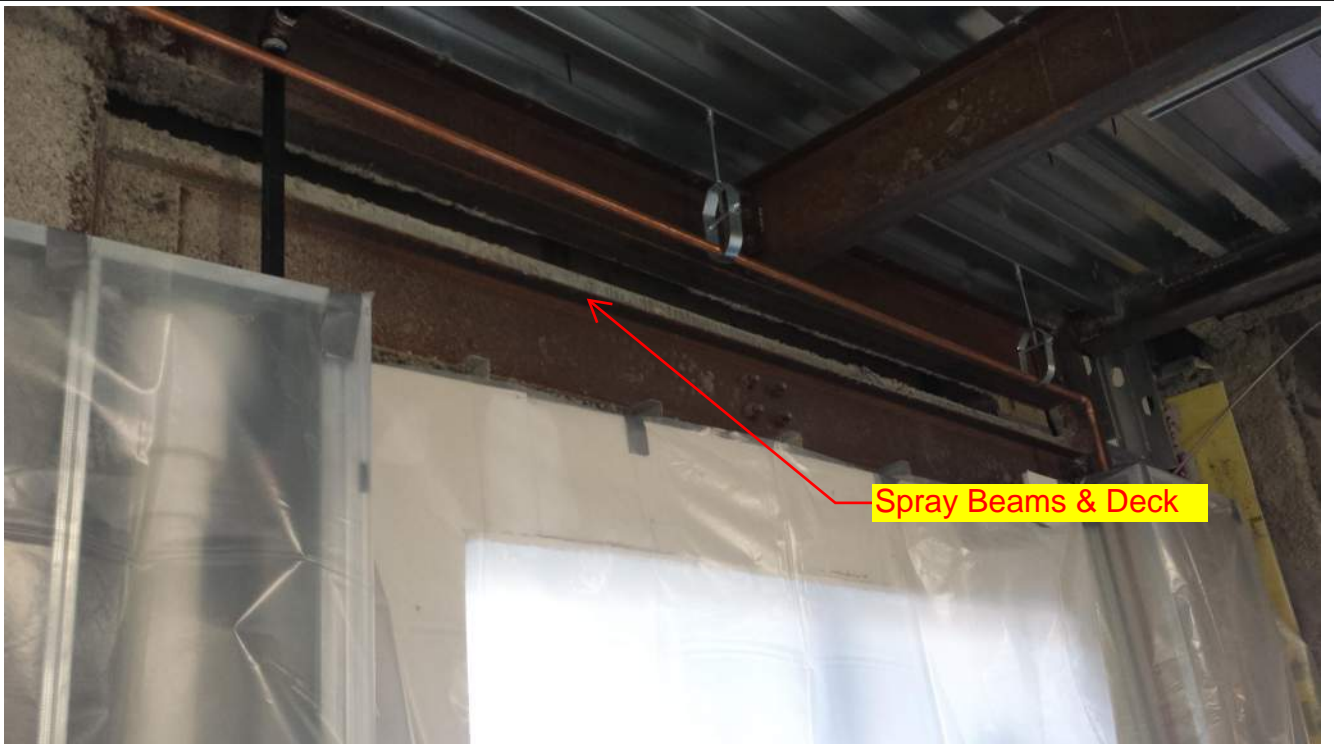
See note 23.04. Connector Corridor 141 shown

See note 23.04. Connector Corridor 141 shown.

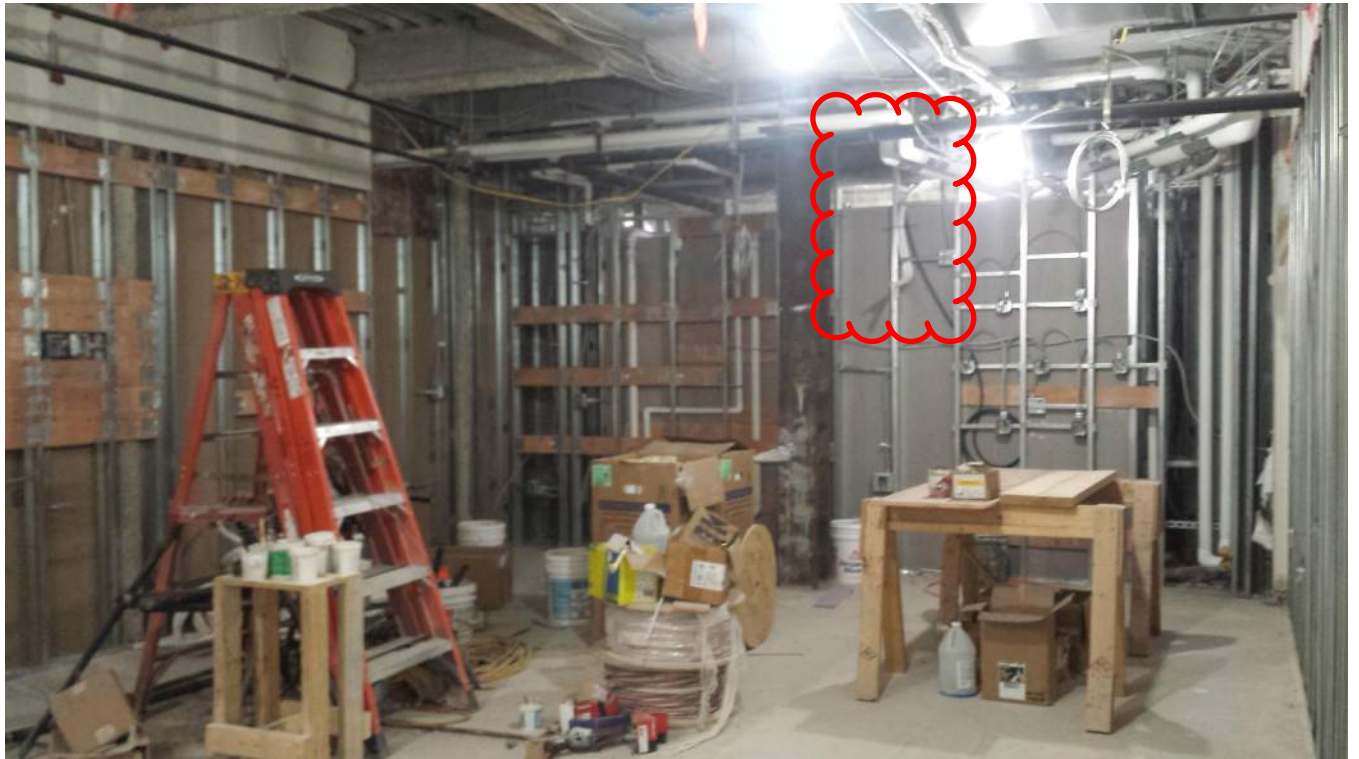
23.05	Relocate supply line for A/C unit in Media Room. Current location will interfere with light artfixtures on wall. Reference RFI 286 See image A P14 of 17	Correct Work

See note 23.05. Media Room 137 shown

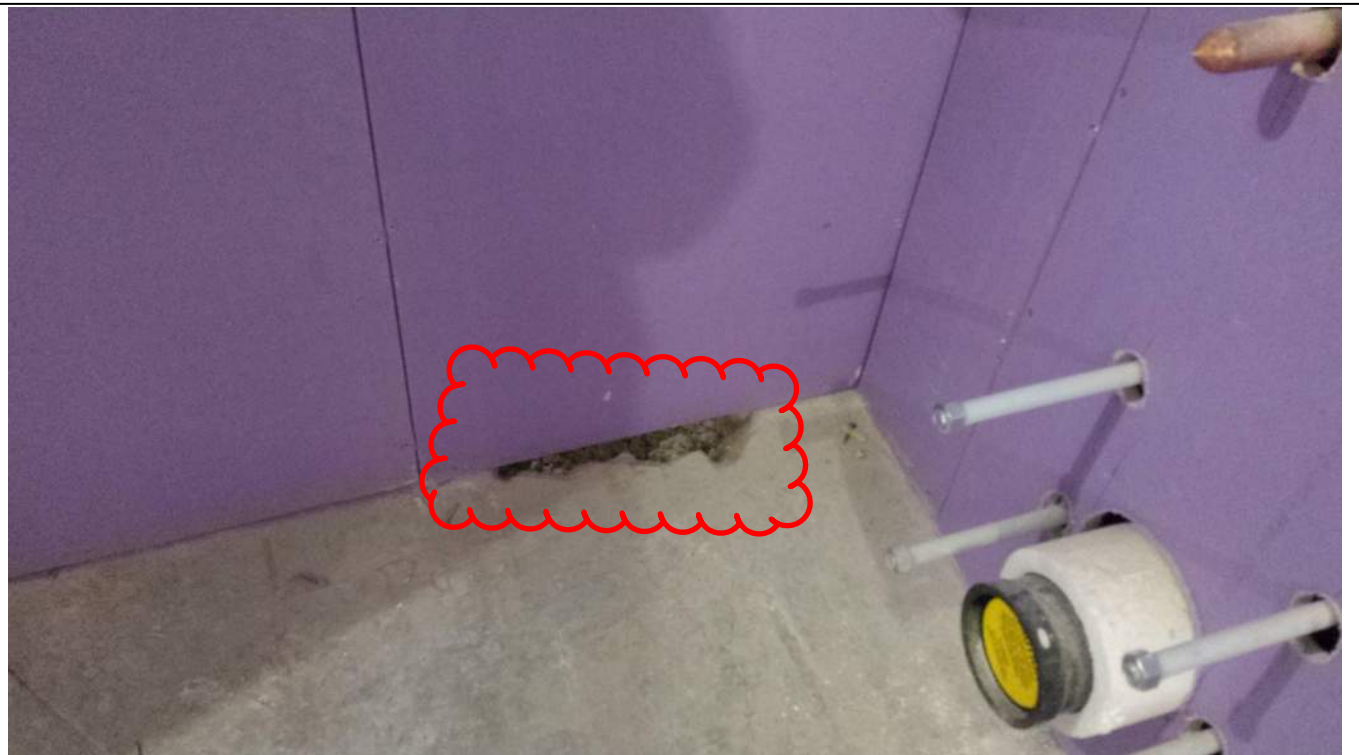
23.10	Fill gap in concrete slab at base of wall. See image B P 14 of 17	Correct Work

See note 23.10. Men's Toilet 145 shown.

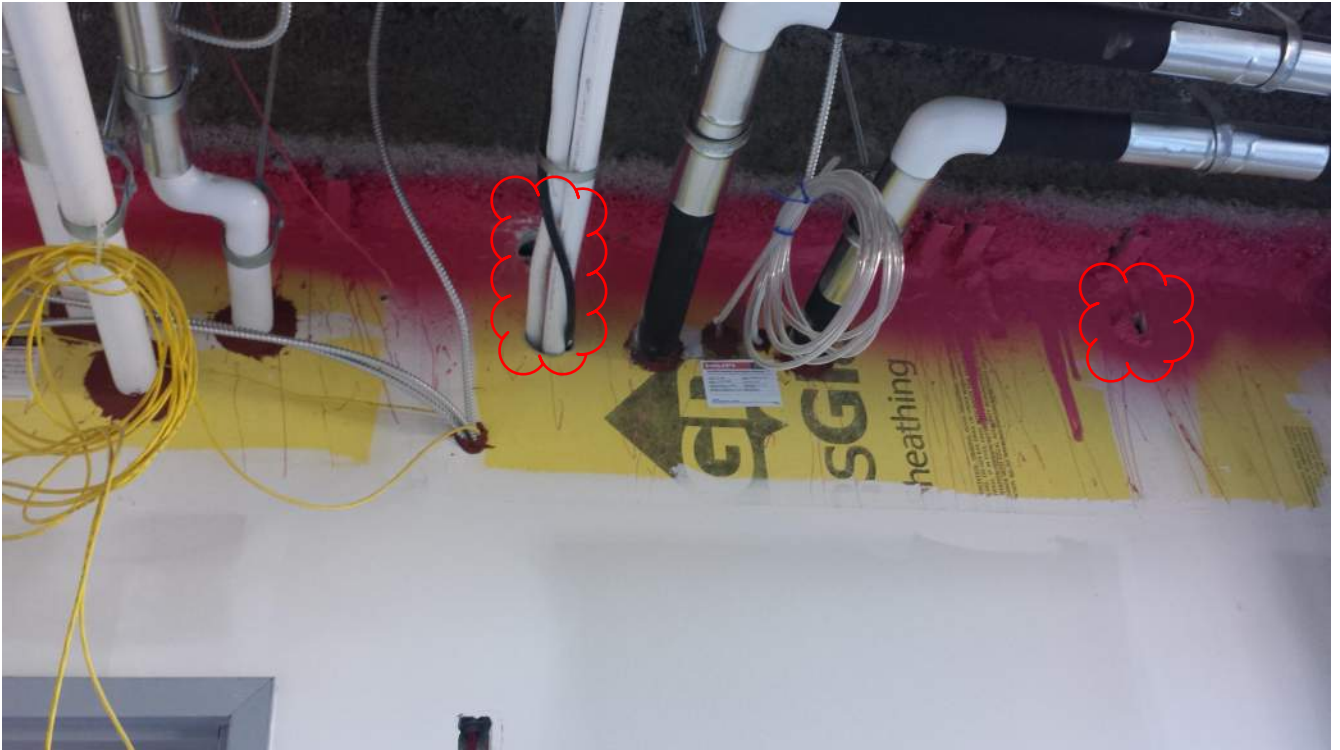
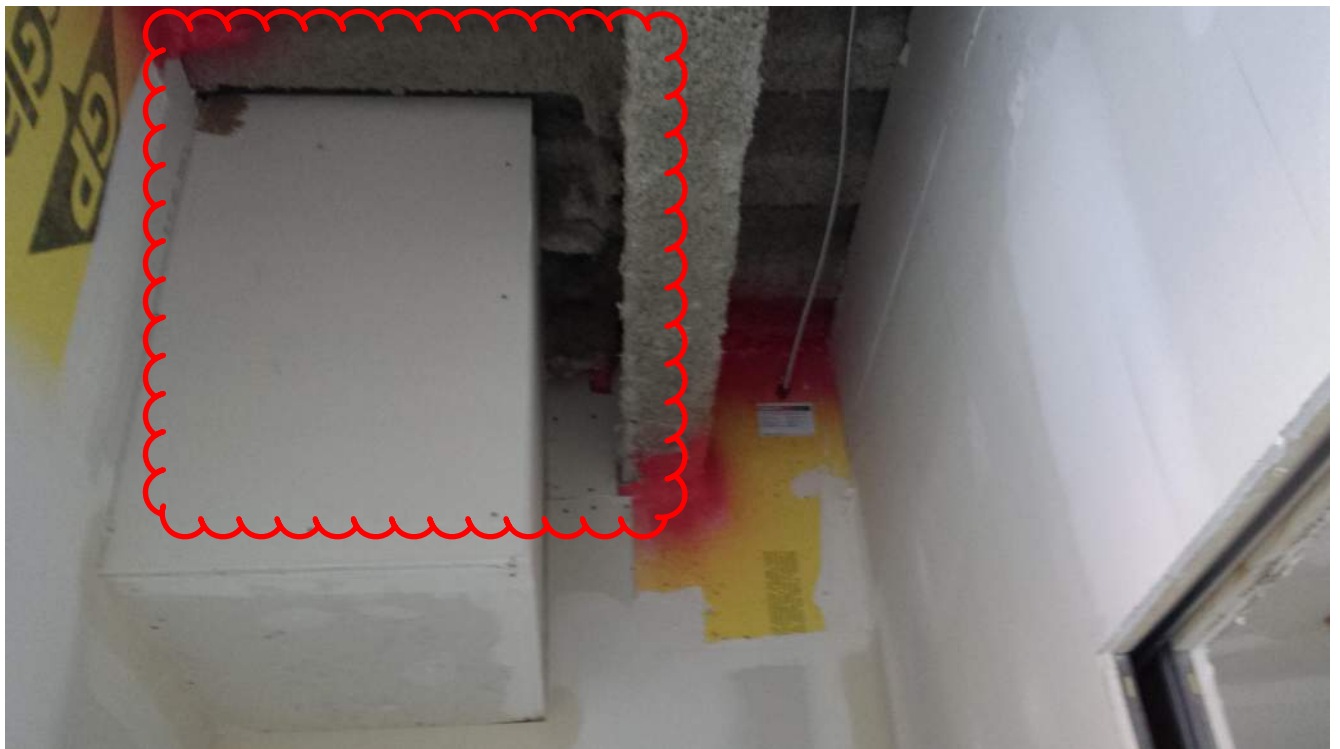
23.06	Ensure firesealing is continuous at through wall penetrations and intersections with structure/deck. See images A and B P 15 of 17	Correct Work
23.07	Ensure wall penetrations are sealed for acoustics. See image A P16 of 17	Correct Work

See note 23.06. Human Resources 1002 shown

See note 23.06. Break room 1005 shown

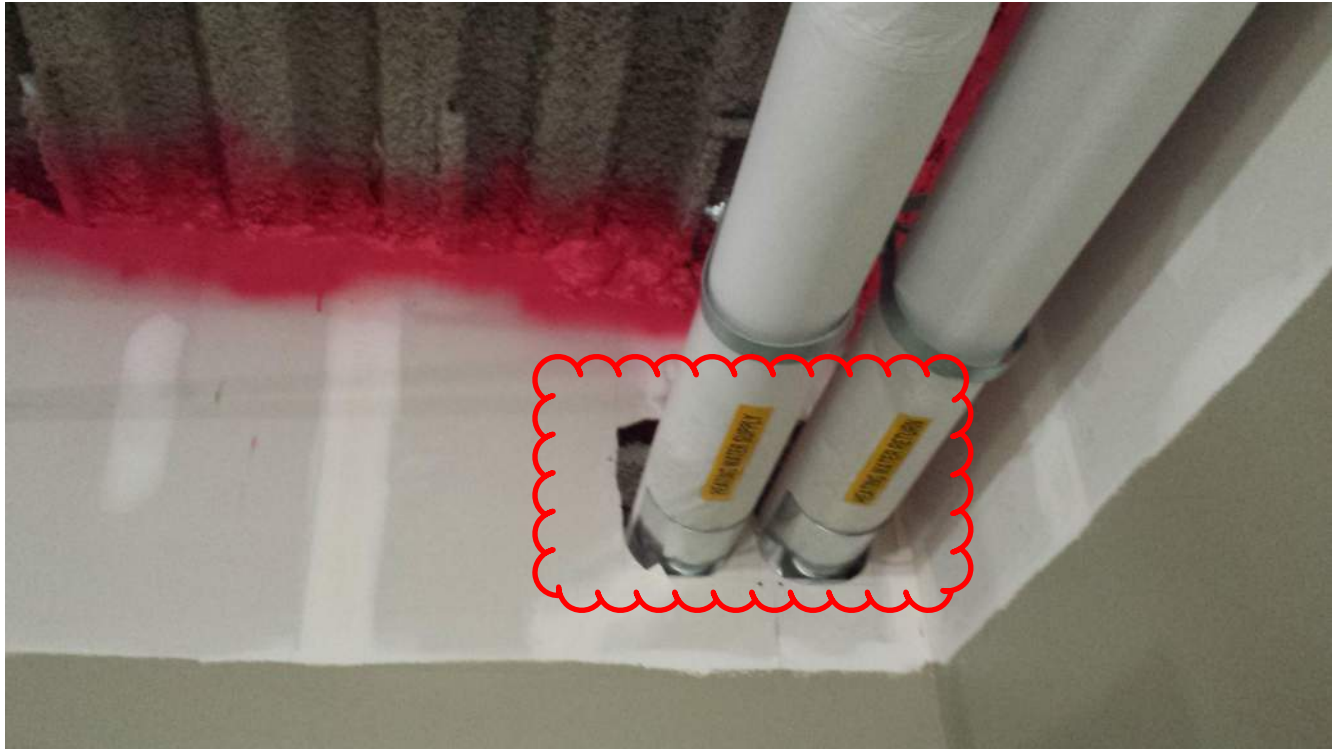
A

See note 23.07. Board Room 1006 shown.

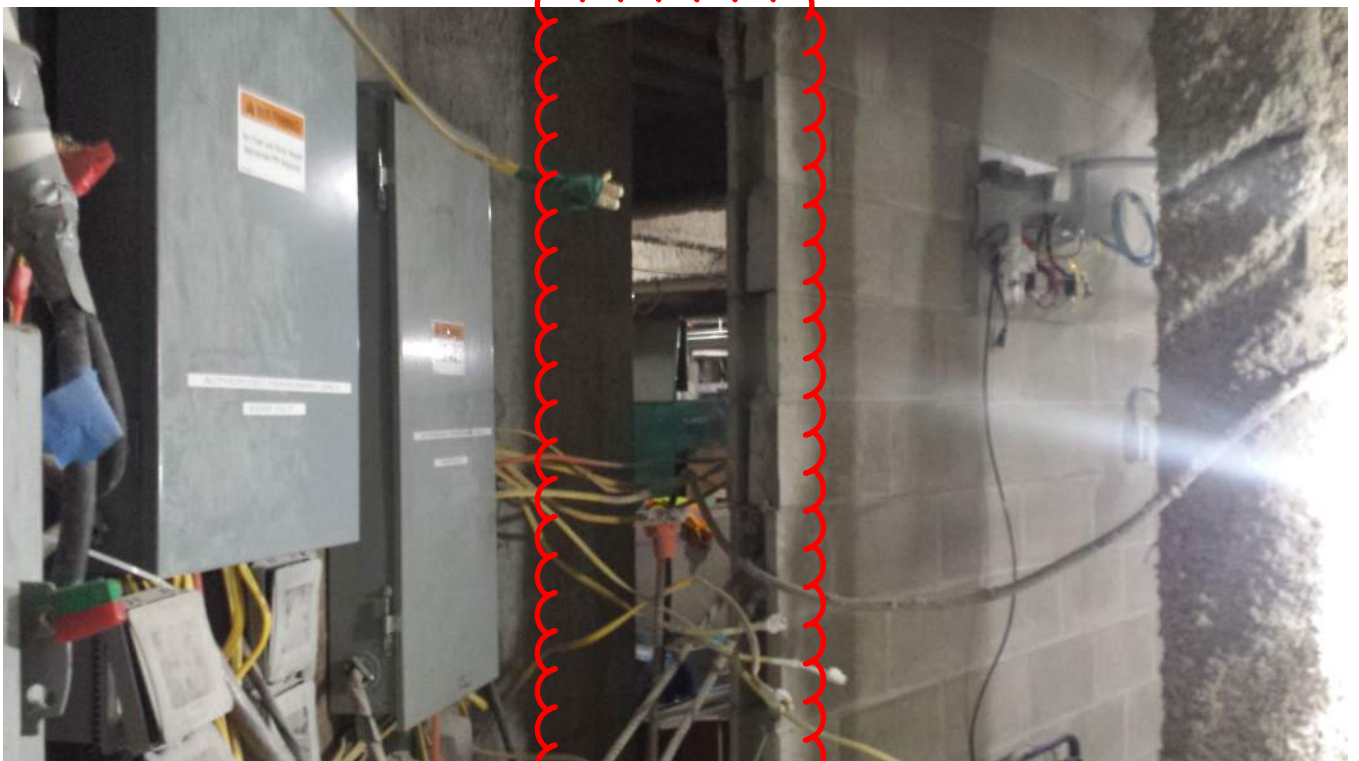
23.08	CMU wall enclosing Trash Collection G009 is not complete. See image B P 16 of 17	Correct Work
23.09	Storefront at emergency door from Roof Deck 5014 to Corridor 5011 is not sealed. Gap size should match the other storefront windows at roof deck. See images A and B P17 of 17	Correct Work

See note 23.08. Board Room 1006 shown.

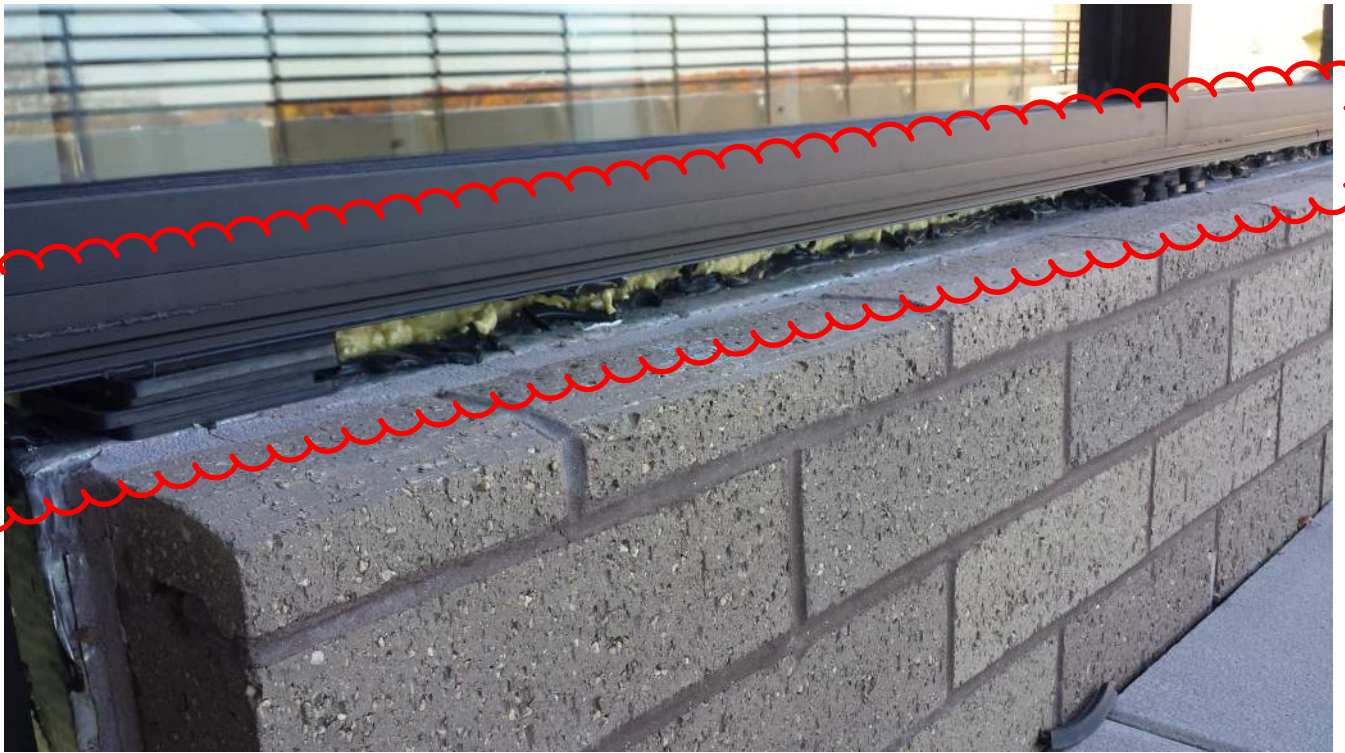
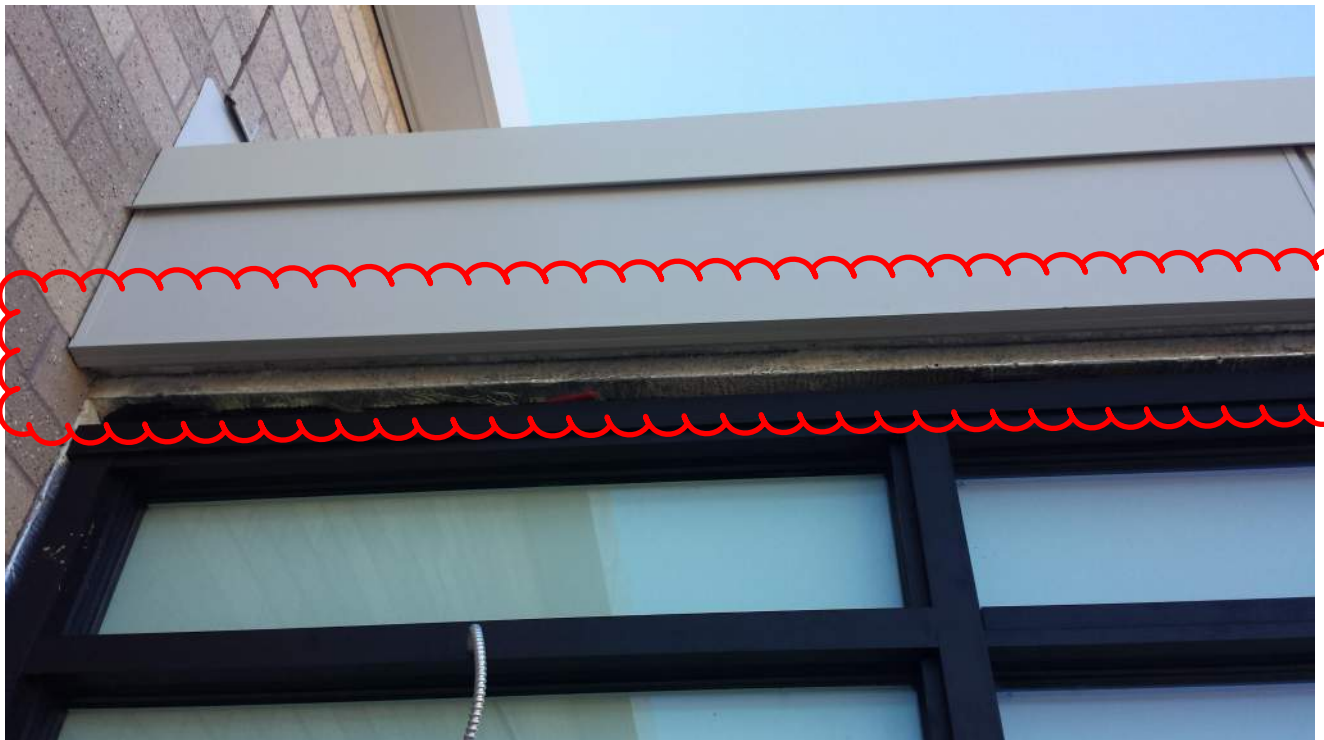
See note 23.09
